CITY OF LEE'S SUMMIT
Development Services Department
220 SE Green Street
Lee's Summit, MO 64063
(816)969-1200

Inspection Summary

Permit #: PRCOM20235733

Address: 209 SE GREEN ST, LEES SUMMIT, MO 64063209 SE GREEN ST, Unit:IR, LEES SUMMIT, MO 64063

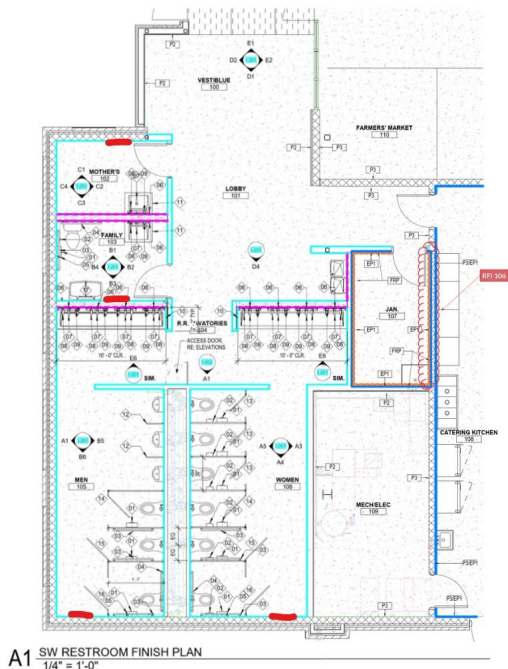
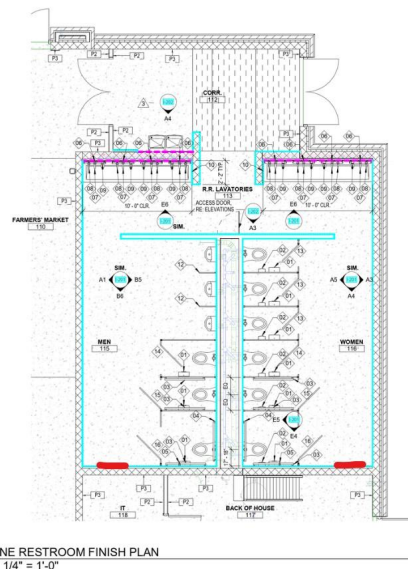
Comments: The top of the mirror should be roughly 80" AFF. We need to be 74" AFF to top of mirror and the lower edge can be no higher than 35" which shouldn't be a problem with a 60" tall mirror. We will need 6 mirrors, one for each restroom and the Family and mother room. In the below sketch we would place them in the red line locations. We are putting the new mirrors at the far end of the restroom so that they are near the ADA stall and don't introduce any sight line issues.

5)Accessible Mirrors. Contractor needs to install one full length mirror. Doing

so will meet the intent of the IBC for accessibility purposes. Revis plans showing the accessible mirror and location of sinks. **See mirror information below**

Initially, we considered requesting a variance due to the fixed height of the installed mirrors. However, after further discussion with the owner, we are moving forward with the installation of **full-length mirrors** in each restroom near the ADA stalls. This solution not only addresses accessibility concerns but also enhances usability for a broader range of individuals.
