# Inspection Report

## Hydro Physics Pipe Inspection

4421 SW Grindstone Cir, Lee's Summit, MO 64082

Inspection Date 6/10/25

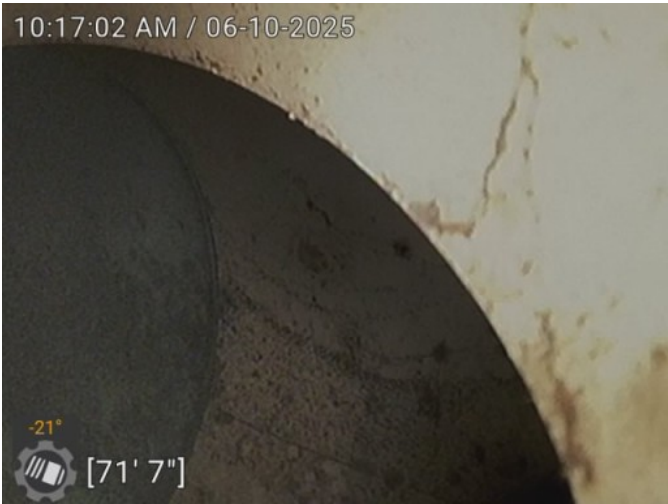
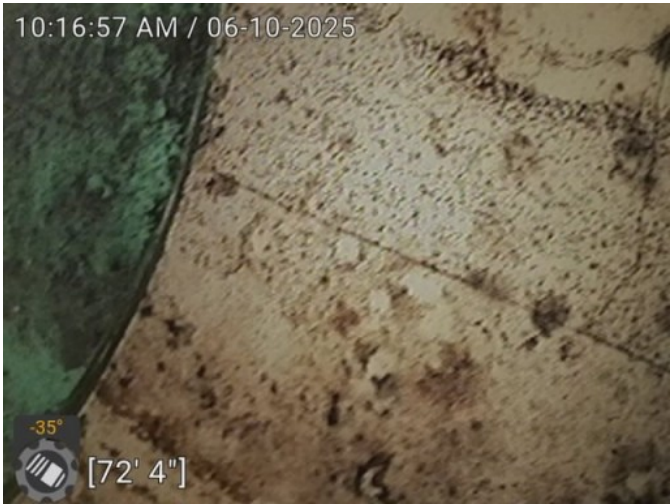
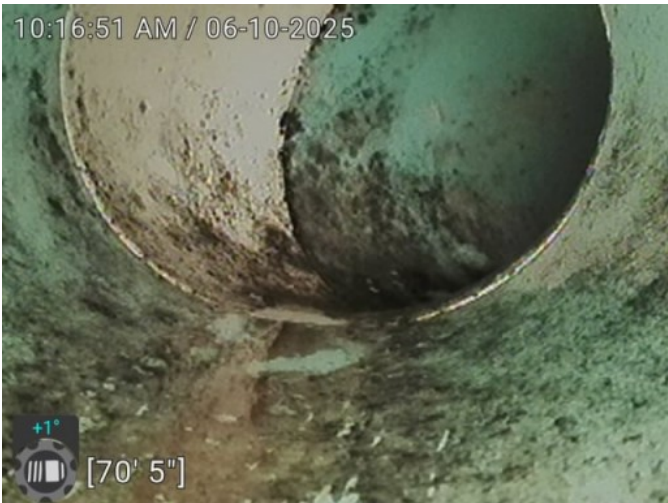
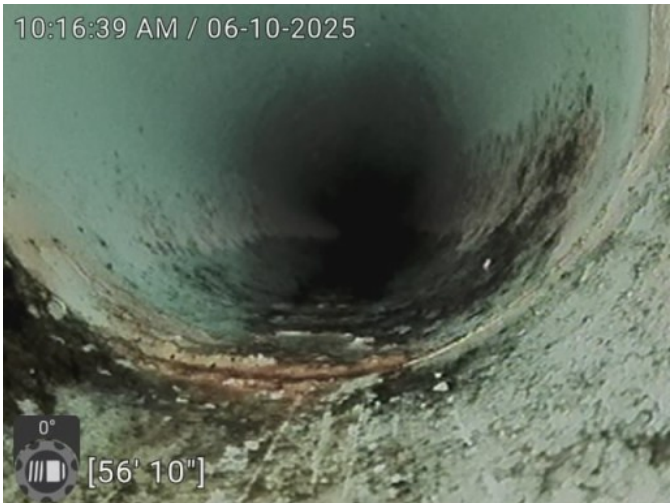
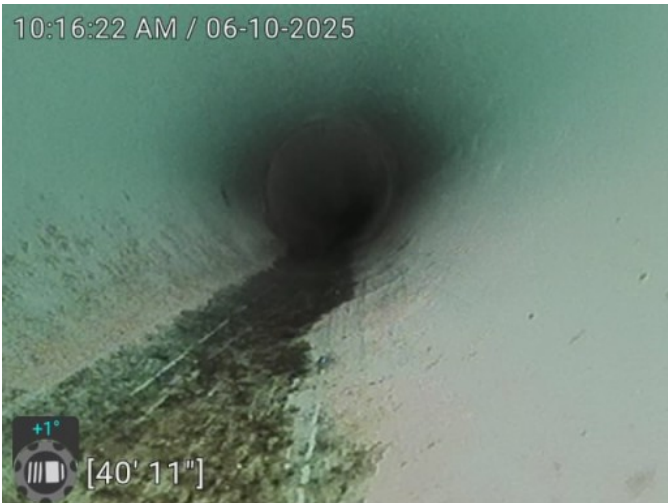
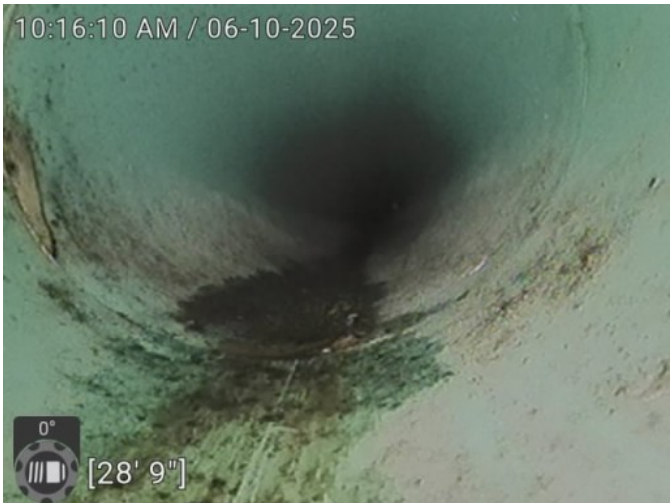
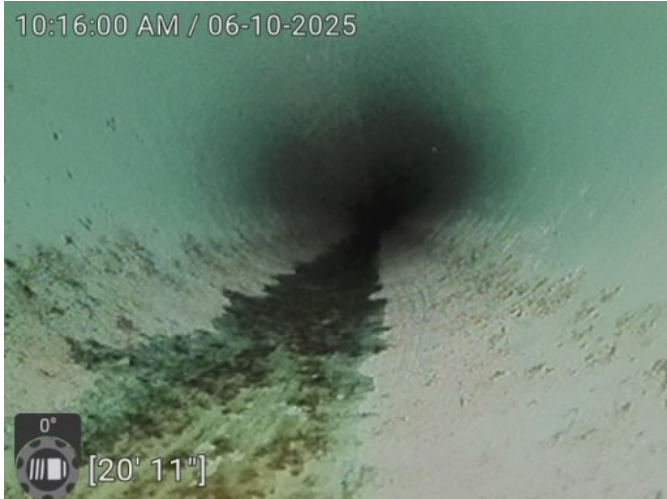
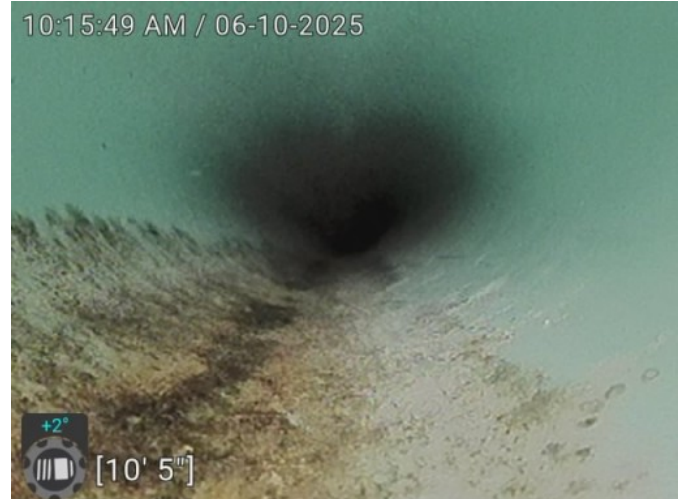
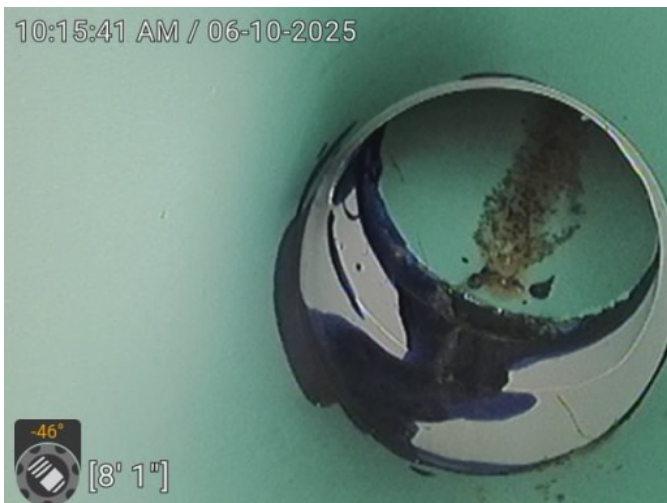
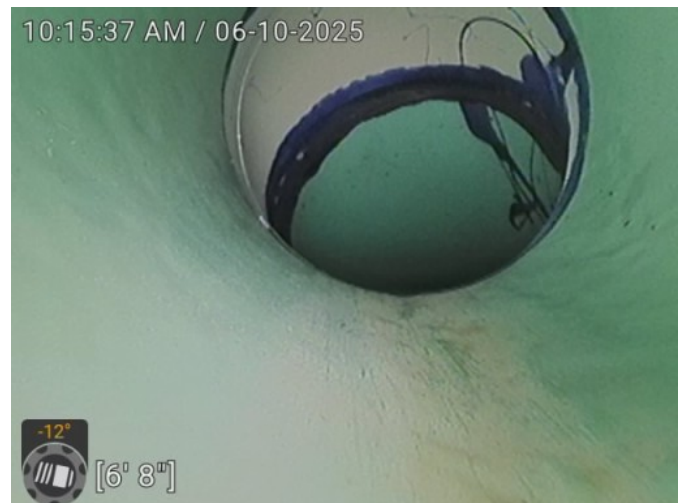
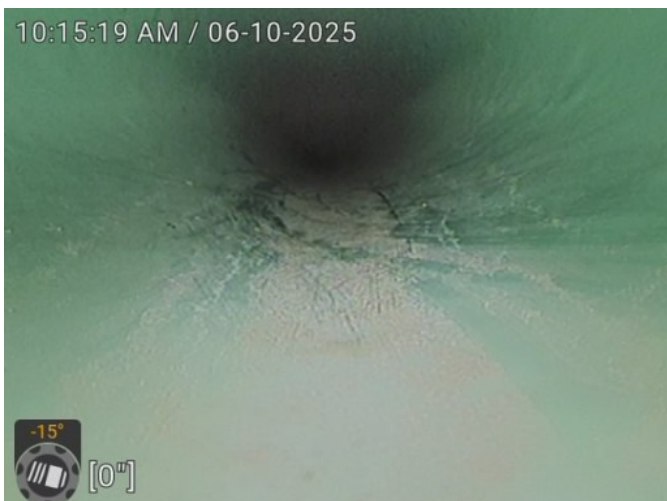
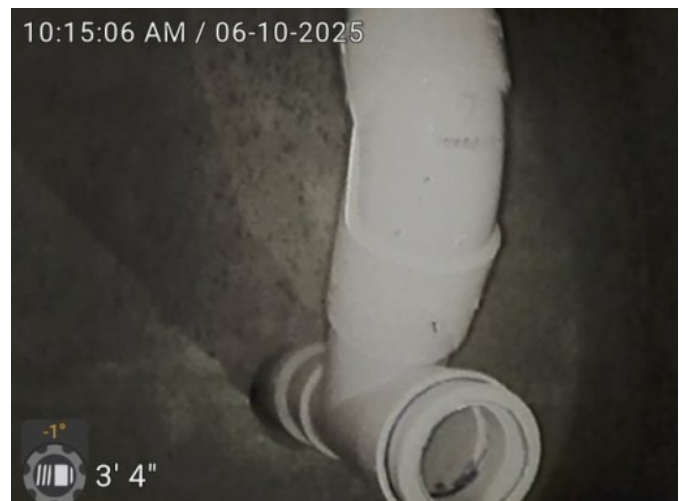
#### 1.5) OUTSIDE PIPE

The line is SDR plastic pipe 0Ft to 71Ft.

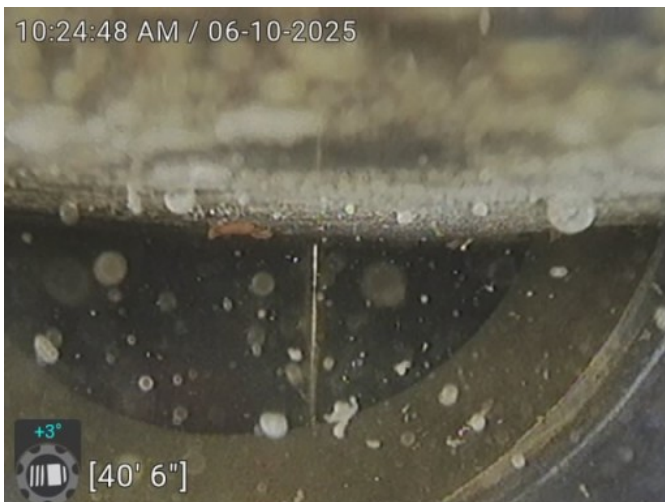
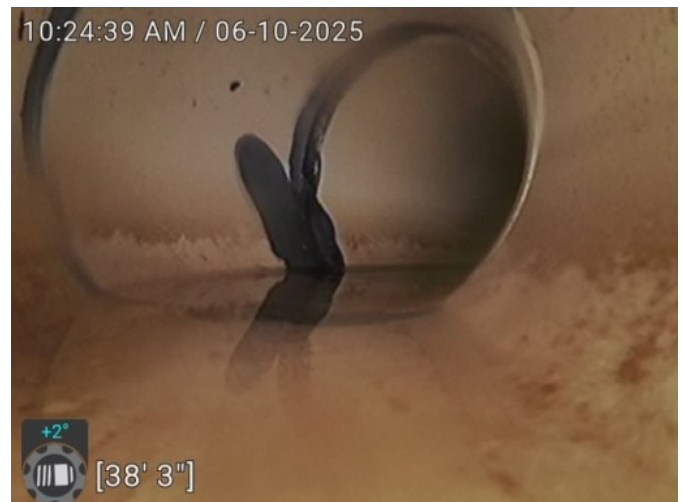
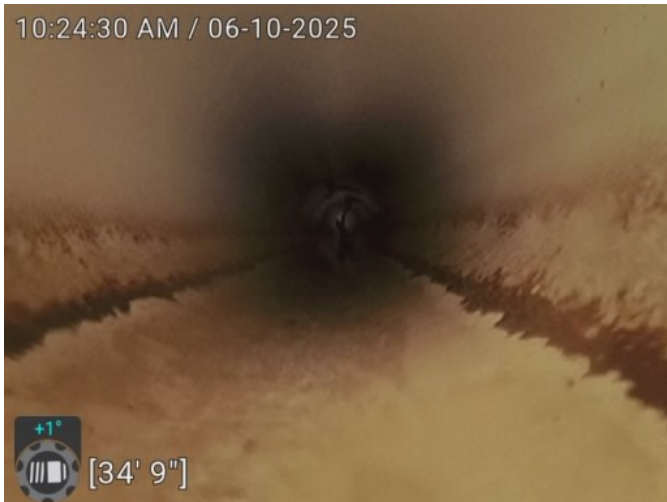
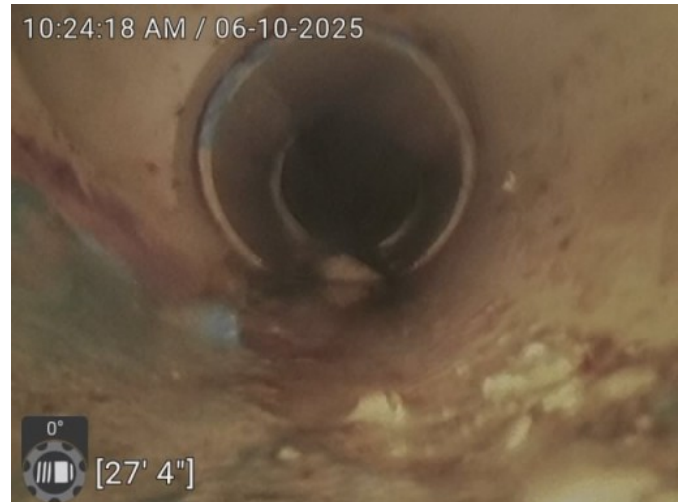
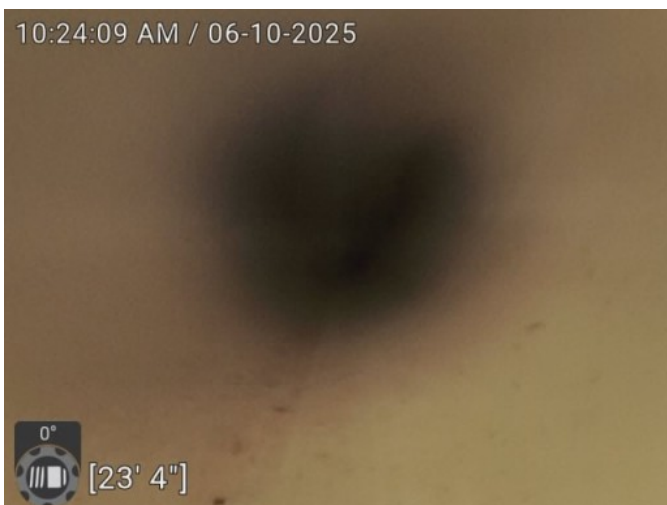
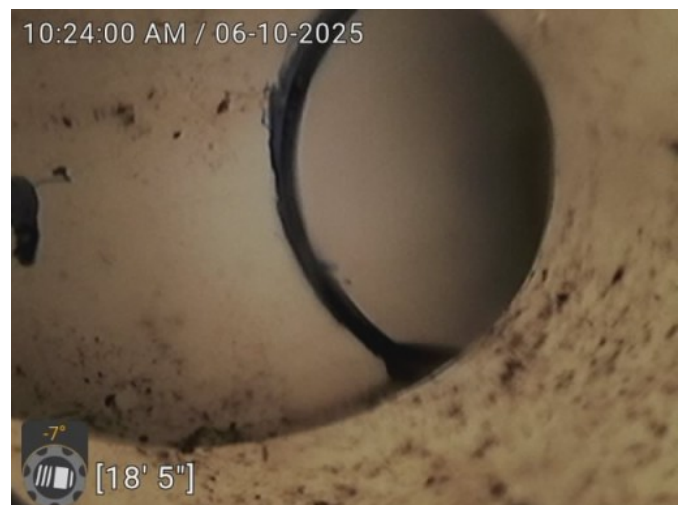
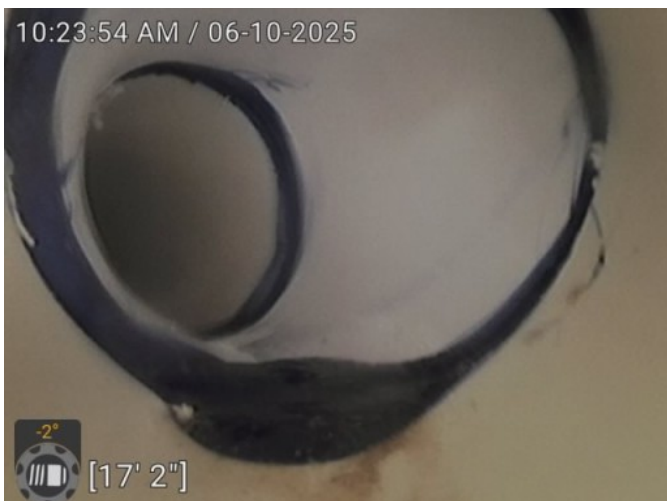
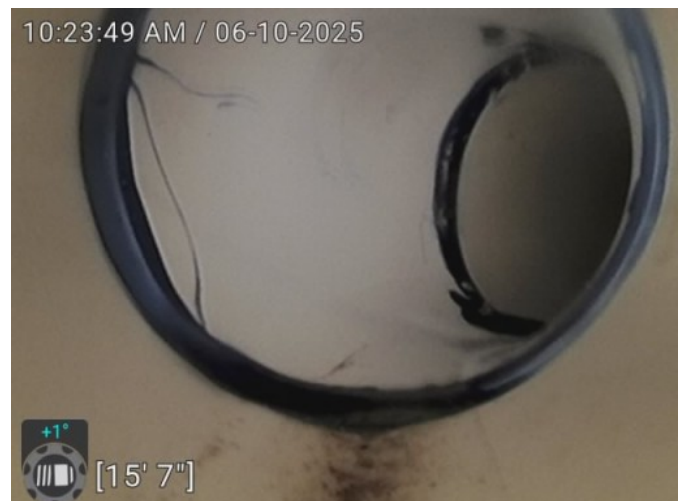
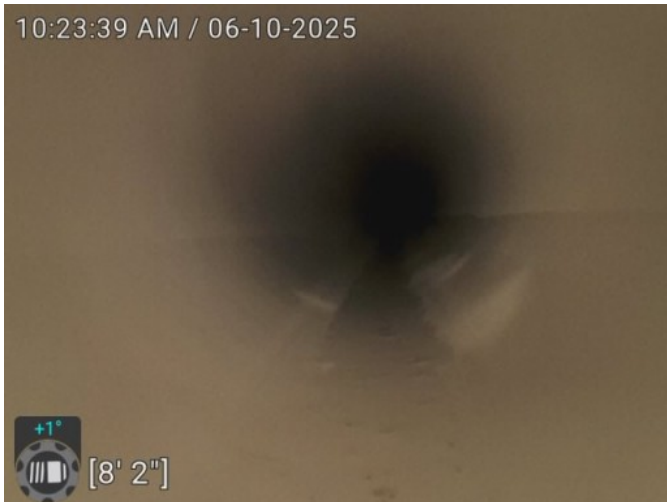
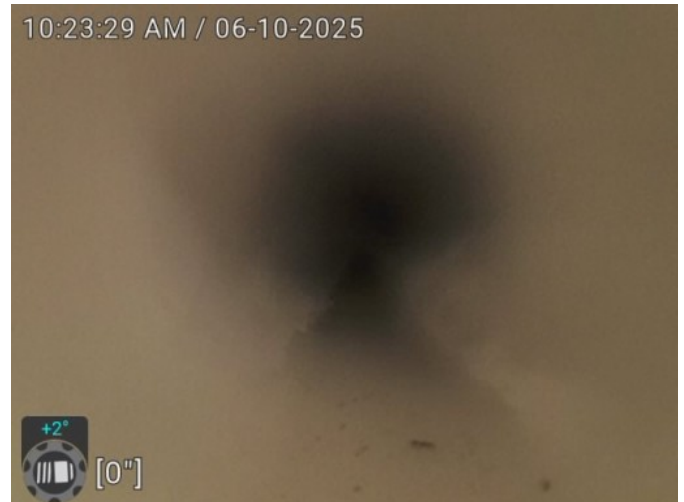
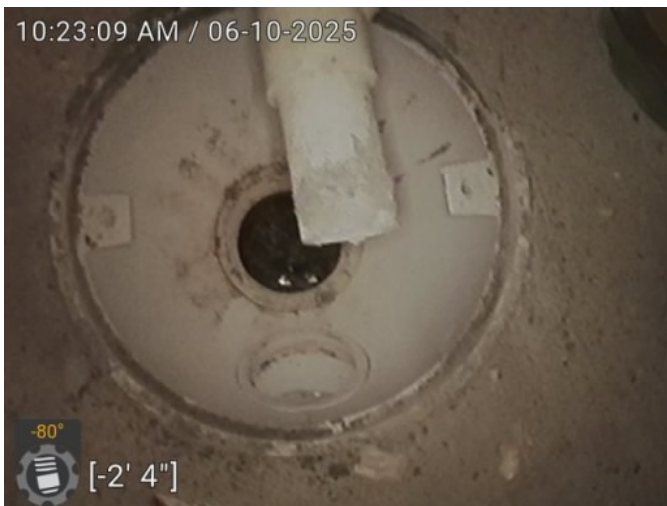
Photos from 2nd run

Run 2 Ran camera downstream from Floor Drain 40Ft to Grinder Pump.

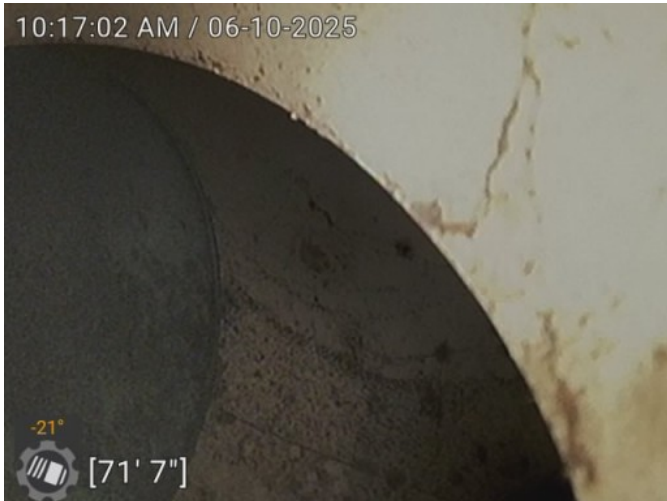
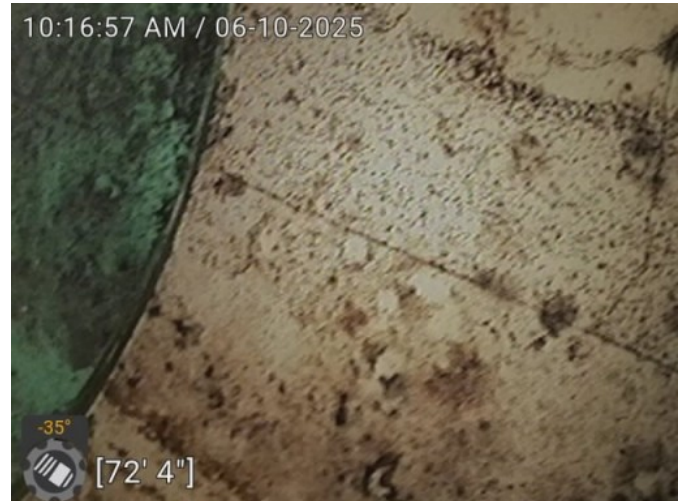
#### 1.13) CITY MAIN, SEPTIC TANK, MAX RUN

The main line runs to the city main at 71ft.

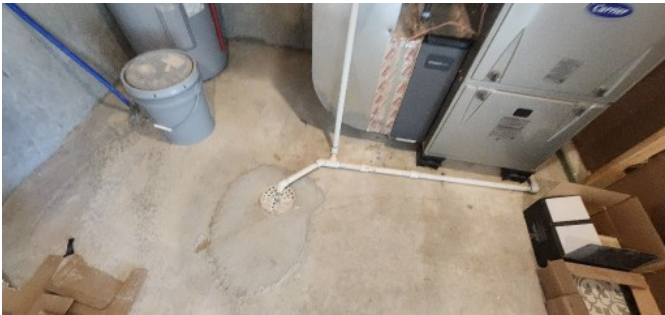
#### 1.14) FLOOR DRAIN

see other notes
