Construction Services
Emergent Care Plus – Primary Care Suite
2741 NE McBaine Drive
Lee's Summit, Missouri 64064
Project No. 122792

DISCREPANCY LIST

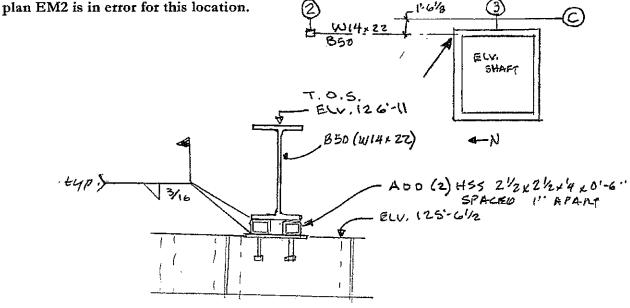
Status		atus	
ltem	Open	Closed	Discrepancies
1	1/5/12	,	Roof frame, W12x22 beam bearing on northeast corner of elevator
			shaft was shimmed up to bearing elevation using two 2 ½" x 2 ½" x 3/16
			square tubes 6 inches long due to embed plate in masonry wall
			installed at incorrect elevation. Tubes were welded to embed plate
			and beam with ¼" fillet welds along both sides of tubes. Review
-			and response by the engineer of record is required.
		1/12/12	As-built condition is acceptable per the attached response to RFI #15
			from Mr. John Funk with Hollis & Miller.

This is a confirming RFI to verify the phone conversation between John Funk of Hollis & Miller and Gene Asher of Doherty steel to use (2) HSS $2\frac{1}{2} \times 2\frac{1}{2} \times 2\frac{1}{4} \times 0^{2}$ -6" side by side, shimming the south end of roof framing beam B50 (W14x22) to the embed plate (see below).

The bearing plate for referenced beam was installed 2 ½" low due to Doherty embed

The as-built condition of the structural framing modification identified in item No. 1 in the enclosed Discrepancy List is acceptable per the attached response to RFI No. 15.

This is acceptable.
