REINFORCING STEEL OBSERVATIONS REPORT

Report Number: 02251170.0078
Service Date: 07/09/25
Report Date: 07/10/25
Task: 03 - Concrete Special Inspection & Testing

Waterway Lee's Summit
1000 NW Pryor Rd.
Lee's Summit, MO 64081

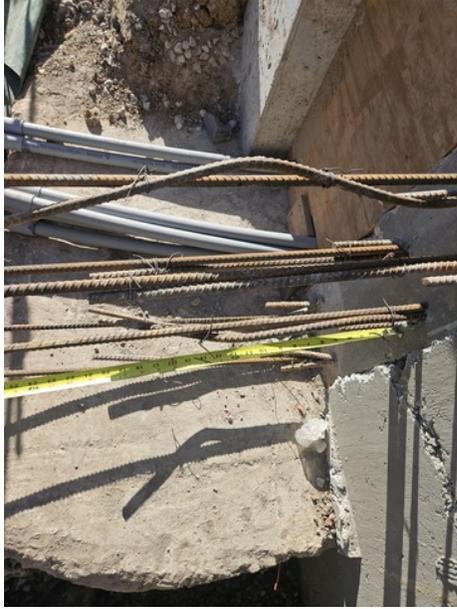
Element	Location	Referenced Documents	Status	Comments
Continuous footing	(1) A/3	S0.0.1	DOES NOT Comply	*DEVIATION* Lap Length: Lap splices from previous pour are 21". See Photo P1.
Slab-on-grade	(2) Pits at B.5/3-4	Detail 2 sheet S2.1	DOES NOT Comply	*DEVIATION* Lap Length: Lap slice Lengths are as low as 6" Installation was not performed with current plans. New plans were NOT available. See Photo P2 and P3.
Slab-on-grade	(2) Bottom of Pits A-C/3-4	S2.1 Detail 1	DOES NOT Comply	*DEVIATION* U bars at bottom of both trenches are in a horizontal orientation. Detail1 on S2.1 shows they are to be installed in a vertical orientation. See Photo P9.
Continuous footing	(3) A-D/1-3	S0.2, S1.0	Complies	Slab dowels for CMU wall were wetset. All other issues noted on report 02251170.0074 were resolved prior to concrete placement

(P1) Laps @ A/3 from previous pour

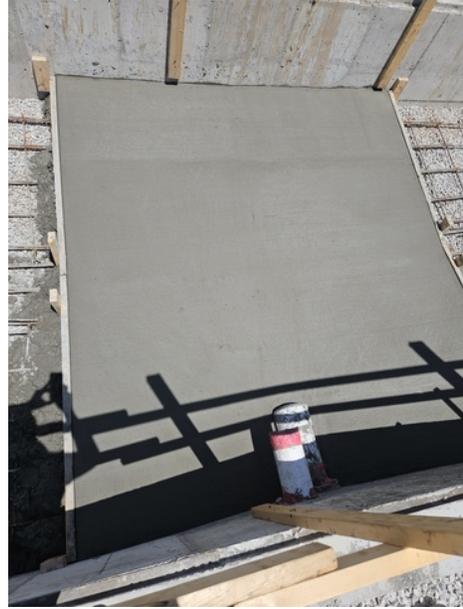
(P7) Pit at B.5/3.5 post concrete placement

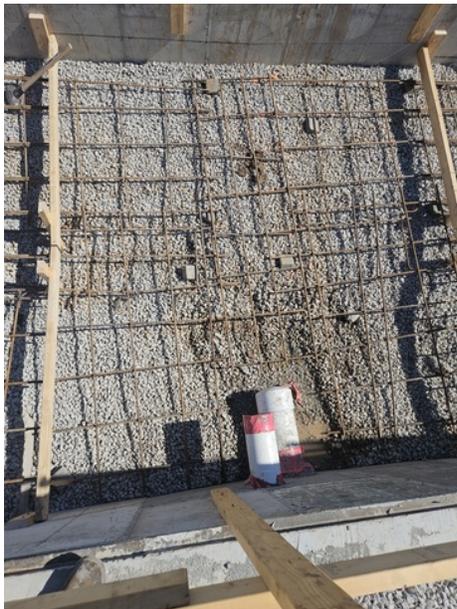
(P2) Pit at B.5/3.5

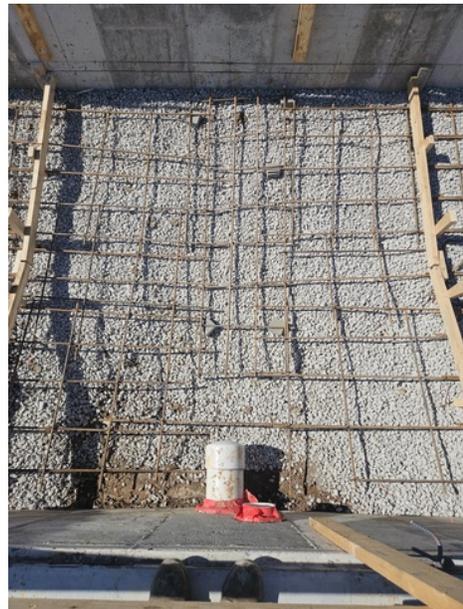
(P3) Pits at B.5/3.75

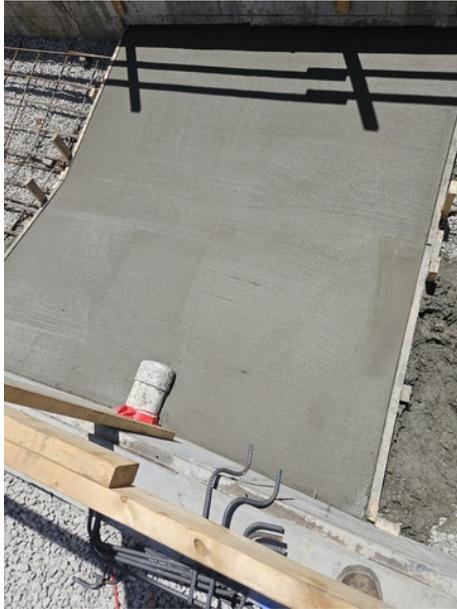
(P8) Pit at B.5/3.75 post concrete placement

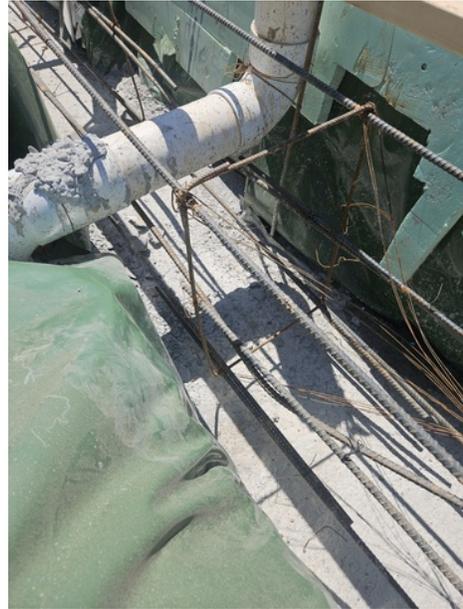
(P5) Lap spliced where bar was cut out

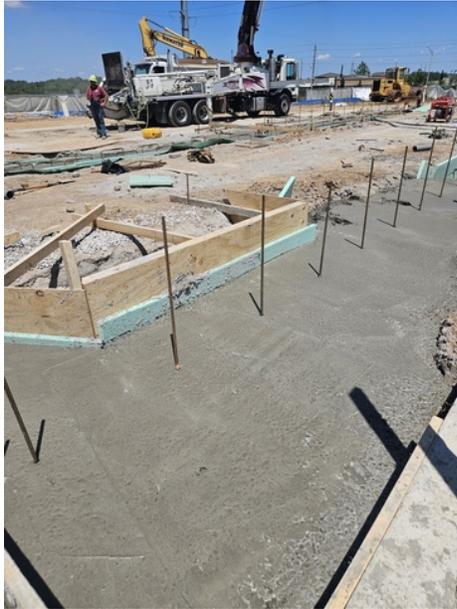
(P7) Post concrete placement @ A/3

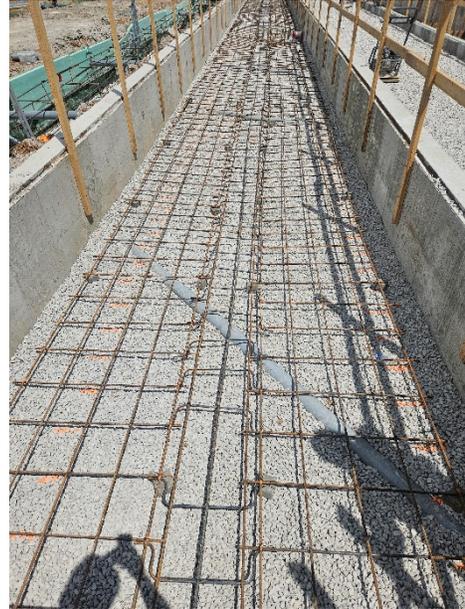
(P9) Bottom of Pits A-C/3-4

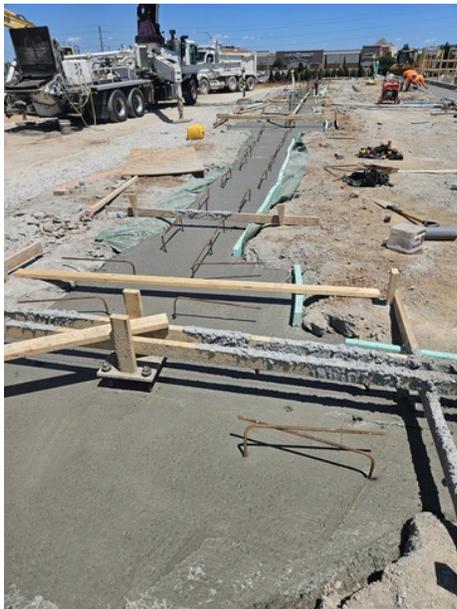
(P8) Post concrete placement @ A/1
