DEVIATION LOG

REINFORCING STEEL OBSERVATIONS REPORT

Report Number: 02251170.0078
Service Date: 07/09/25
Report Date: 07/10/25
Task: 03 - Concrete Special Inspection & Testing

Waterway Lee's Summit
 1000 NW Pryor Rd.
 Lee's Summit, MO 64081

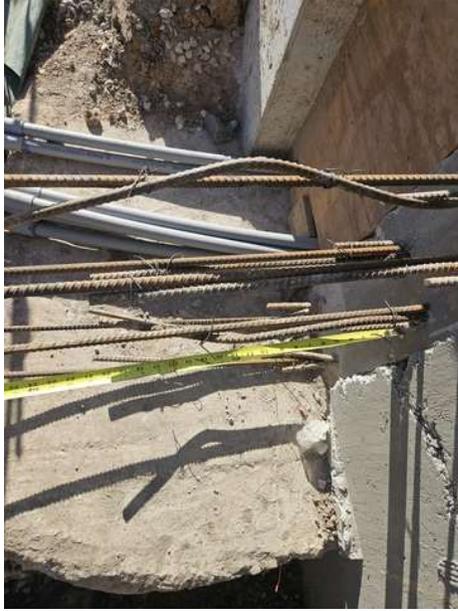
Element	Location	Referenced Documents	Status	Comments
Continuous footing	(1) A/3	S0.0.1	DOES NOT Comply	*DEVIATION* Lap Length: Lap splices from previous pour are 21". See Photo P1.
Slab-on-grade	(2) Pits at B.5/3-4	Detail 2 sheet S2.1	DOES NOT Comply	*DEVIATION* Lap Length: Lap slice Lengths are as low as 6" Installation was not performed with current plans. New plans were NOT available. See Photo P2 and P3.
Slab-on-grade	(2) Bottom of Pits A-C/3-4	S2.1 Detail 1	DOES NOT Comply	*DEVIATION* U bars at bottom of both trenches are in a horizontal orientation. Detail 1 on S2.1 shows they are to be installed in a vertical orientation. See Photo P9.
Continuous footing	(3) A-D/1-3	S0.2, S1.0	Complies	Slab dowels for CMU wall were wetset. All other issues noted on report 02251170.0074 were resolved prior to concrete placement

(P1) Laps @ A/3 from previous pour

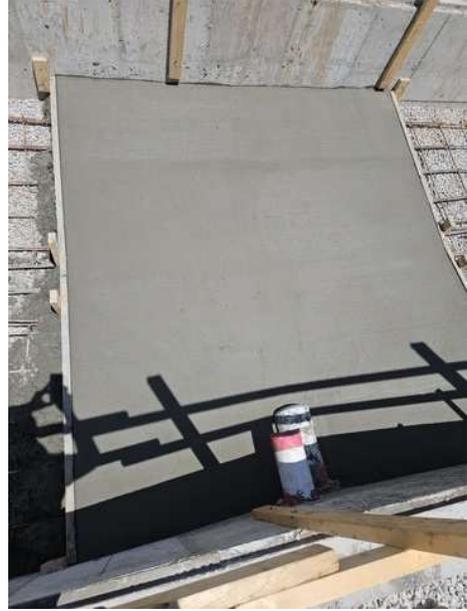
(P7) Pit at B.5/3.5 post concrete placement

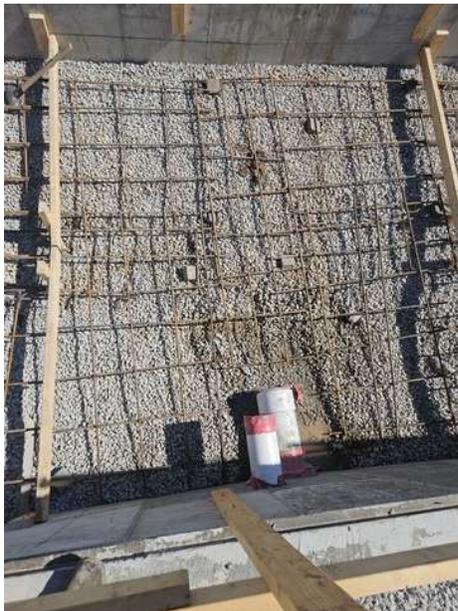
(P2) Pit at B.5/3.5

accepted
Kreher
12/16/25

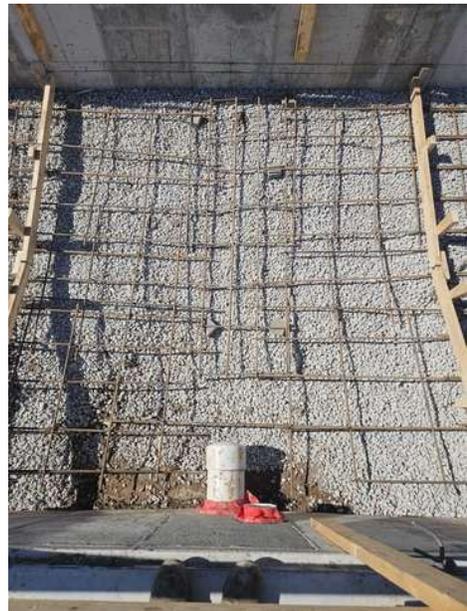
(P3) Pits at B.5/3.75

accepted
Kreher
12/16/25

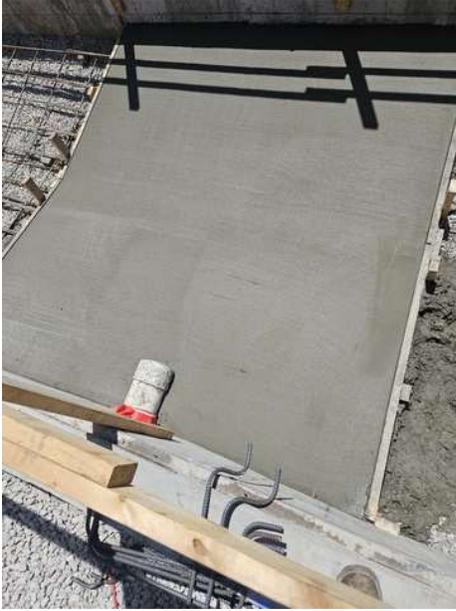
(P8) Pit at B.5/3.75 post concrete placement

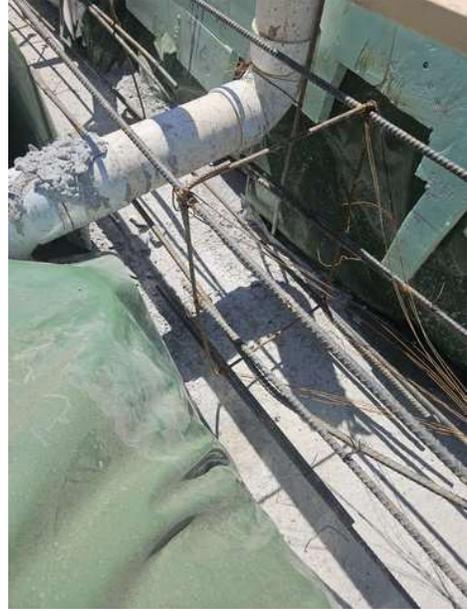
(P5) Lap spliced where bar was cut out

accepted
Kreher
12/16/25

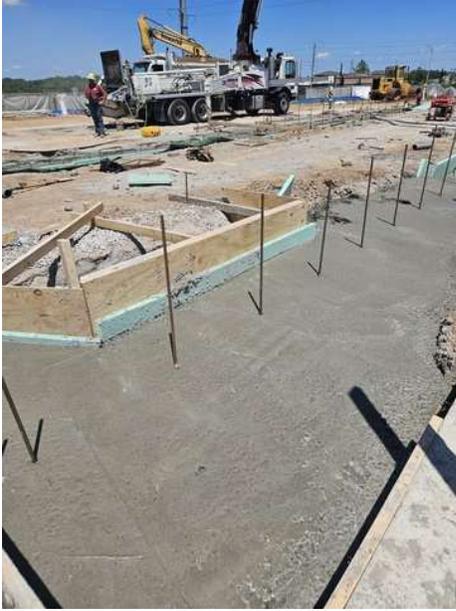
(P7) Post concrete placement @ A/3

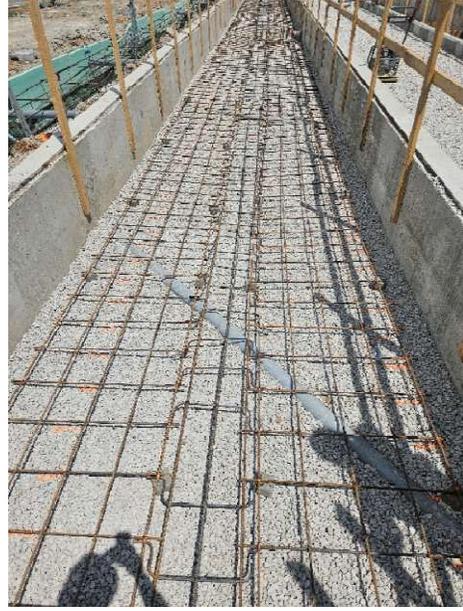
(P9) Bottom of Pits A-C/3-4

accepted
Kreher
12/16/25

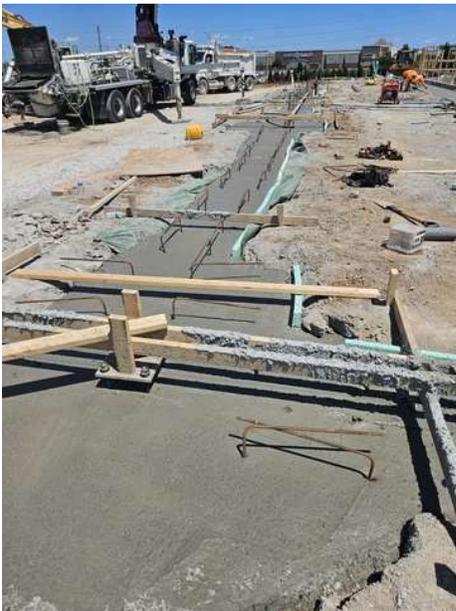
(P8) Post concrete placement @ A/1

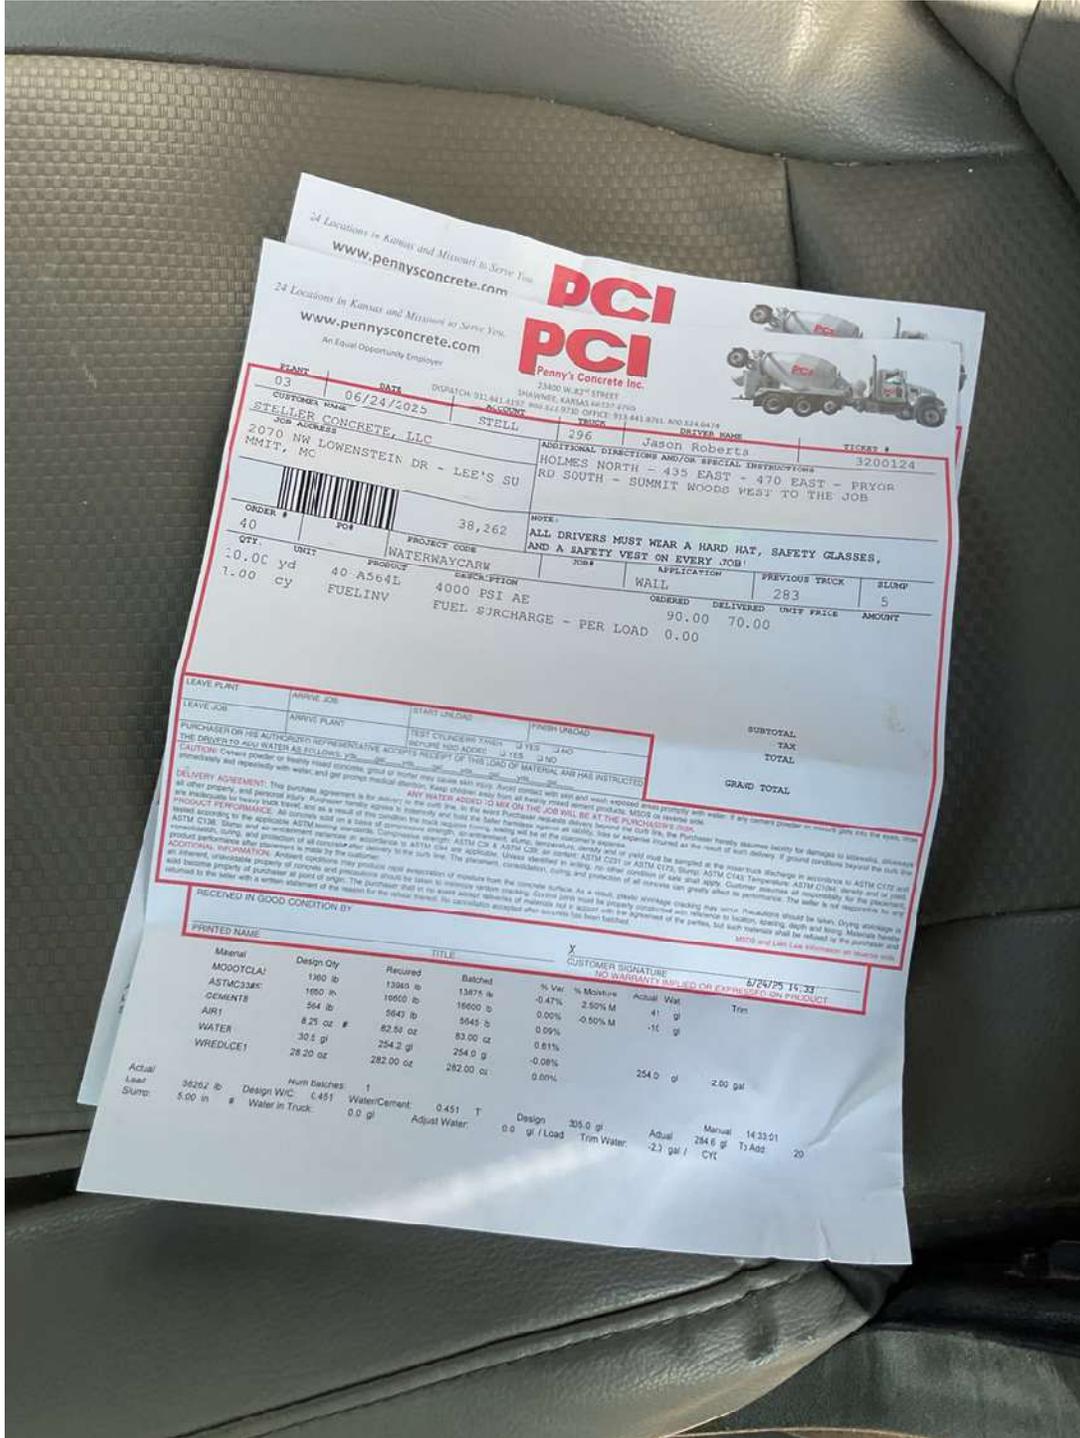
Test	Result	Specification
Slump (in):	8 *	3 - 5
Air Content (%):	7.5	4.5 - 7.5
Concrete Temp. (F):	80	
Ambient Temp. (F):	91	
Plastic Unit Wt. (pcf):	135.6

(P1) Batch ticket for test 2

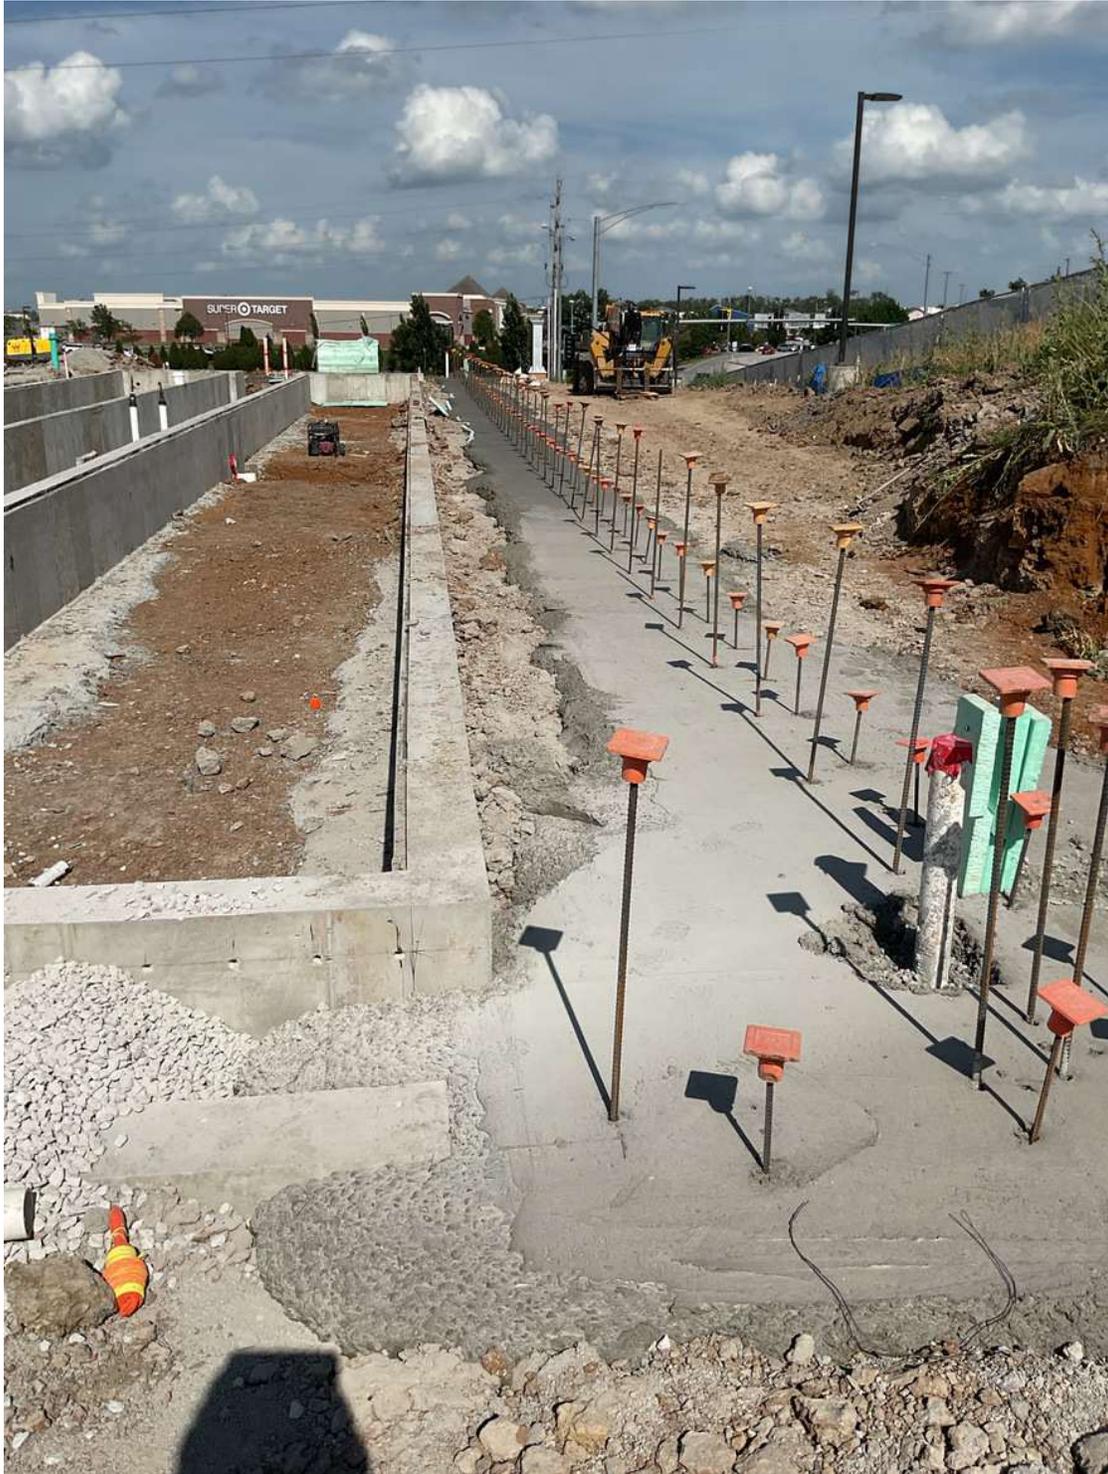
(P3) Sample 1 at bottom. SW Corner
