January 9, 2026

**RE: DECK DESIGN
2826 SW HEARTHSTONE PLACE
LEE'S SUMMIT, MISSOURI**

JOB #2025-2443

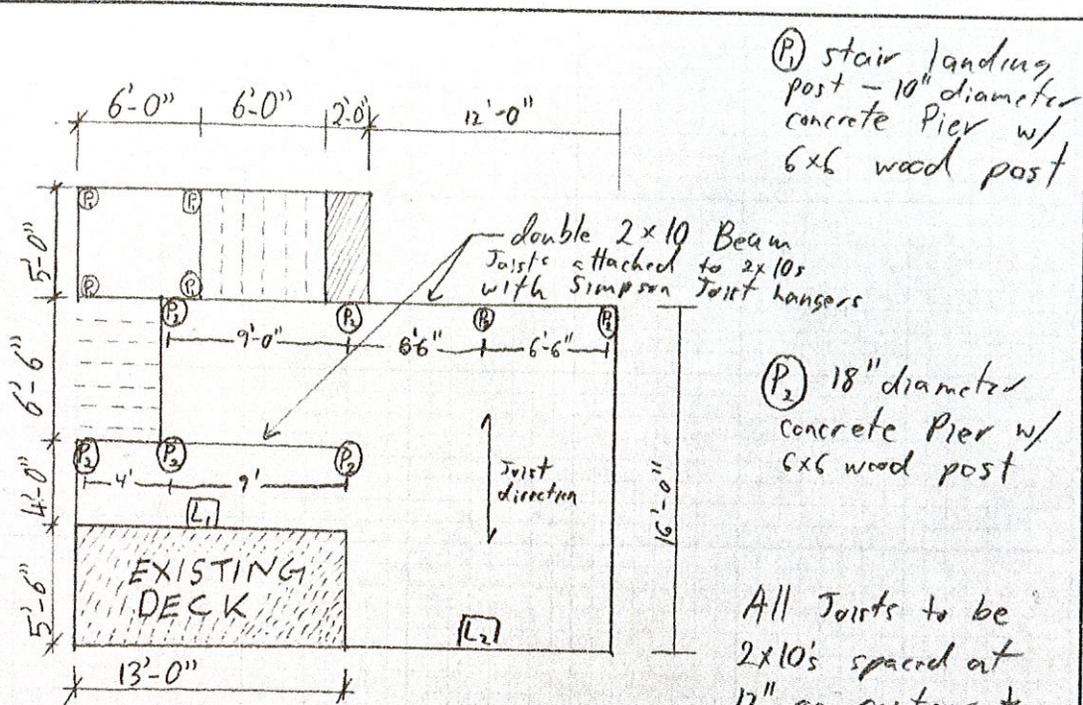
L₁ - Joist attached to existing 2x10 with Simpson Joist hangers

L₂ = ledger attached to rim Joist w/ ledger lock fasteners, 2 rows with a max spacing of 9" horizontally per deck guidelines.
use 1/2" spacers between ledger board & exterior siding of the house.

All Joists to be 2x10's spaced at 12" on center & attached with Joist hangers.

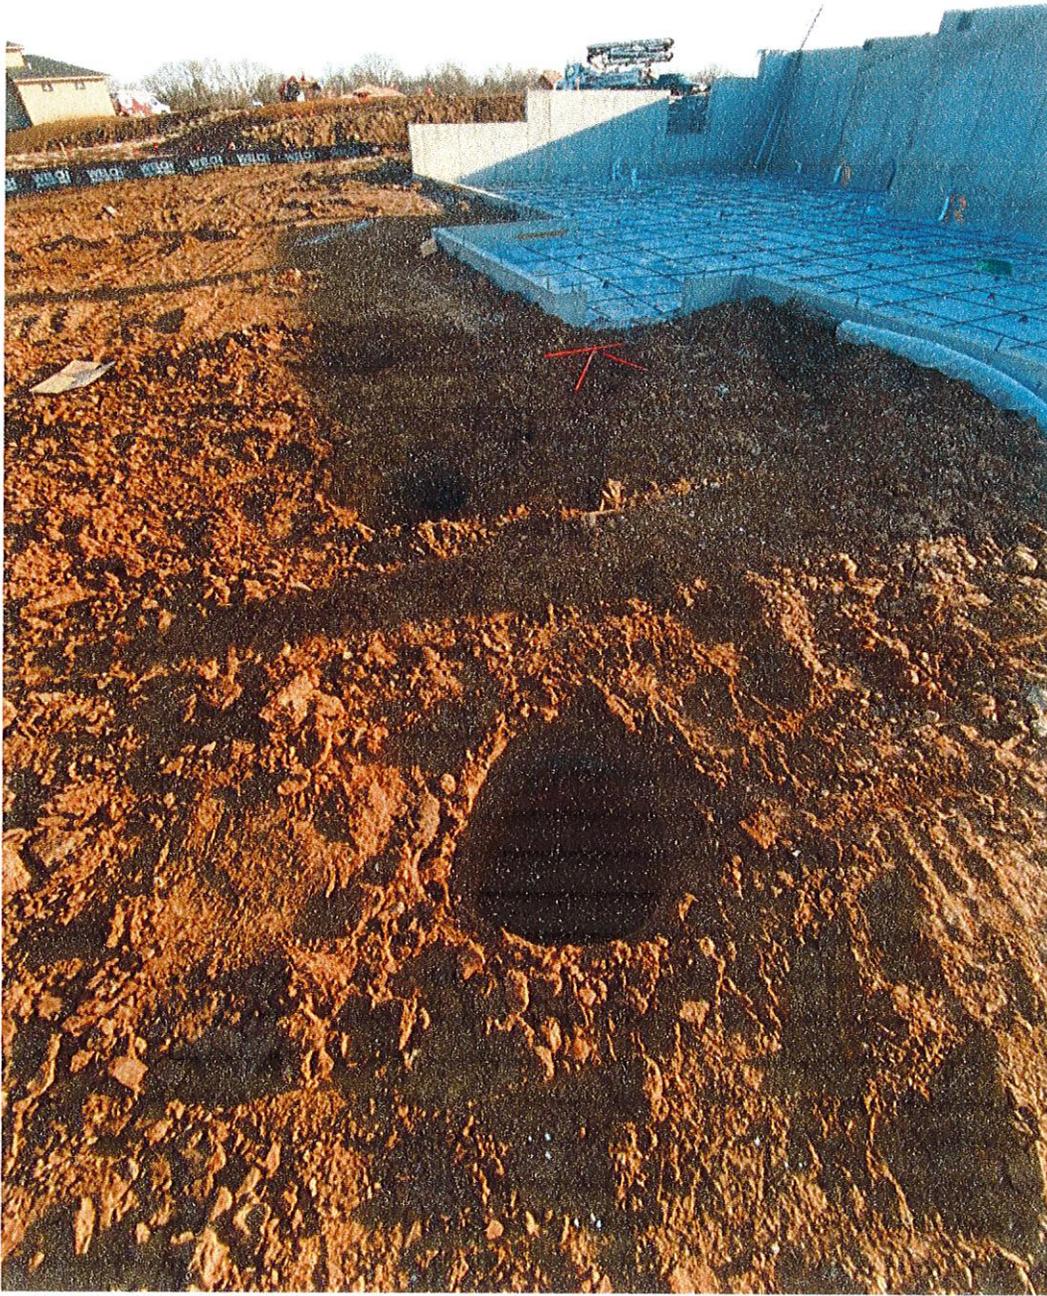
The existing deck at the rear of the house had 3 posts (6x6's) at approximately 6.5 feet on center along the west side of the deck. According to the contractor the piers supporting the posts were 24" in diameter (see attached photograph). In order to reduce the additional load to the posts, I recommend that an additional interior beam be added at the top of the stairs and run across the length of the existing deck (see attached sketch). I have also upsized the pier diameters of the two pier types, flush beams, and ledger attachments to the existing house to be consistent with the Johnson County Deck guidelines, per the Lee's Summit deck permit guidelines indicated on the website.

It's great to hear from you! Your (3) deck piers were roughly 24" in diameter (x) roughly 36"-48" deep. They were drilled and then inspected by the engineer, before placement. Here is a picture from the day they were poured. I hope this helps!
