August 10, 2016

RE: STRUCTURAL REVIEW – AUTOMOBILE INTO BLDG.
1160 — 1184 NE DOUGLAS STREET
LEE'S SUMMIT, MISSOURI

JOB #2016-1282

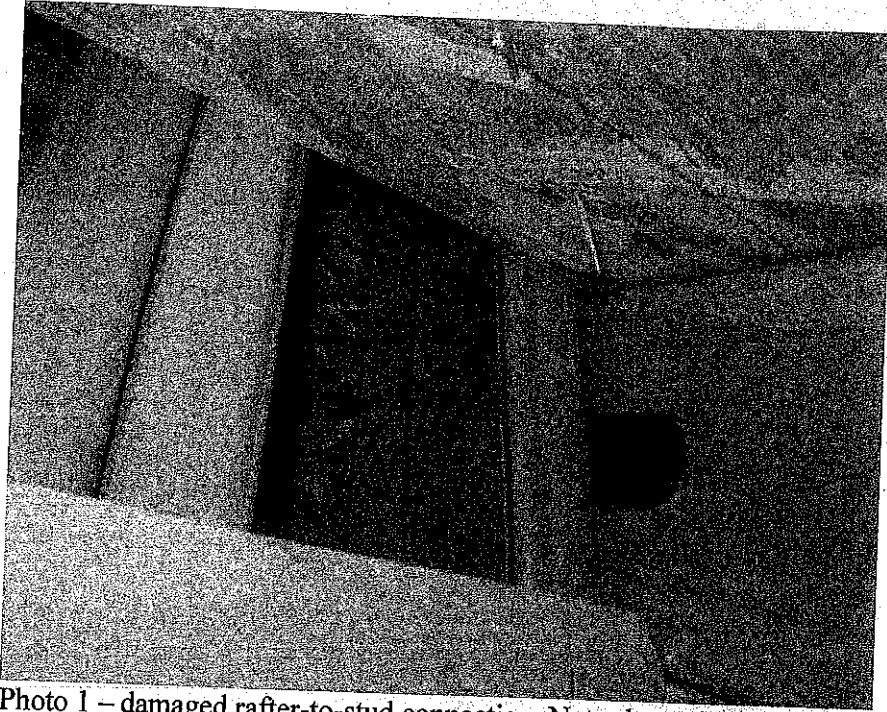
The rafters are 6" cold form steel (CFS) C-shapes at 16". The rafters themselves were not damaged and can be re-used. Some inboard and outboard connections have been damaged and will need to be repaired. At the inboard end each rafter is connected to a wall stud with two screws. At several rafters the screws were sheared in two and the roof has fallen up to 2". This is apparent from the photographs. I recommend these rafters be lifted to their original location (using the existing top of drywall as a guide) and attached with (2) #10 screws. Faces of rafters and wall studs must be tight together, and screws must be long enough to penetrate minimum 3 threads through the connected faces. In addition, I recommend that all remaining rafter-to-stud connections within the affected area (approximately 40' of roof), regardless of whether the original screws appear to have been damaged, be secured with (2) additional #10 screws.

Photo 1 – damaged rafter-to-stud connection. Note sheared off screws.
Note rafter is pushed $\frac{3}{4}$ " into drywall.

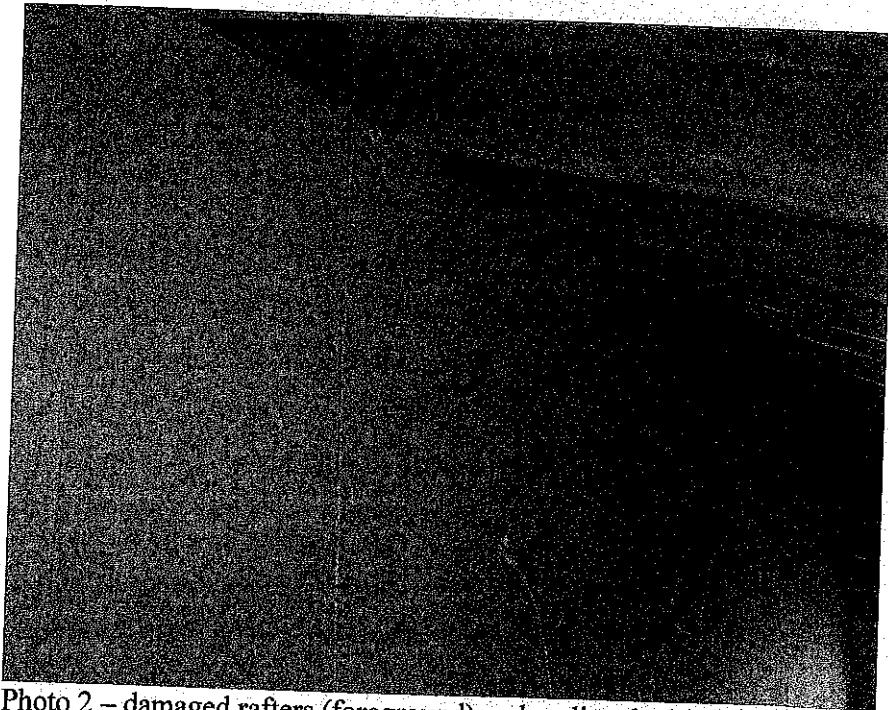
Photo 2 – damaged rafters (foreground) and undisturbed rafters (background). Note the gap between drywall and studs that is present in background but not in foreground.

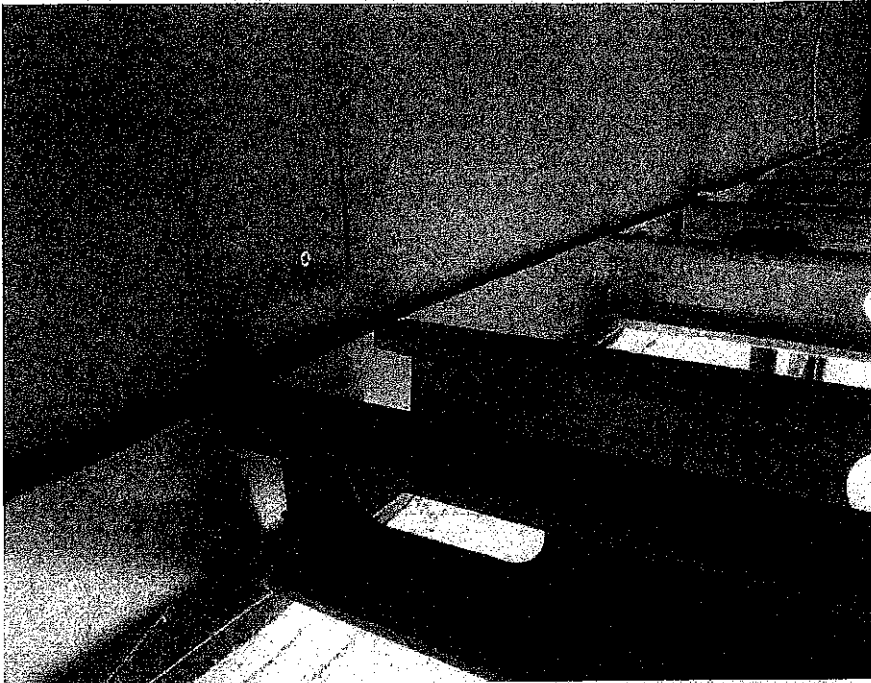
Some ceiling joists are not seated fully into the track at the building wall. See photo. This may be the result of the collapse, and this condition may be corrected after final adjustments are made on the position of the roof, as described below. If this is not corrected after final adjustments, the ceiling joists should be attached to the track with 54 mil steel clip angles with two #10 screws in each leg.

Photo 3 – ceiling joists at track at building wall. Note insufficient bearing. Note screws were not installed in both flanges.

The ceiling joists are 3½" CFS C-shapes at 16" attached to CFS track at both the building wall and the steel HSS beam. All joists and track can be re-used. I recommend attaching each joist to the track with two #8 screws – one in each flange.

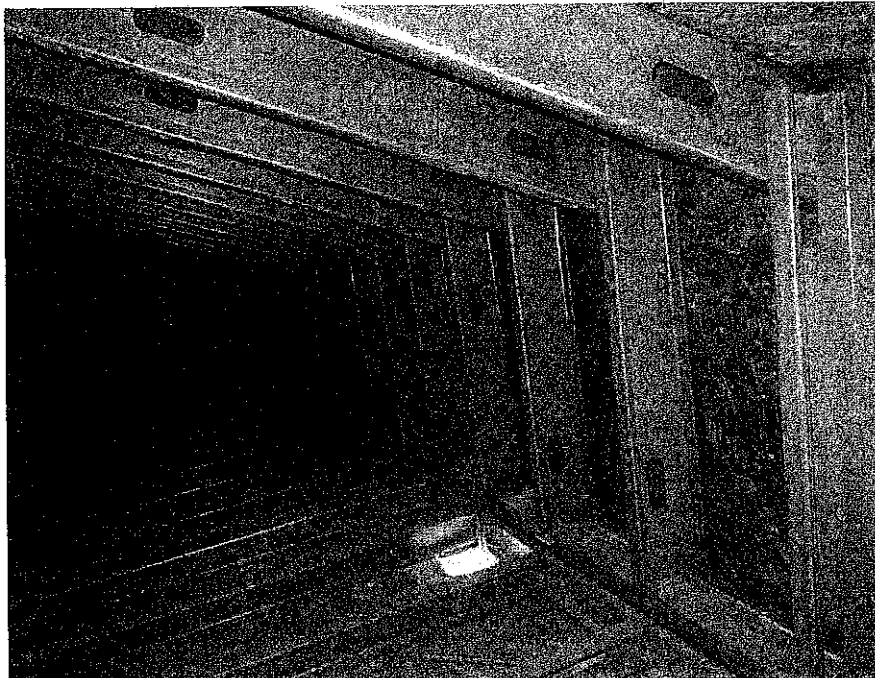
The fascia is framed with 6" CFS C-shapes @ 16" and was originally plumb. At the center of the affected area, where the masonry column was destroyed, the distortion in the fascia is greatest and the top of the fascia leans outward approximately 1½". This distortion should be corrected as described below, and after the fascia is in proper position all fascia-to-rafter connections should be secured with two #10 screws. These screws are in addition to the existing screws.

Photo 4 – fascia, rafter, and ceiling members

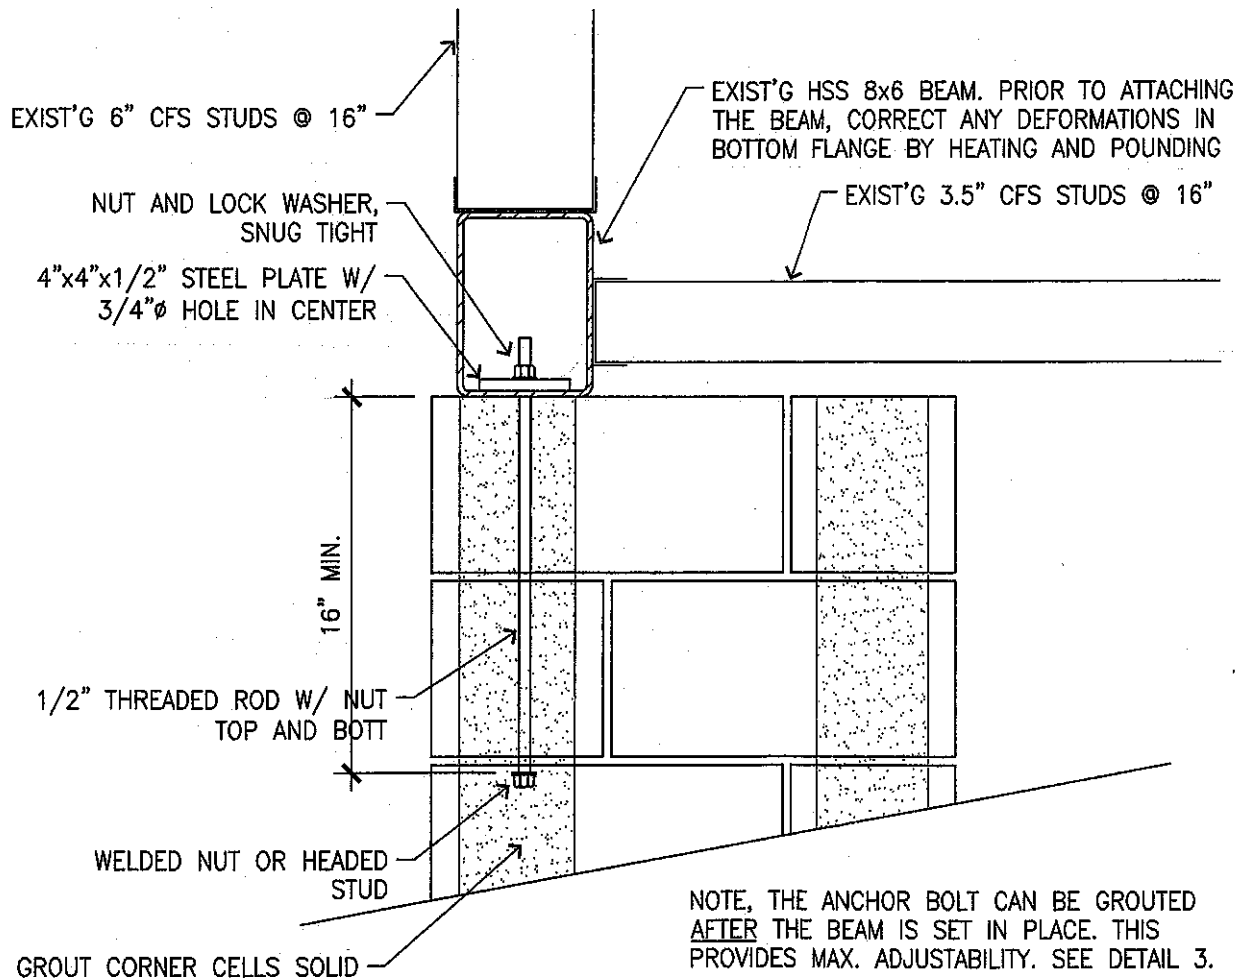
2 BEAM CONNECTION DETAIL

The south beam was damaged by the collision when the anchor bolt was pulled through the bottom flange. I recommend the distorted flange be heated and pounded in so it will sit flush on the masonry. See the attached detail for a connection that does not require welding.
