Re: 212 NW Carson Drive Lot 1452, Winterset Valley Permit #20200164

Apex Engineers, Inc. observed the excavation for the proposed house located at the address above. The sub-grade bearing conditions were evaluated.

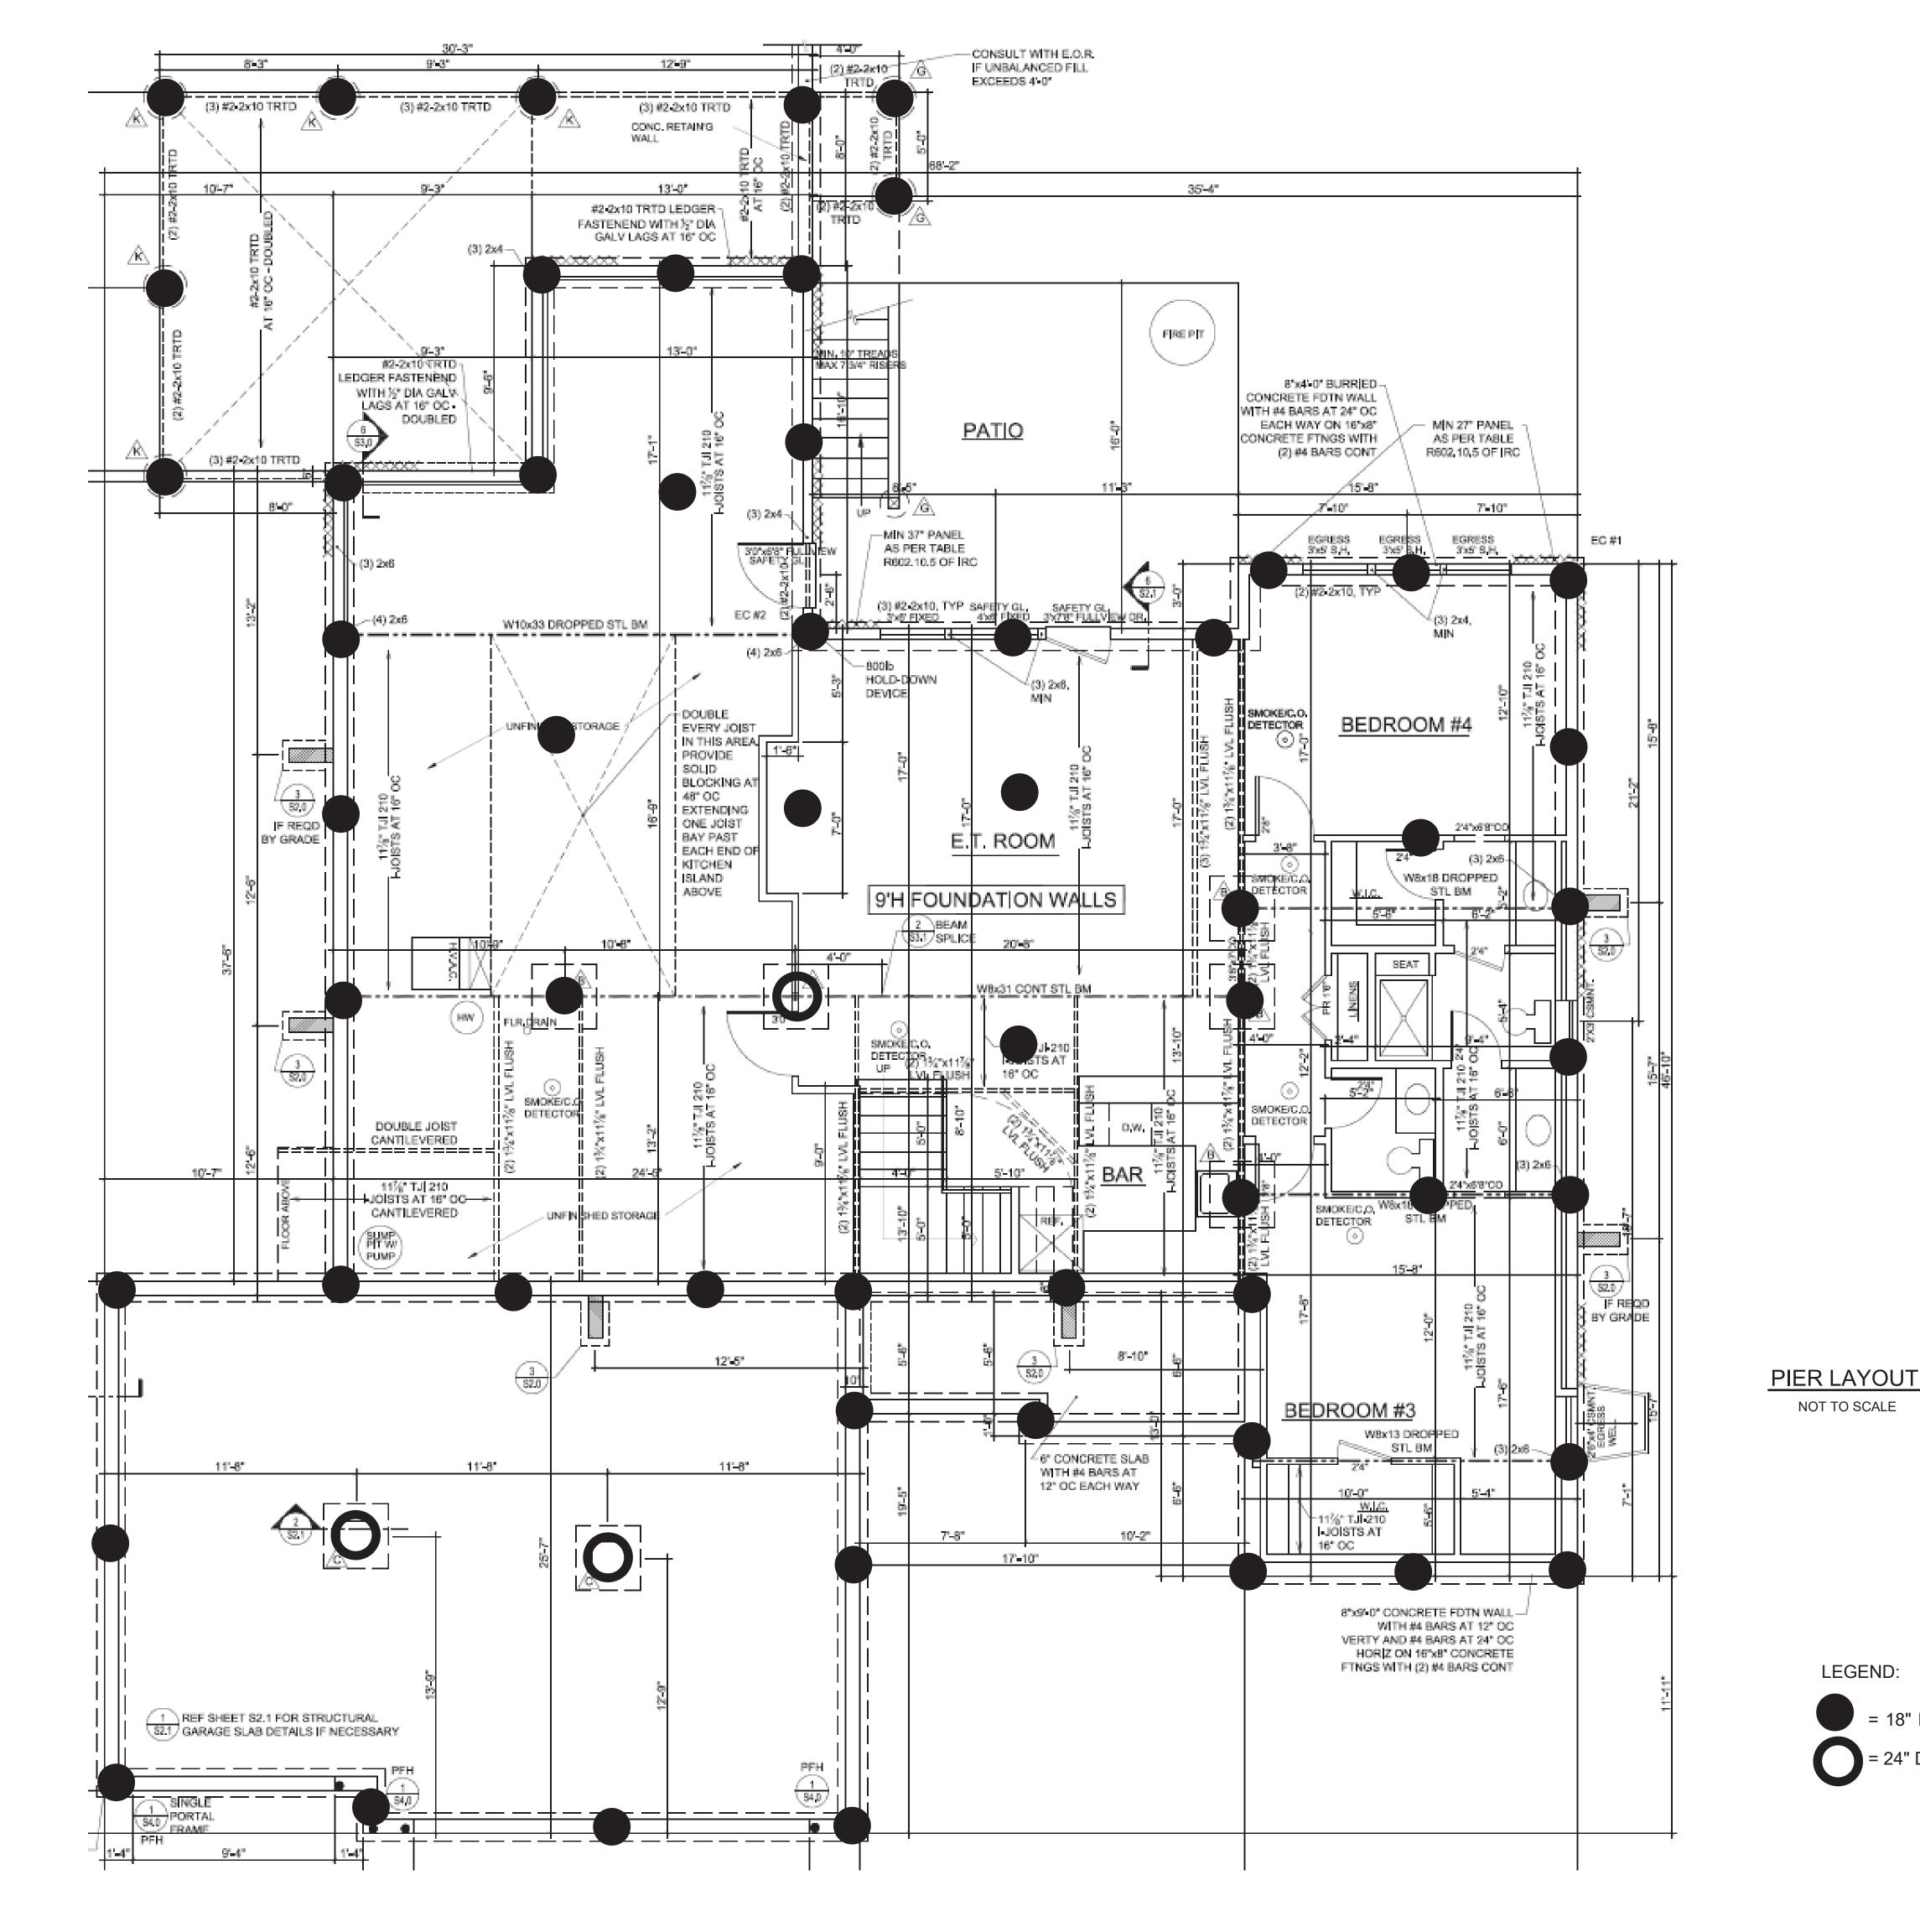
The excavation terminates on material that will not adequately support the proposed house. Our firm recommends the following foundation system:

- Drill 18" and 24" diameter reinforced concrete piers per the attached layout.
- Piers shall be drilled/dug to refusal on and end bear on competent original limestone, sandstone, or shale.

- The piers shall be reinforced with (2) #4 bars for the depth of the pier.
- (2) #4 bars shall be embedded a minimum of 24" into the top of each pier and shall extend a minimum of 24" into the footings.

- All piers shall be inspected by our firm prior to the placement of concrete.
- Upon approval and completion of the piers, the foundation footings, walls, and slabs shall be placed over the piers. If the city approved plans do not exceed the following minimum specifications, then, as needed, the foundation shall be improved per the following:

- Add (4) 10'-0" long #4 bars each-way over the column pads and slab support piers. Place with 1" to 1-1/2" slab top cover (3" chairs). See attached layout and slab details for clarity.
