Re: 1804 River Run Drive

Vista Structural Engineering, LLC, was asked to address the following item called out during rough-in inspection by the city. Below is the inspection report comment and our response:

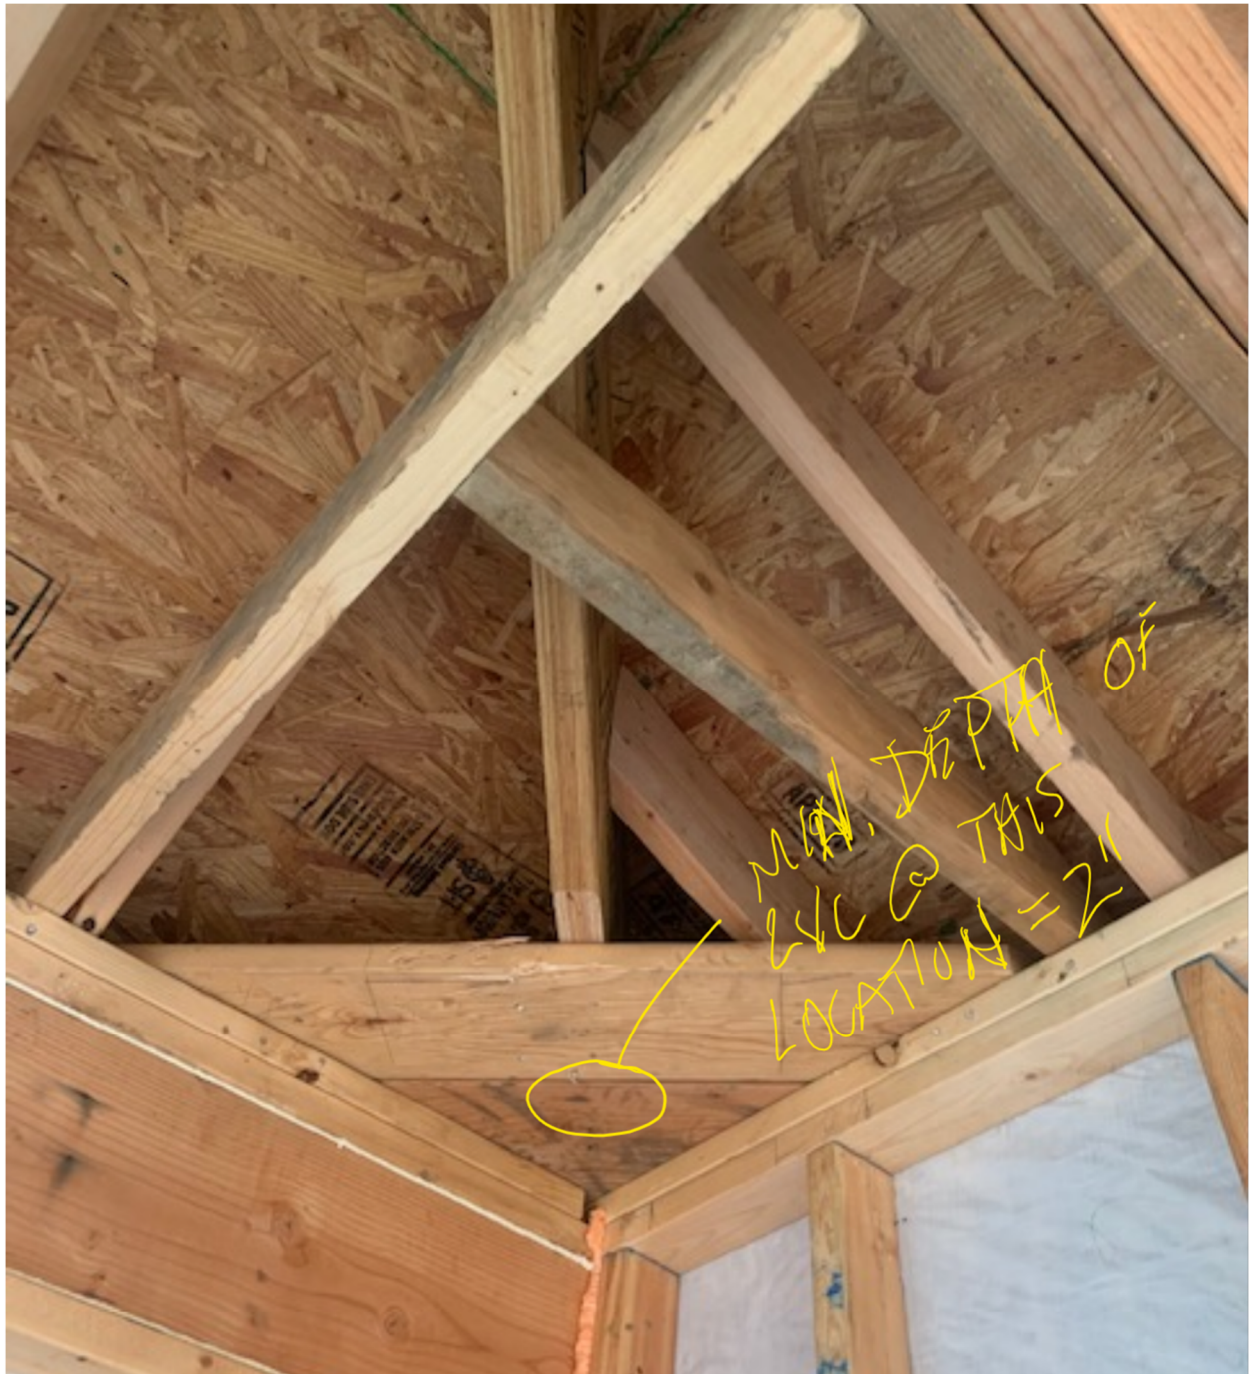
- **Address over-cut LVL hips in great room and master closet.** *Based on the attached calculation, the minimum depth of the LVL hip required at the interior face of both bearing locations is 2". Since there is more than 2" of depth at both locations, we recommend approval of the LVL's without remediation.*

$$P = \frac{(0' \times 10')}{4} \times 30 \text{ psf} = 750 \#$$

$$F_b = 285 \text{ psi}$$

$$A_{min} = \frac{P}{F_b} = \frac{750 \#}{285 \#/\text{in}^2} \\ = 2.63 \text{ in}^2$$

$$\text{WIDTH OF LVL} = 1.75 \text{ in.}$$

$$d_{min} = \frac{2.63 \text{ in}^2}{1.75 \text{ in}} \\ = 1.50 \text{ in.}$$
