Re: 1909 River Run Drive

Vista Structural Engineering, LLC, was asked to address the following item called out during rough-in inspection by the city. Below is the inspection report comment and our response:

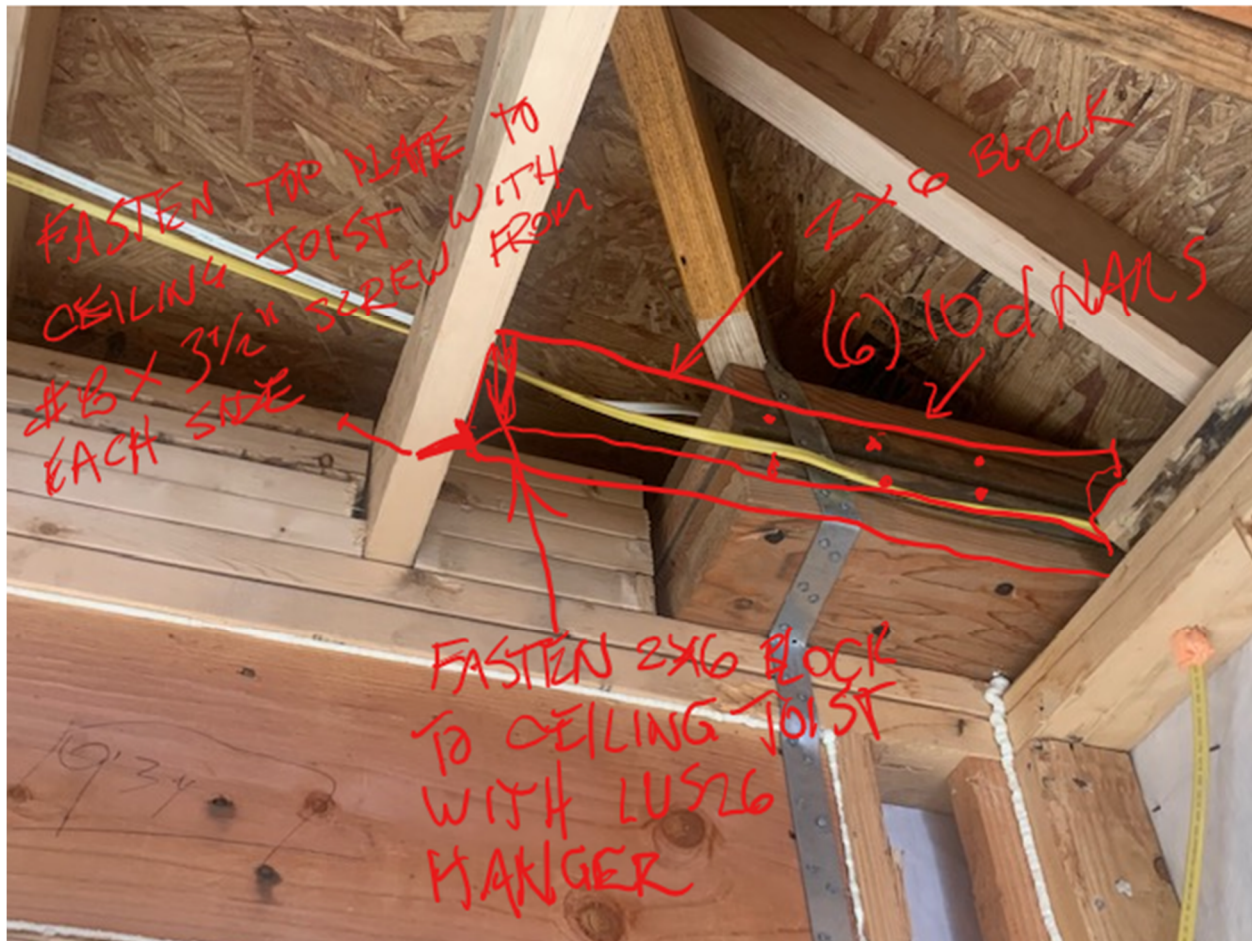
- **Address rafters and hip landing on multiple blocks throughout.** *The marked up picture on page 2 of this report shows our firm's recommended solution. To prevent the hip support blocks from rotating, we recommend fastening a 2x6 to the side of the blocks with (6) 10d nails, and to the adjacent 2x6 ceiling joist with a Simpson LUS26 joist hanger. To prevent the bearing plates supporting the rafters from rotating, the top plate (of the four) should be fastened to the adjacent ceiling joists at each end with #8 x 3 1/2" screws at an angle, as shown on the attached picture.*

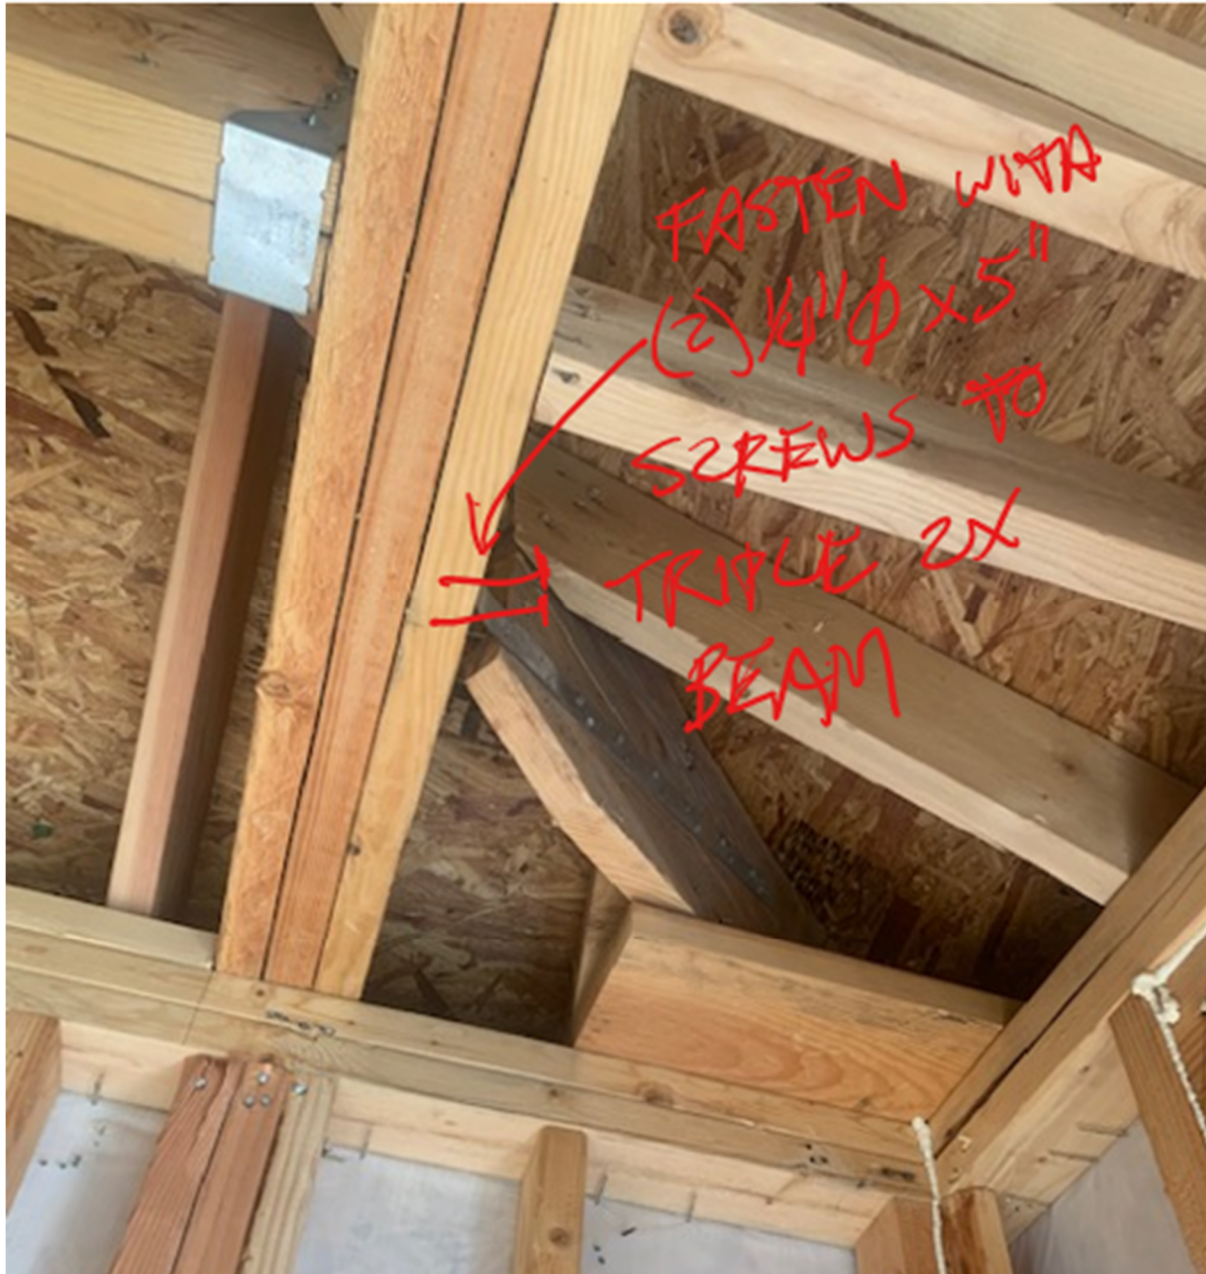
- **Address split out hip in master.** *The attached picture shows the split hip above the master. Our firm has determined the design load at the triple 2x beam to be approximately 30 pounds. We recommend fastening the end of the split hip nearest the triple 2x beam to the beam with (2) 1/4"-diameter x 5"-long screws, as shown on the attached picture. These screws have a combined capacity of approximately 500#.*
