WOOD FRAME OBSERVATIONS REPORT

Report Number: 02191565.0079
Service Date: 11/24/20
Report Date: 11/25/20
Task: 19 - Wood Framing Observation

DCI - Lee's Summit
2001 Shamrock Rd
Lee's Summit, MO

Project Number: 02191565

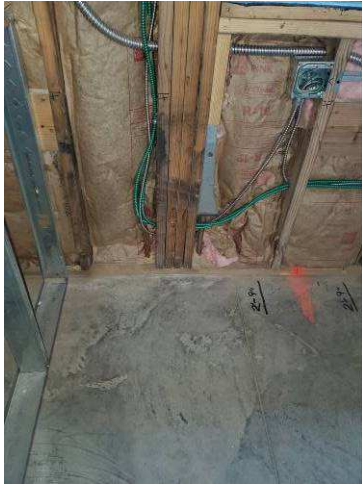
Figure #1

- d. The following items for shear wall SW4 appear to be outstanding:
 - i. The HDU8 hold down at the north end of the north section of shear wall was placed under the window instead of specified other side of stud pack (Figure 1).

Item 1.d – Observed that the hold down at the north end of the north section for the above shear wall had the screws replaced with the 6" screws per the recommendations of the Engineer of record.

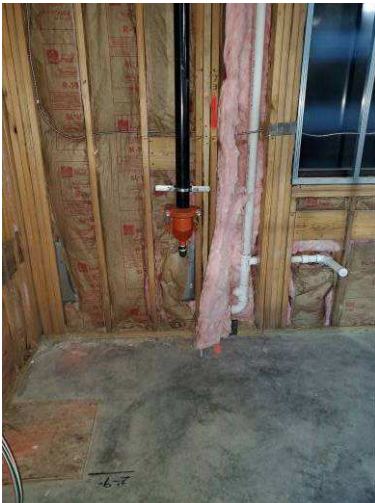
Figure #2

- e. The following items for shear wall SW1 appear to be outstanding:
 - i. The HDU8 hold down at the east end of the west section of the shear wall was placed 16" from adjacent window instead of the specified edge of window (Figure 2).

- Item 1.b – The OSB sheathing used was APA rated
- Item 1.c – A notarized statement by the subcontractor was provided
- Item 1.e – Accepted as built

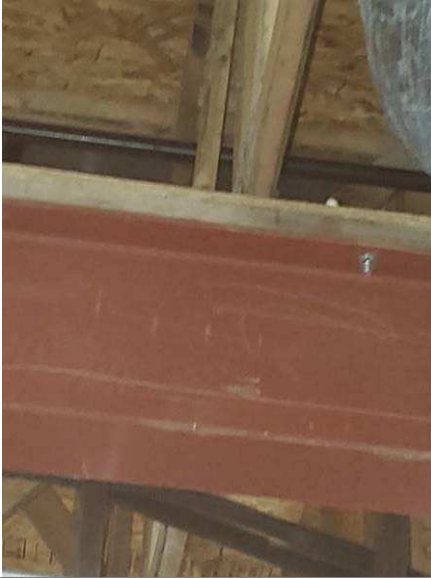
Figure #3

2. Perimeter walls and supporting beams
 - a. We observed the connections and truss bearing. In general, the framing connections and members appear to be in general accordance with project plans and specifications except noted below:
 - b. The following item at approximate grid lines D/4.7 appear to be outstanding
 - i. The Simpson H2.5 clips specified on both sides of support beam are missing for this truss (Figure 3).

Item 2.b – Observed the missing Simpson H2.5 clips at the above truss to beam connection were installed.
