Spire Service Work Order Form SERVICE ABANDONMENT FULL OR PARTIAL

Work Type Desc

WO Task Type (circle one) ☒ FULL ☐ PARTIAL

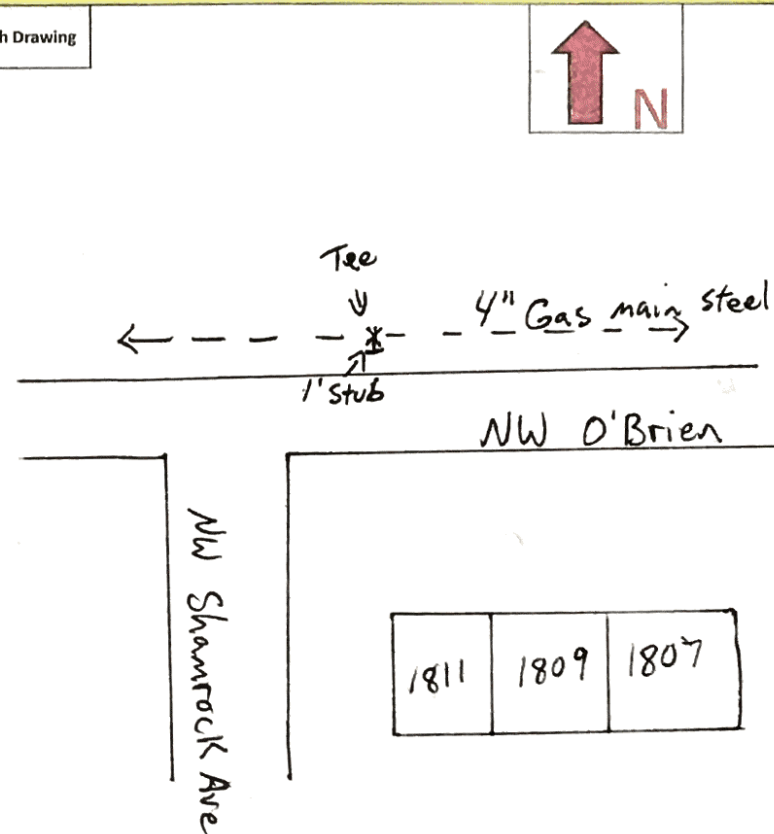
← 4" steel gas main → Tee  
1' stub

NW O'Brien Rd

NW Moore St
