Re: 2330 SW Old Port Road

Vista Structural Engineering, LLC, was asked to address the following framing inspection item for the house being built at 2330 SW Old Port Road:

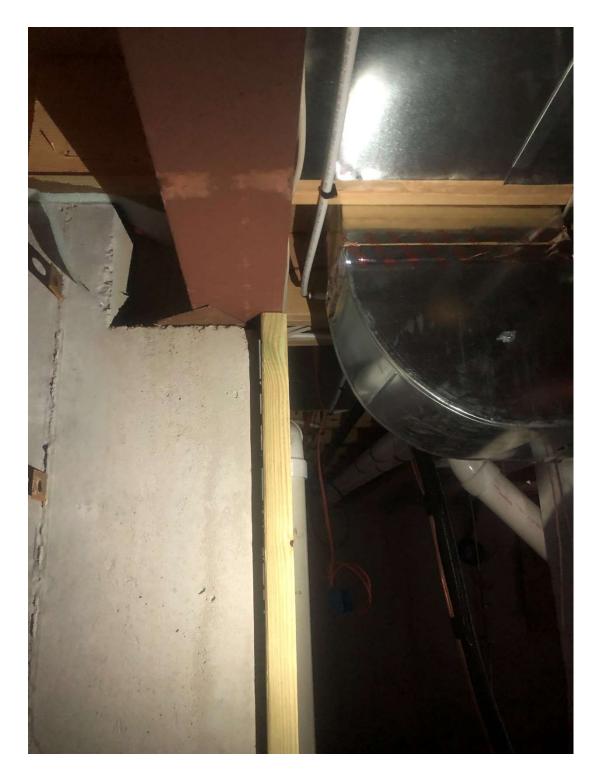
A floor beam is not sitting fully in pocket at foundation wall. Roughly 1-¾" is overhanging due to foundation being out of square. Can a 2x4 be bolted to the foundation wall to fully support the beam? A treated 2x4, or a 2x4 with a moisture barrier installed, bolted to the concrete foundation per the attached sketch, will sufficiently support the beam at the foundation wall. Reference the attached picture and sketch on the following pages. We approve of this attached detailed solution.
