June 28, 2021

New Mark Homes

Re: 1916 SW River Run Dr
Lot 4, Whispering Woods
Lee's Summit, MO

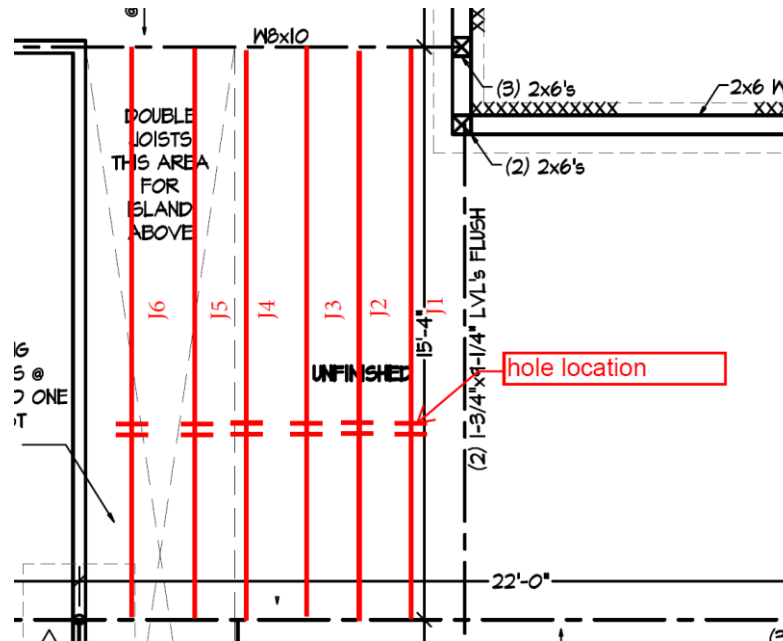
Figure 1.0 – Bored Joists

1. *Joists under first floor kitchen observed to have bore holes approximately 3" in diameter and located 5'-0" from the main basement steel beam.*
 - (6) 2x10 floor joists were observed to have bore holes varying in locations within the depth of the member. The joists in question have been labeled and shown in figure 1.0

- J1: Joists J1 falls within code allowable limitations for bored holes per IRC R502.8.1. No repair is required.
 - J2-J6: Joists 2 through 6 do not fall within code allowable limitations for bored holes per IRC R502.8.1. A repair is required.

- Option 1: install an additional full-length 2x10 ply adjacent to damaged joist. Bore the new holes a minimum 6" away from previously bored holes and per IRC R502.8.1. (Bored holes shall have a maximum diameter of 1/3 the depth of member and shall maintain 2" of edge distance from top and bottom faces of beam and 2" of edge distance to any holes and notches in the beam.)

- Option 2: re-route plumbing to avoid boring of floor joists. Install a min 2'-6" long ply of #2-2x6 centered over the bored hole and tight to subfloor. Glue and face nail with (25) 10d common nails each side of hole (arrange nails in 5x5 grid pattern). Provide min 1/2" of spacing between rows and edge distances.
