JOB: City Review Comments
329 NW Ambersham Drive,
Lees Summit, MO 64081

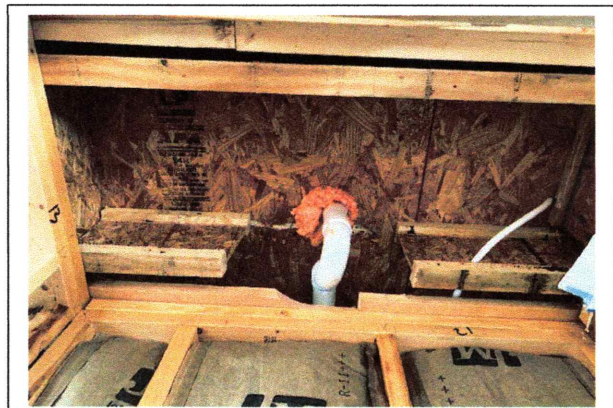
1. Cut floor joist in the front coat closet:
Plumbing fixture cut thru joist – the joist has a short span distance. The joist on the east side will cantilever the other side is not supported. It is suggested that the back loading wall framing or a trim 2x10 be placed between the top of the wall and the subfloor. This will support the subfloor on that side of the plumbing fixture.

I have also included a photo joist in the coat closet that will required solid blocking or wall extension..
