RE: Revision to main and second floor framing for field Issue of over-bored holes in LVL above the owner's entry and above the pantry for Lot # 140 Woodside Ridge – 2118 NW Killarney Lane. Lee's Summit, MO 64081 – Permit # PRRES20210880

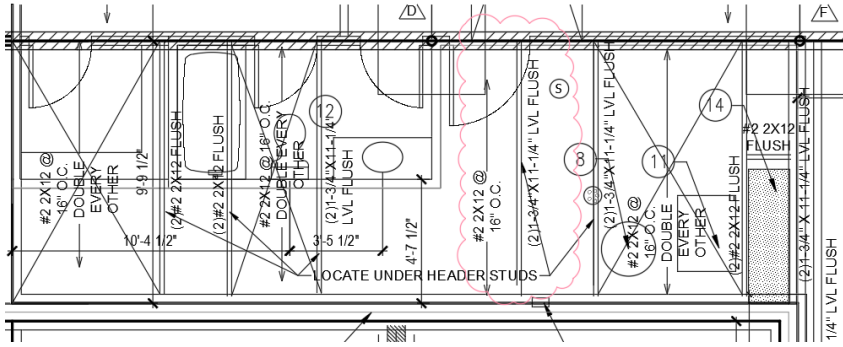
- Over-bored hole above owner's entry is approximately 3.5" diameter and located 2 ft from owner entry support for bed #1 toilet DWV.

- (2) 1-3/4" x 11-1/4" 3100 Fb Versalam LVL flush shall span approximately 7.5 ft with with 12 ft tributary width with standard floor loads of approximately 600 plf. End supports shall be (3) #2 2x4 at owner entry and (3) 2x4 jack studs at pantry header.
- Over-bored HVAC duct is approximately mid-span above the dropped LVL pantry header with a 6.5" diameter hole in LVL. Distance from HVAC chase to bottom of LVL is approximately 3.5".
- Install (2) 1-3/4" x 11-1/4" 3100 Fb Versalam LVL dropped header under over-bored flush LVL header for HVAC chase.
- (2) 1-3/4" x 11-1/4" 3100 Fb Versalam LVL dropped shall span approximately 3 ft with with 12 ft tributary width with standard floor loads of approximately 600 plf. End supports shall be (3) 2x4 jack studs at pantry header.

- Install (2) 1-3/4" x 11-1/4" 3100 Fb Versalam LVL flush spanning approximately 9.75 ft located underneath pantry/fridge support as shown in image below:
- End supports shall be foundation wall and W10x39 steel beam dropped.
