### **Letter of Transmittal 1**

Project: Hy-Vee – Lee's Summit #2 Remodel

Re: Reports and Test Results

Daily Reports January 21, 2021 – February 24, 2021

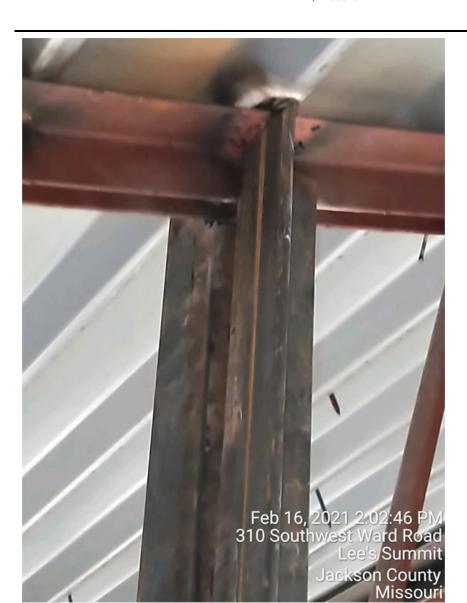
In progress welding inspection of 30 web reinforcement installations of double angles in joists in roof below new RTU installations at grid approximations of H.5 - 3, E - 3, H - 5, and G - 9 as shown on detail 5 of sheet S.5.1. All angles are currently unfinished as the required welding calls out 1/8" fillets at a minimum of 1 inch in length on both sides of the joint design.

Nearly all connections are in need of additional and necessary welding

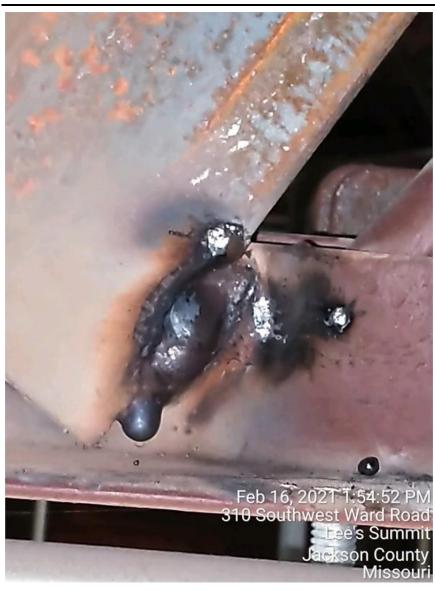
Improper technique and lack of post cleaning is a concern along with angle melt through
