Client: Hy-Vee Construction
Project: Hy-Vee – Lee's Summit #2 Remodel

Project No: B2100276

Re: Reports and Test Results

Documents Sent	Comments
Daily Reports	August 19, 2021 – September 2, 2021
Compressive Strength of Concrete Reports	Set Nos. 4-6

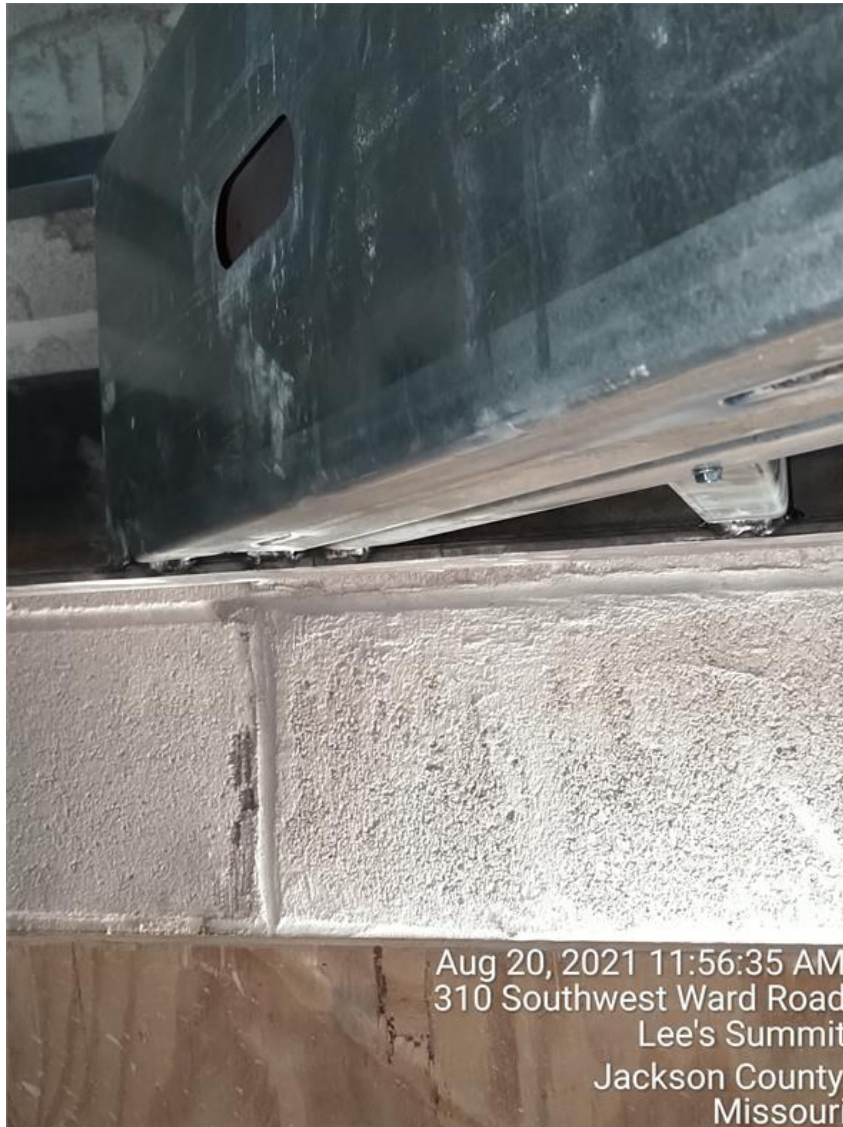
In progress weld inspection of welded king studs in cold-formed steel adjacent to lintel over the door at Grid Line K from 9 to 10. Final inspection not ready.

Underside of structural kingstud
