**Letter of Transmittal 6**

**Client:** Hy-Vee Construction  
**Project:** Hy-Vee – Lee's Summit #2 Remodel

**Project No:** B2100276

# Special Inspection Daily Report

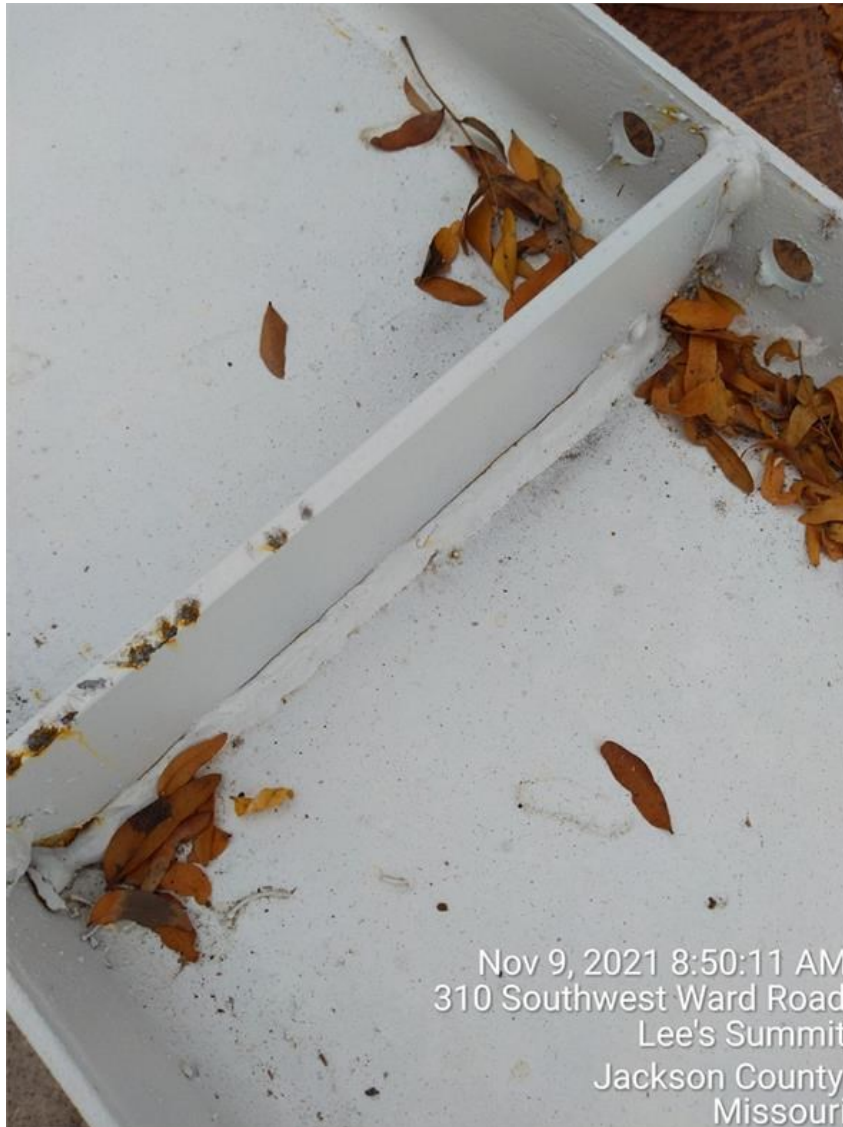
- 1) All welds found unacceptable to AWS D1.1. Welds found to have incomplete fusion, slag, cold lap, and improper weld profiles.
- 2) Bolting found unacceptable due to excessive flash in the bolt holes preventing contact between nut and plate surface.

Unacceptable flash on the bolt holes. Unacceptable Welding – Incomplete Fusion, Cold Lap , & Weld Profile

As found conditions were discussed with HyVee and a repair procedure were agreed to between HyVee and the contractor.

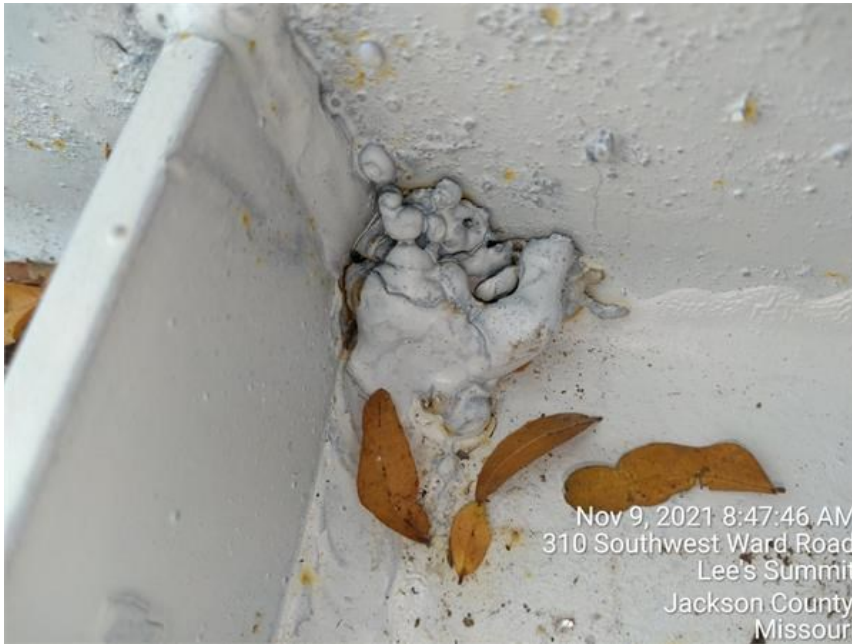
Unacceptable welding – Cold Lap, Incomplete Fusion, & Weld Profile

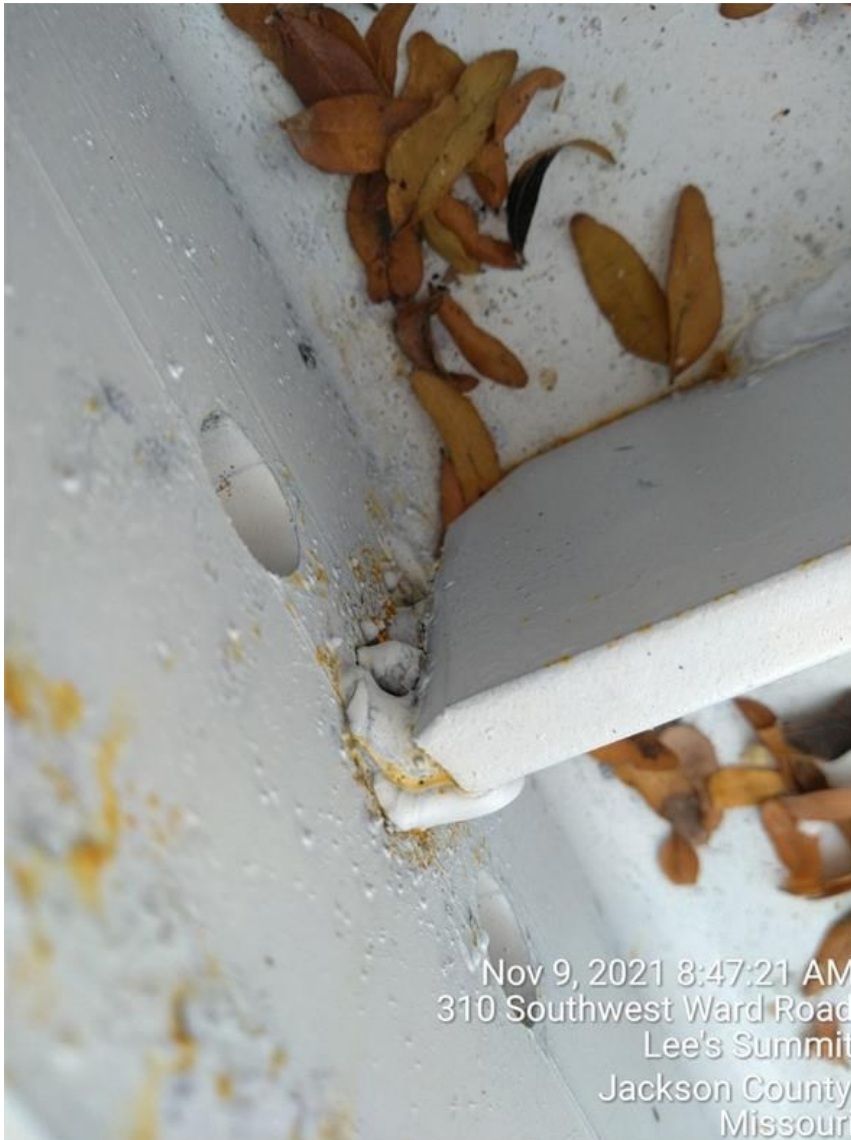
Missing welds and Unacceptable welding – Cold Lap, Incomplete Fusion, & Weld profile.

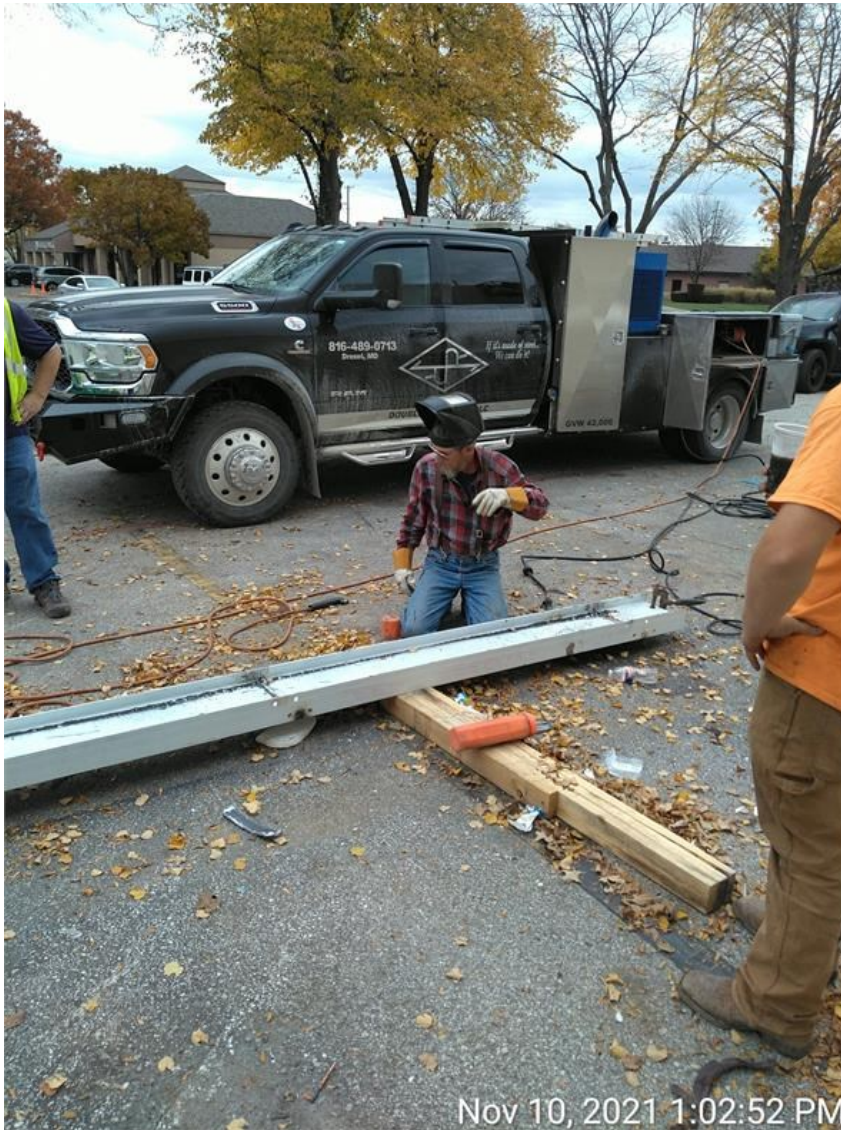
Weld repairs in progress

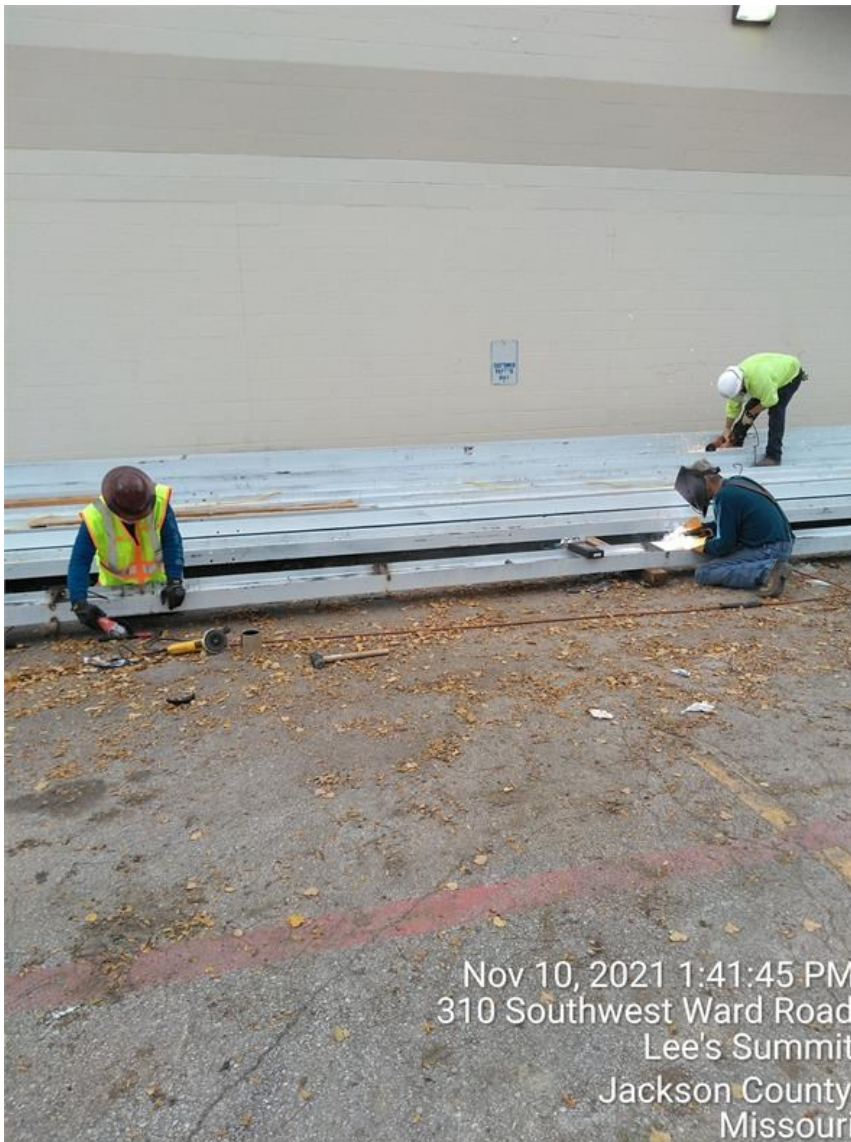
Welding criteria discussed with contractor

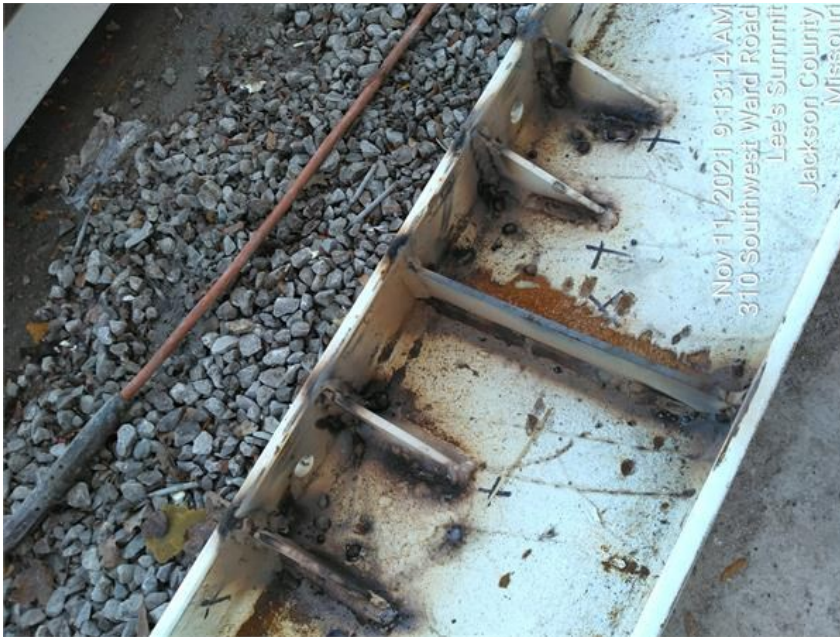
Weld repairs acceptable

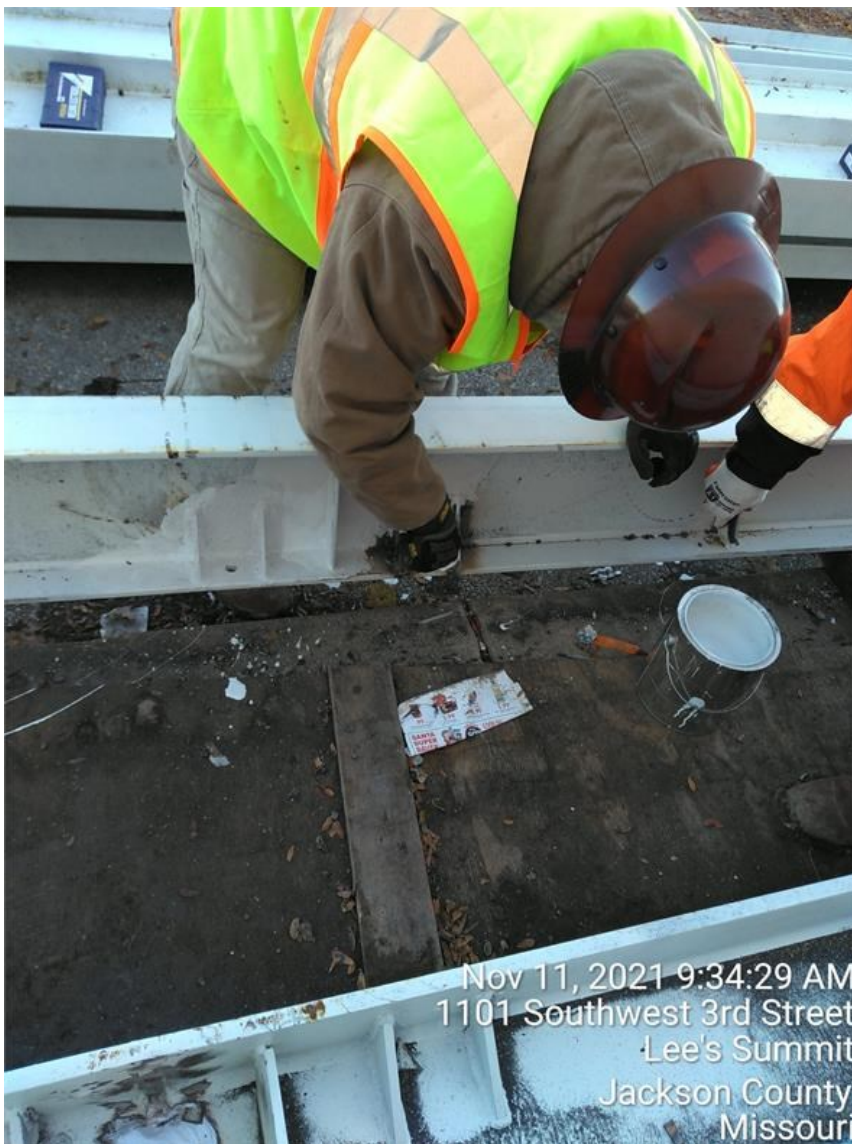
Painting touch ups applied by brush

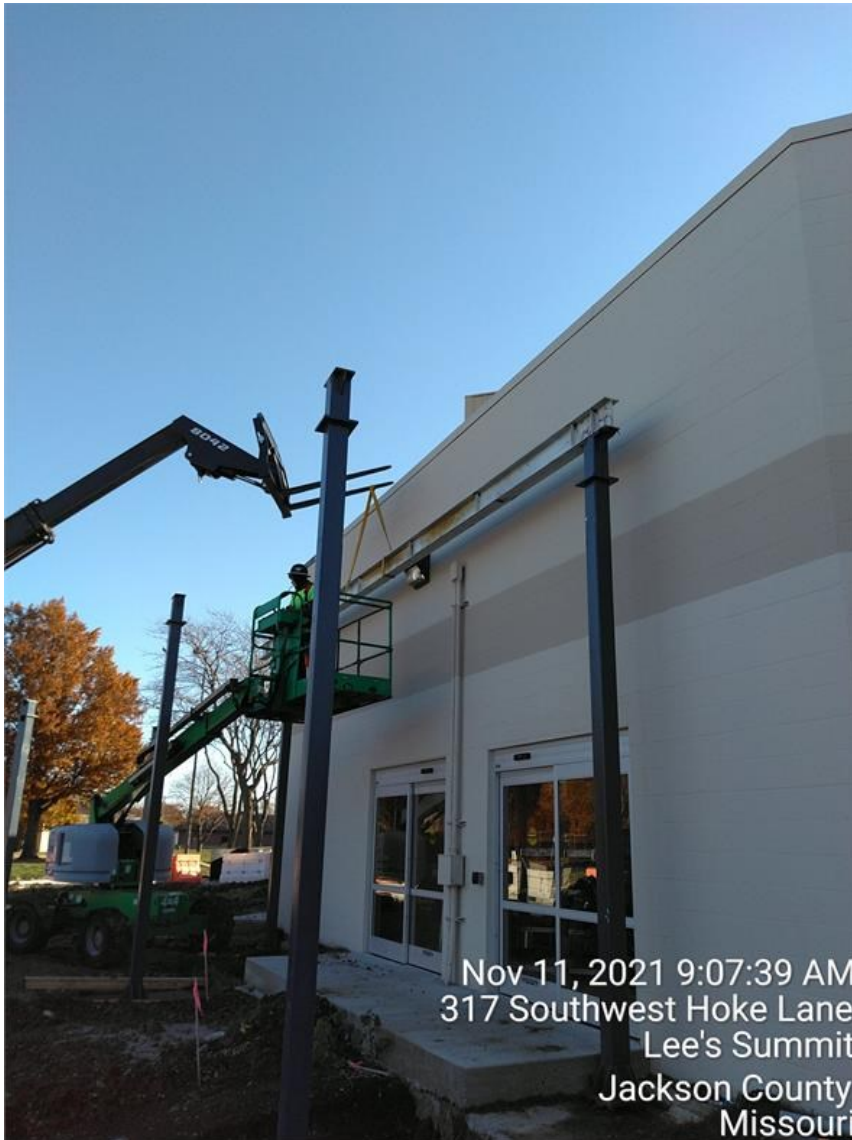
Repaired beam erected on acceptable column

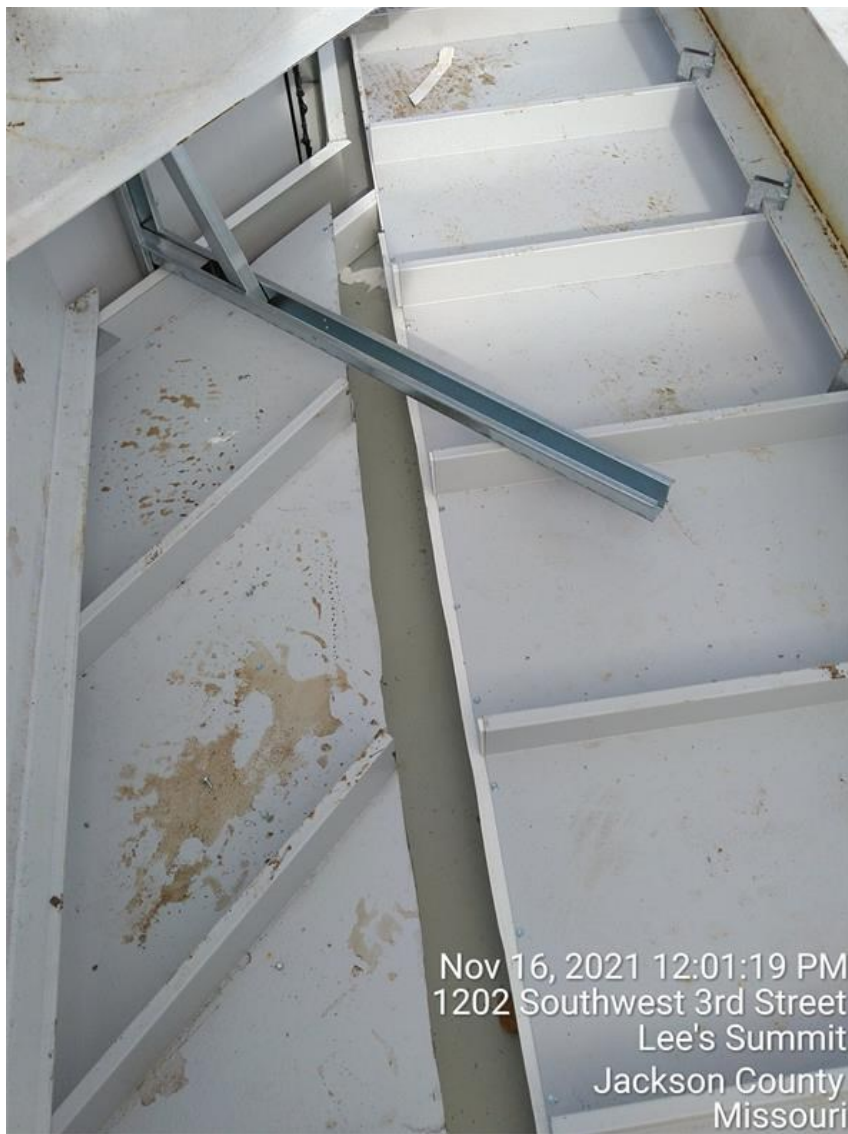
Screw lap installation acceptable throughout

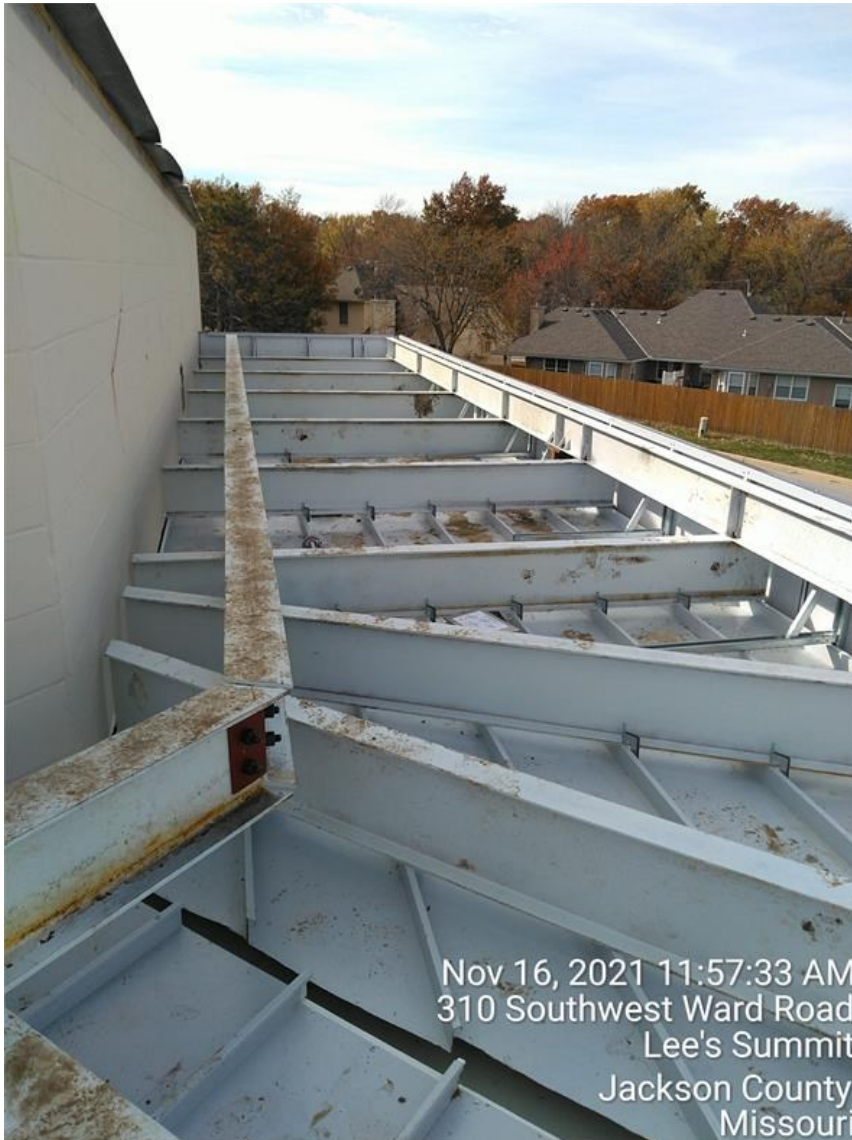
Structural members repaired

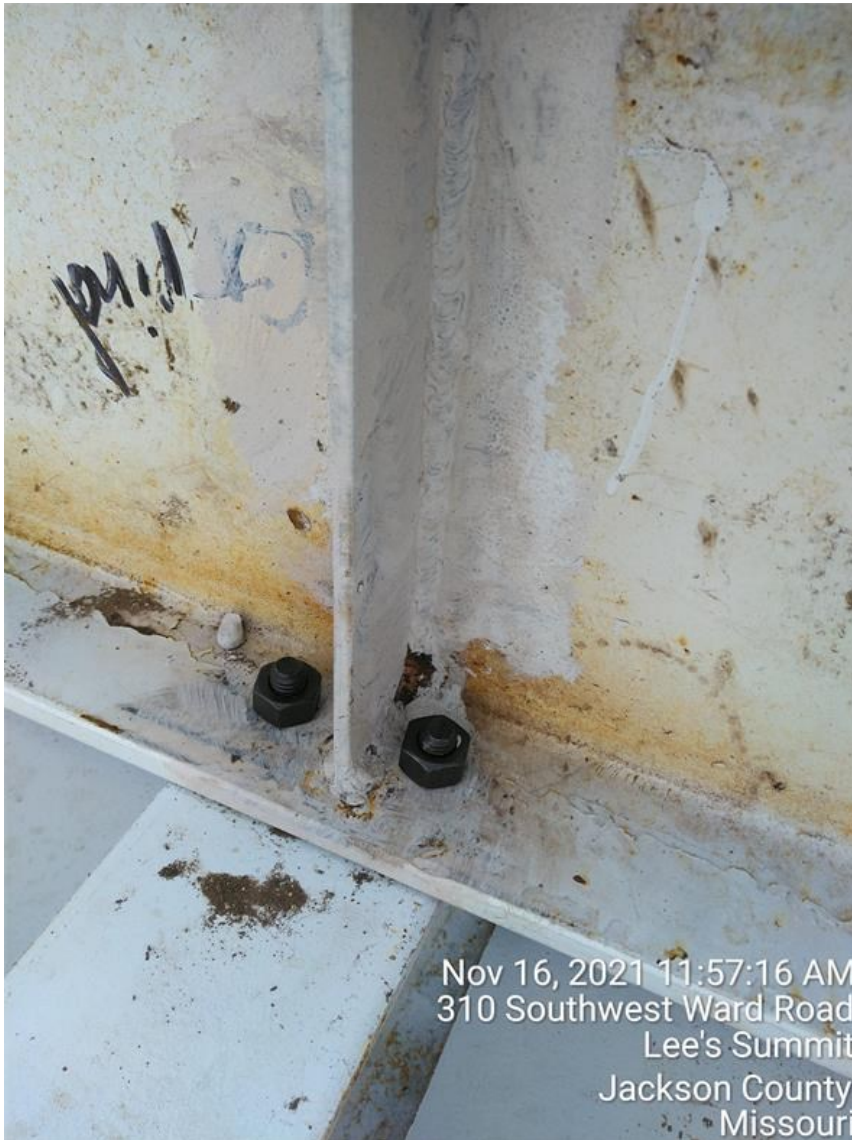
Observations of Aisles Online Canopy in grid area J to K - 10.3 to 15' west of line 11 were inspected after welding repairs were made by Double R Welding.  
All welding repairs appeared to be acceptable according to AWS D1.1 criteria and final inspection was made

Welding repairs acceptable
