RE: HARRISON II LOT 64 SVF  
2316 SW CHASE CIR  
LEE'S SUMMIT, MO

Our firm has been asked to address framing inspection items for the home being built at the location listed above. At the time of inspection the home was in a rough framed state.

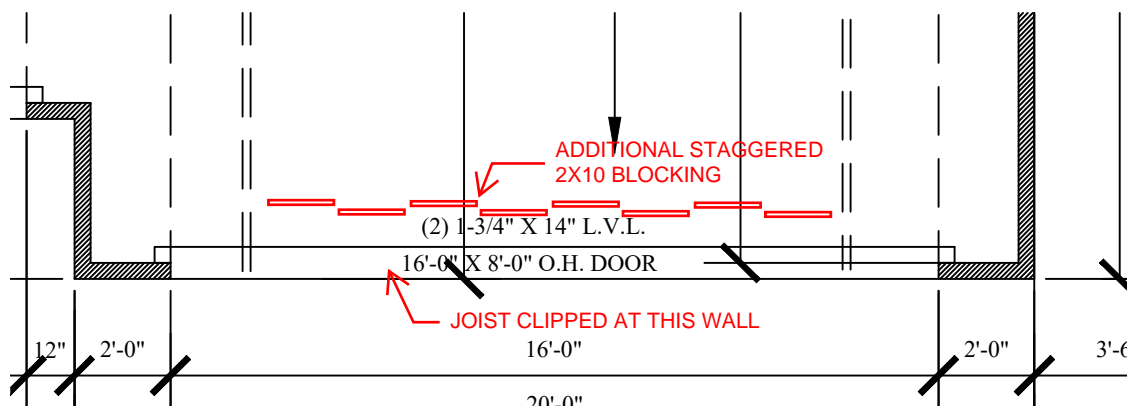
The framer has clipped the top of the floor joist at the front wall of the garage. The clip extends inside the interior face of the wall. To allow the joist to transfer load as intended our firm recommends blocking the joist, see below.

With the addition of the blocking our firm recommends approval of this item.
