April 14, 2022

**RE: Field Issue of over-notched floor joist, drilled floor joist, non-continuous top plate above HVAC chase, and non-continuous (3) floor joist for Lot #88 Reserve at Stoney Creek – 1532 SW Georgetown Dr. Lee's Summit, MO 64082 – Permit # PRRES20212957**

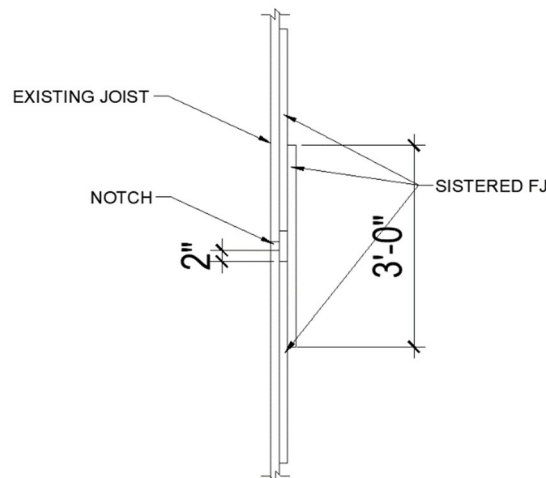
Over-notched floor joist in basement:

- Floor joist is located under bath #1 and supporting main level flooring system.
- Floor joist has been notched to allow for plumbing DWV line.
- Notch is approximately 5" deep by 4" wide.

**Recommendations:**

- Fasten (2)-3 foot 2x10 members to existing notched floor joist.
  - Additional members shall be no more than 2" from notch.
  - Fasten to existing floor joist with 4 fasteners per linear ft in "W" pattern with 2-1/2" structural screws or 16D nails.
- Fasten addition 3' 2x10 floor joist to (2) 2x10 sistered floor joists (see image below).
  - Fasten to sistered floor joists with 4 fasteners per linear ft in "W" pattern with 2-1/2" structural screws or 16D nails to each floor joist added
