May 16, 2022

Summit Homes  
120 SE 30<sup>th</sup> St.  
Lee's Summit, MO 64082

**RE: Field Issue of top plate connection, over-bored rim joist, and basement slider header for Lot #19A/B – Lee's Summit, MO 64082 – Permit # PRRES20214081**

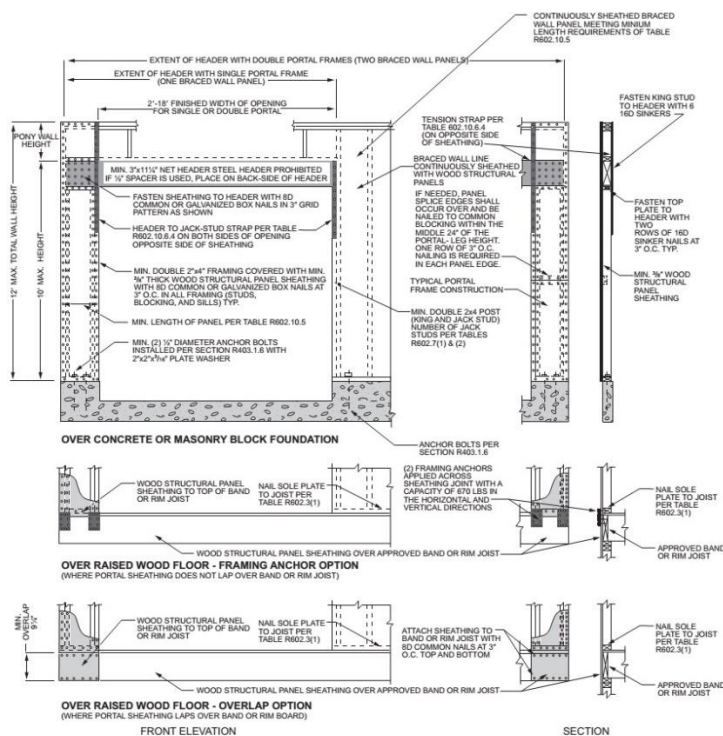
### 3. CS-PF Bracing in the basement (Unit A):

- (2) 2x10 rim was installed above basement window.
- Plans call for (2) 2x12 header with CS-PF.

- Install a dropped (3) #2- 2x12 header with CS-PF per detail as shown in image below.
- Drill and epoxy anchor bolts per CS-PF detail.
