FRAMING ADDENDUM

4-7-22

STEWART BUILDERS

RE: PRRES20212466
508 SE DAVID RD
LEE'S SUMMIT, MO.

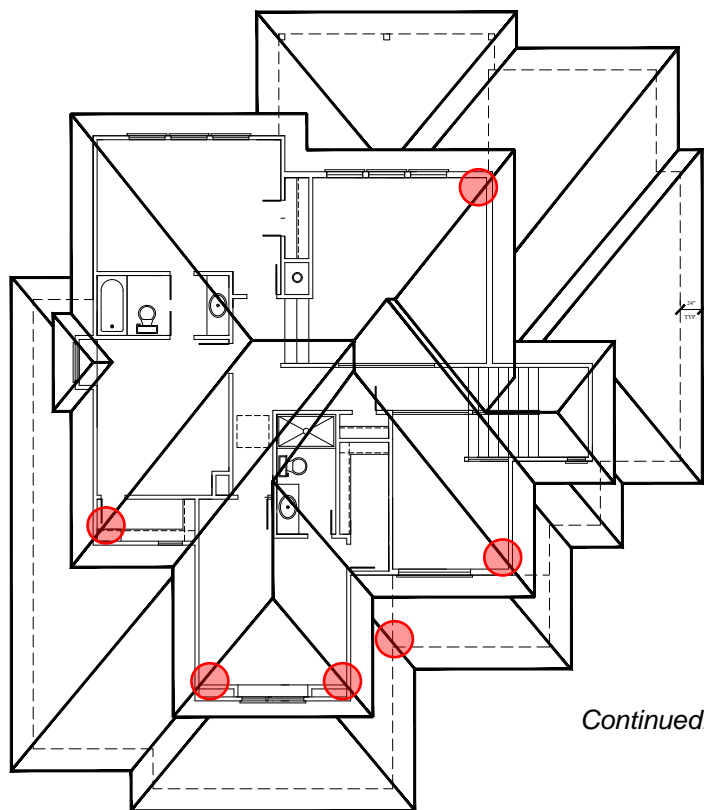
- Overnotched hip joist at entry/ garage beam
- Address ceiling joist, hip, rafter and beam taper cuts and overnotched rafters throughout

There are several locations where the hip and valley seat cuts have been over cut to allow clearance. After review of the roof loads our firm has identified the locations (see below marked in red) in need of additional reinforcing to ensure proper transfer of roof loads. The locations marked will be reinforced with a layer of 7/16 OSB attached as shown in the detail below.
