FRAMING INSPECTION ITEM RESPONSE

7/15/2022
SAB HOMES
RE: Solaia Plan (HF047)
2023 SW Wheatfield Ct
Lee's Summit, Mo

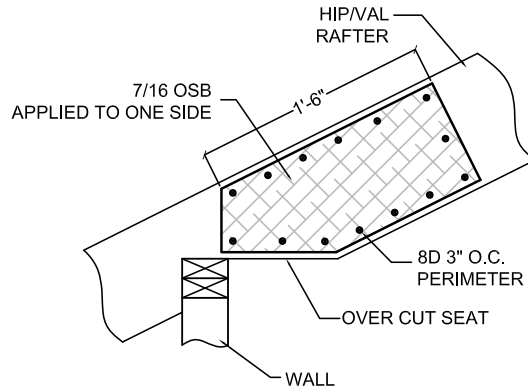
HIP/VAL OVER CUT SEAT REINFORCING DETAIL

Over-cut Hip at Dining Area

The framer has over-cut the seat cut of the hip rafter at the dining room and set it on top of the box vault. The location of the hip landing on the box vault will not prevent the box vault from transferring load as intended. The unsupported portion of the seat cut will require reinforcing the hip rafter, see below.
