RE: Field issue of LP panel siding not extending over upper top plate and header for floor joists for Lot #111 Manor at Stoney Creek –4409 SW Grindstone Circle Lee's Summit, MO 64082 – Permit # PRRES20216314

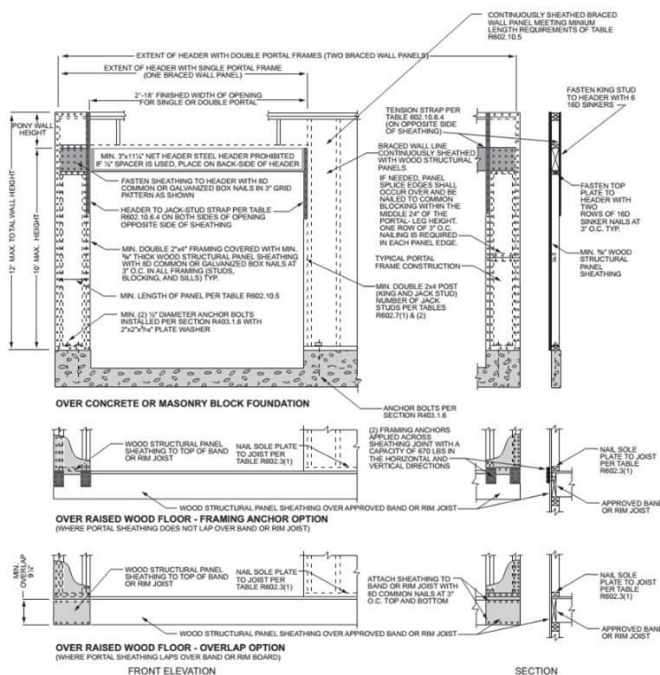
FIGURE R602.10.6.4 METHOD CS-PF—CONTINUOUSLY SHEATHED PORTAL FRAME PANEL CONSTRUCTION

- LP Panel Siding does not extend to the upper top plate at exterior dining, great room and bedroom #1 surrounding covered deck.

- Install (2) #2 DFL 2x12 continuous header corner to corner flush under double top plate at dining for CS-PF.
- Attach siding with nail pattern as specified in IRC figure below:

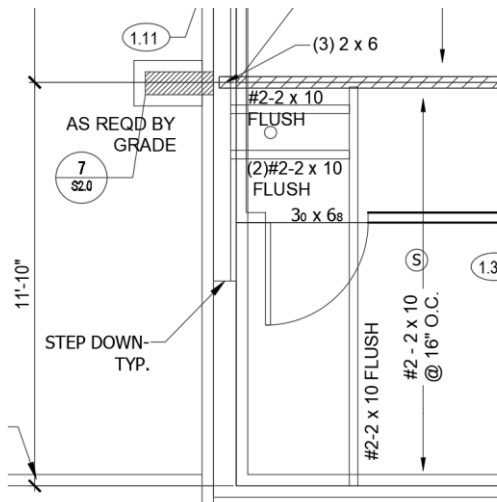
Headered floor joist for DWV:

- Floor joist shall be headered for DWV as shown in image below:
