Re: 2804 SW Hearthstone Place
Lot 55, Hook Farms
Lee's Summit, MO 64082

Apex Engineers Inc. observed the house under construction at the above-referenced address. Our firm has been retained to address comments from the city rough-in inspection. For the purposes of this report, the house will be referred to as facing north.

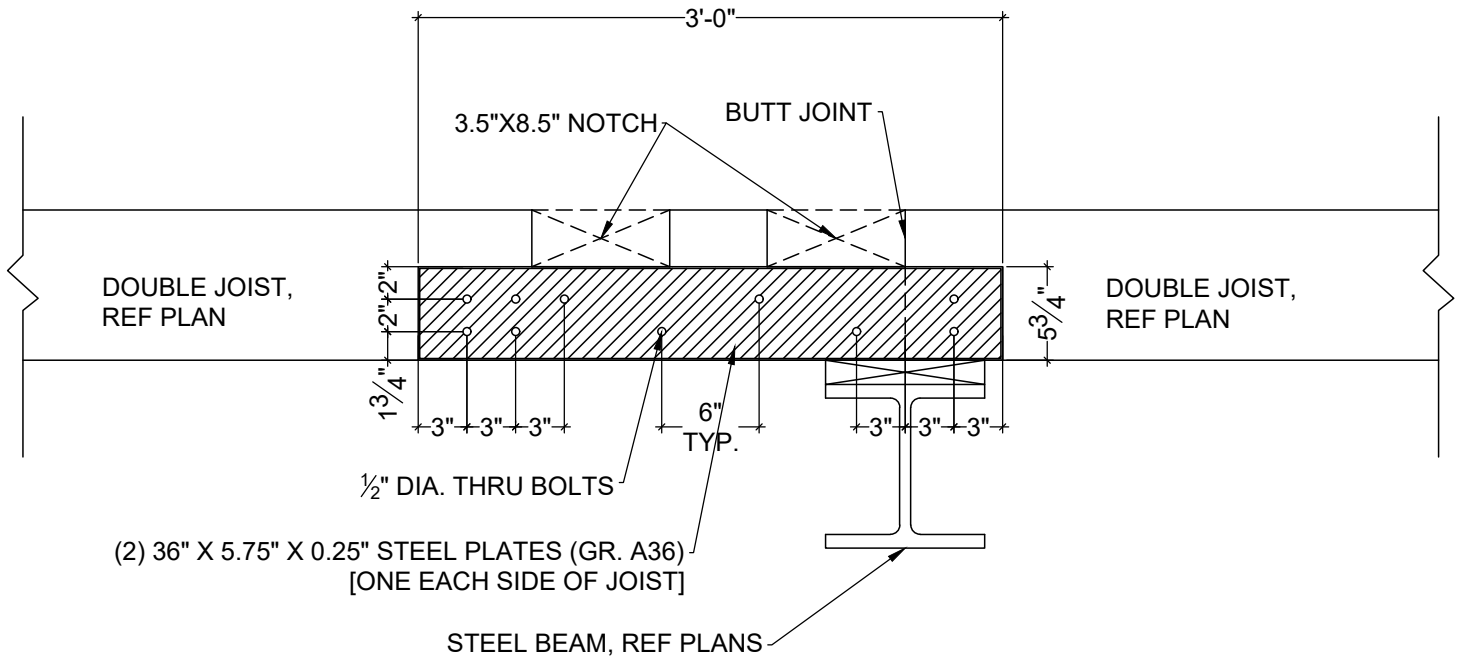
Figure 1.0 – Notched Joist Plate Repair

1. *The beam splice is located above the column at the bottom of the stairs. Is this okay? Plans show it floating approx. 3' off bedroom wall in front of the bar area.*
 - After computations, our firm has determined that the splice is in an acceptable location.
2. *There is an over-notched joist above the basement bath entry.*
 - Two (2) 3.5"x8.5" square notches were observed on the top edge of a doubled joist and located approximately 2'0" from steel beam support. The observed notches are **not** acceptable. The joist shall be repaired per the following:
 - (2) 36"x5.75"x0.25" steel plates (Gr.A36) shall be installed and bolted per figure 1.0.
 - One plate shall be installed on each side of the notched joist.

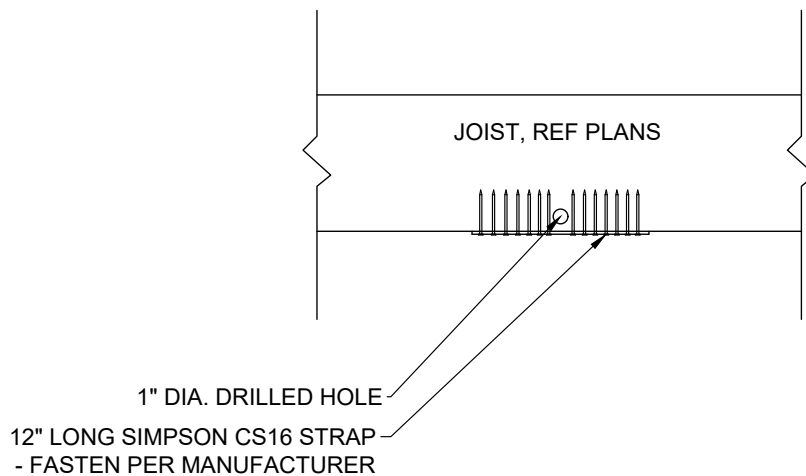
Figure 2.0 – Notch Repair with CS Strap

3. *Holes drilled in joists too close to each other at the electrical service panel.*
 - Drilled holes were observed too close to the bottom edge of the joist, taking the effective depth of the joist to 7". After computations, our firm recommends installing an additional full-length ply with the maximum possible depth without interfering with electrical (#2-2x4 DFL or #2-2x6 DFL) and fastened per the beam fastening schedule per detail 10/S3.1 of city-approved plans.
4. *Holes drilled in joist above the entry to bedrooms from rec room too close to the edge.*
 - Vertical 1" diameter holes were observed in triple #2-2x10 joists.
 - After computations, our firm has determined that the holes are acceptable.
5. *Hole too close to the bottom – near basement door and bedroom hall entry.*
 - 12" long Simpson CS16 strap shall be installed centered under the hole. Reference figure 2.0.
