Re: 2337 SW Old Port Road

Vista Structural Engineering, LLC, was asked to address the following inspection item for the house being built at 2337 SW Old Port Road:

**Provide an engineer report regarding a cracked foundation wall on the west side (see attached picture).**

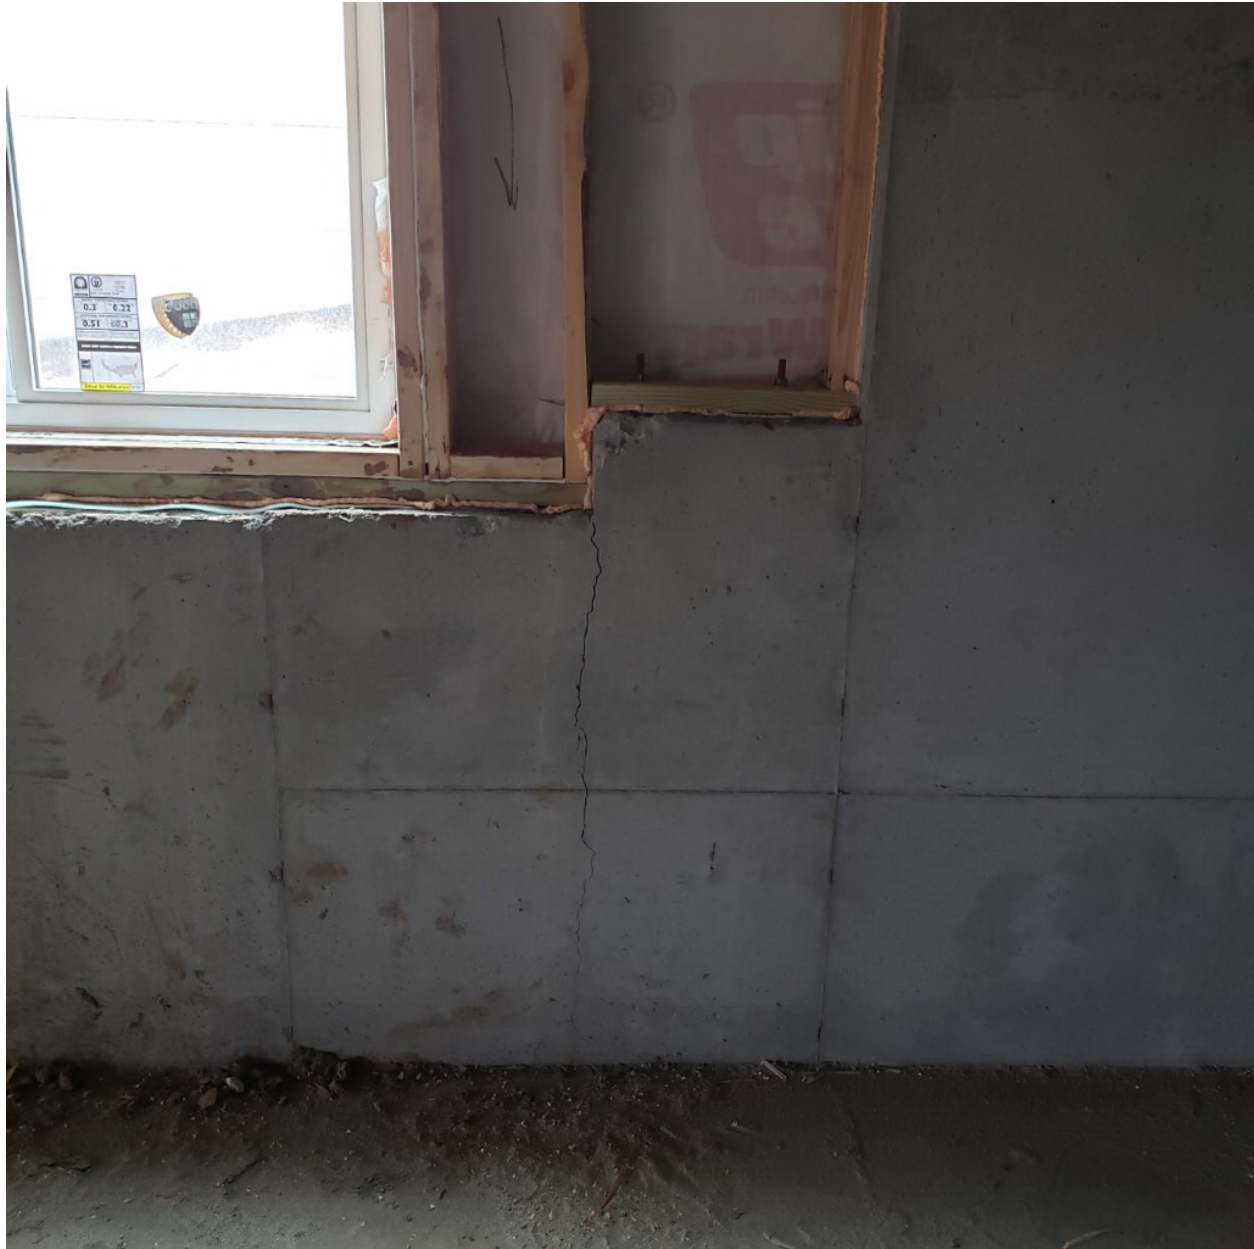
*The crack in the foundation wall appears to be originating from the step in the top of the wall. The crack does not appear to be large enough to cause any structural issues, as long as code minimum required horizontal reinforcing was installed in the wall prior to pouring the concrete. If it cannot be determined that reinforcing was installed then we recommend monitoring the crack for movement for a minimum of 14 days. If the crack grows in width, contact Vista structural engineers for further direction.*

*At the contractor or owner's option, the crack may be epoxy injected with Simpson CI-LV or another approved epoxy to avoid future movement. This is recommended if any brittle finishes are intended to be installed on the wall.*
