Re: 2059 NW O'Brien Rd
Lot 182, The Estates of Woodridge
Lee's Summit, MO
Permit # PRRES20222990

Apex Engineers Inc. observed the house under construction at the above-referenced address. Our firm has been retained to address comments from the city rough-in inspection. For the purposes of this report, the house will be referred to as facing north.

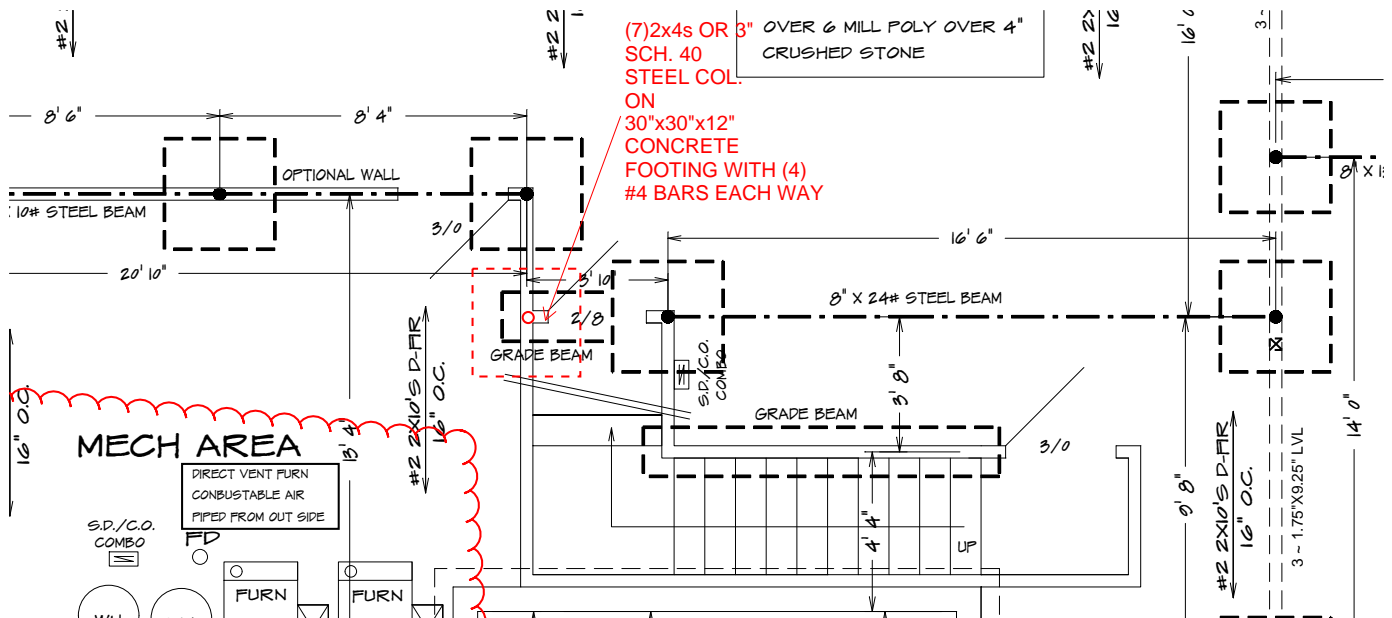
Figure 1.0 – Basement Plan

4. *Address/clarify (3) 2x4s used instead of column shown on plans resting directly on the beam below by stairs.*
 - Min (7) 2x4 built-up wood studs** or 3" (3.5' O.D) shall be installed to support the steel beam at the main floor stairs, above and below the flush beam in the floor. The column in the basement shall bear on a minimum of 30"x30"x12" concrete pad with #4 bars each way (contractor to verify condition).
