## Third Party Inspection Report

| Company<br><b>David P. Ainsworth, P.E.</b> | Permit #<br><b>2023-1605</b> | Permit Holder<br><b>WALKER CUSTOM HOMES</b> |
| Inspection Type<br><b>FOOTING</b> | Address<br><b>HOOK FARMS LOT 1K<br/>2215 SW HOOK FARM DR LSMO</b> | |

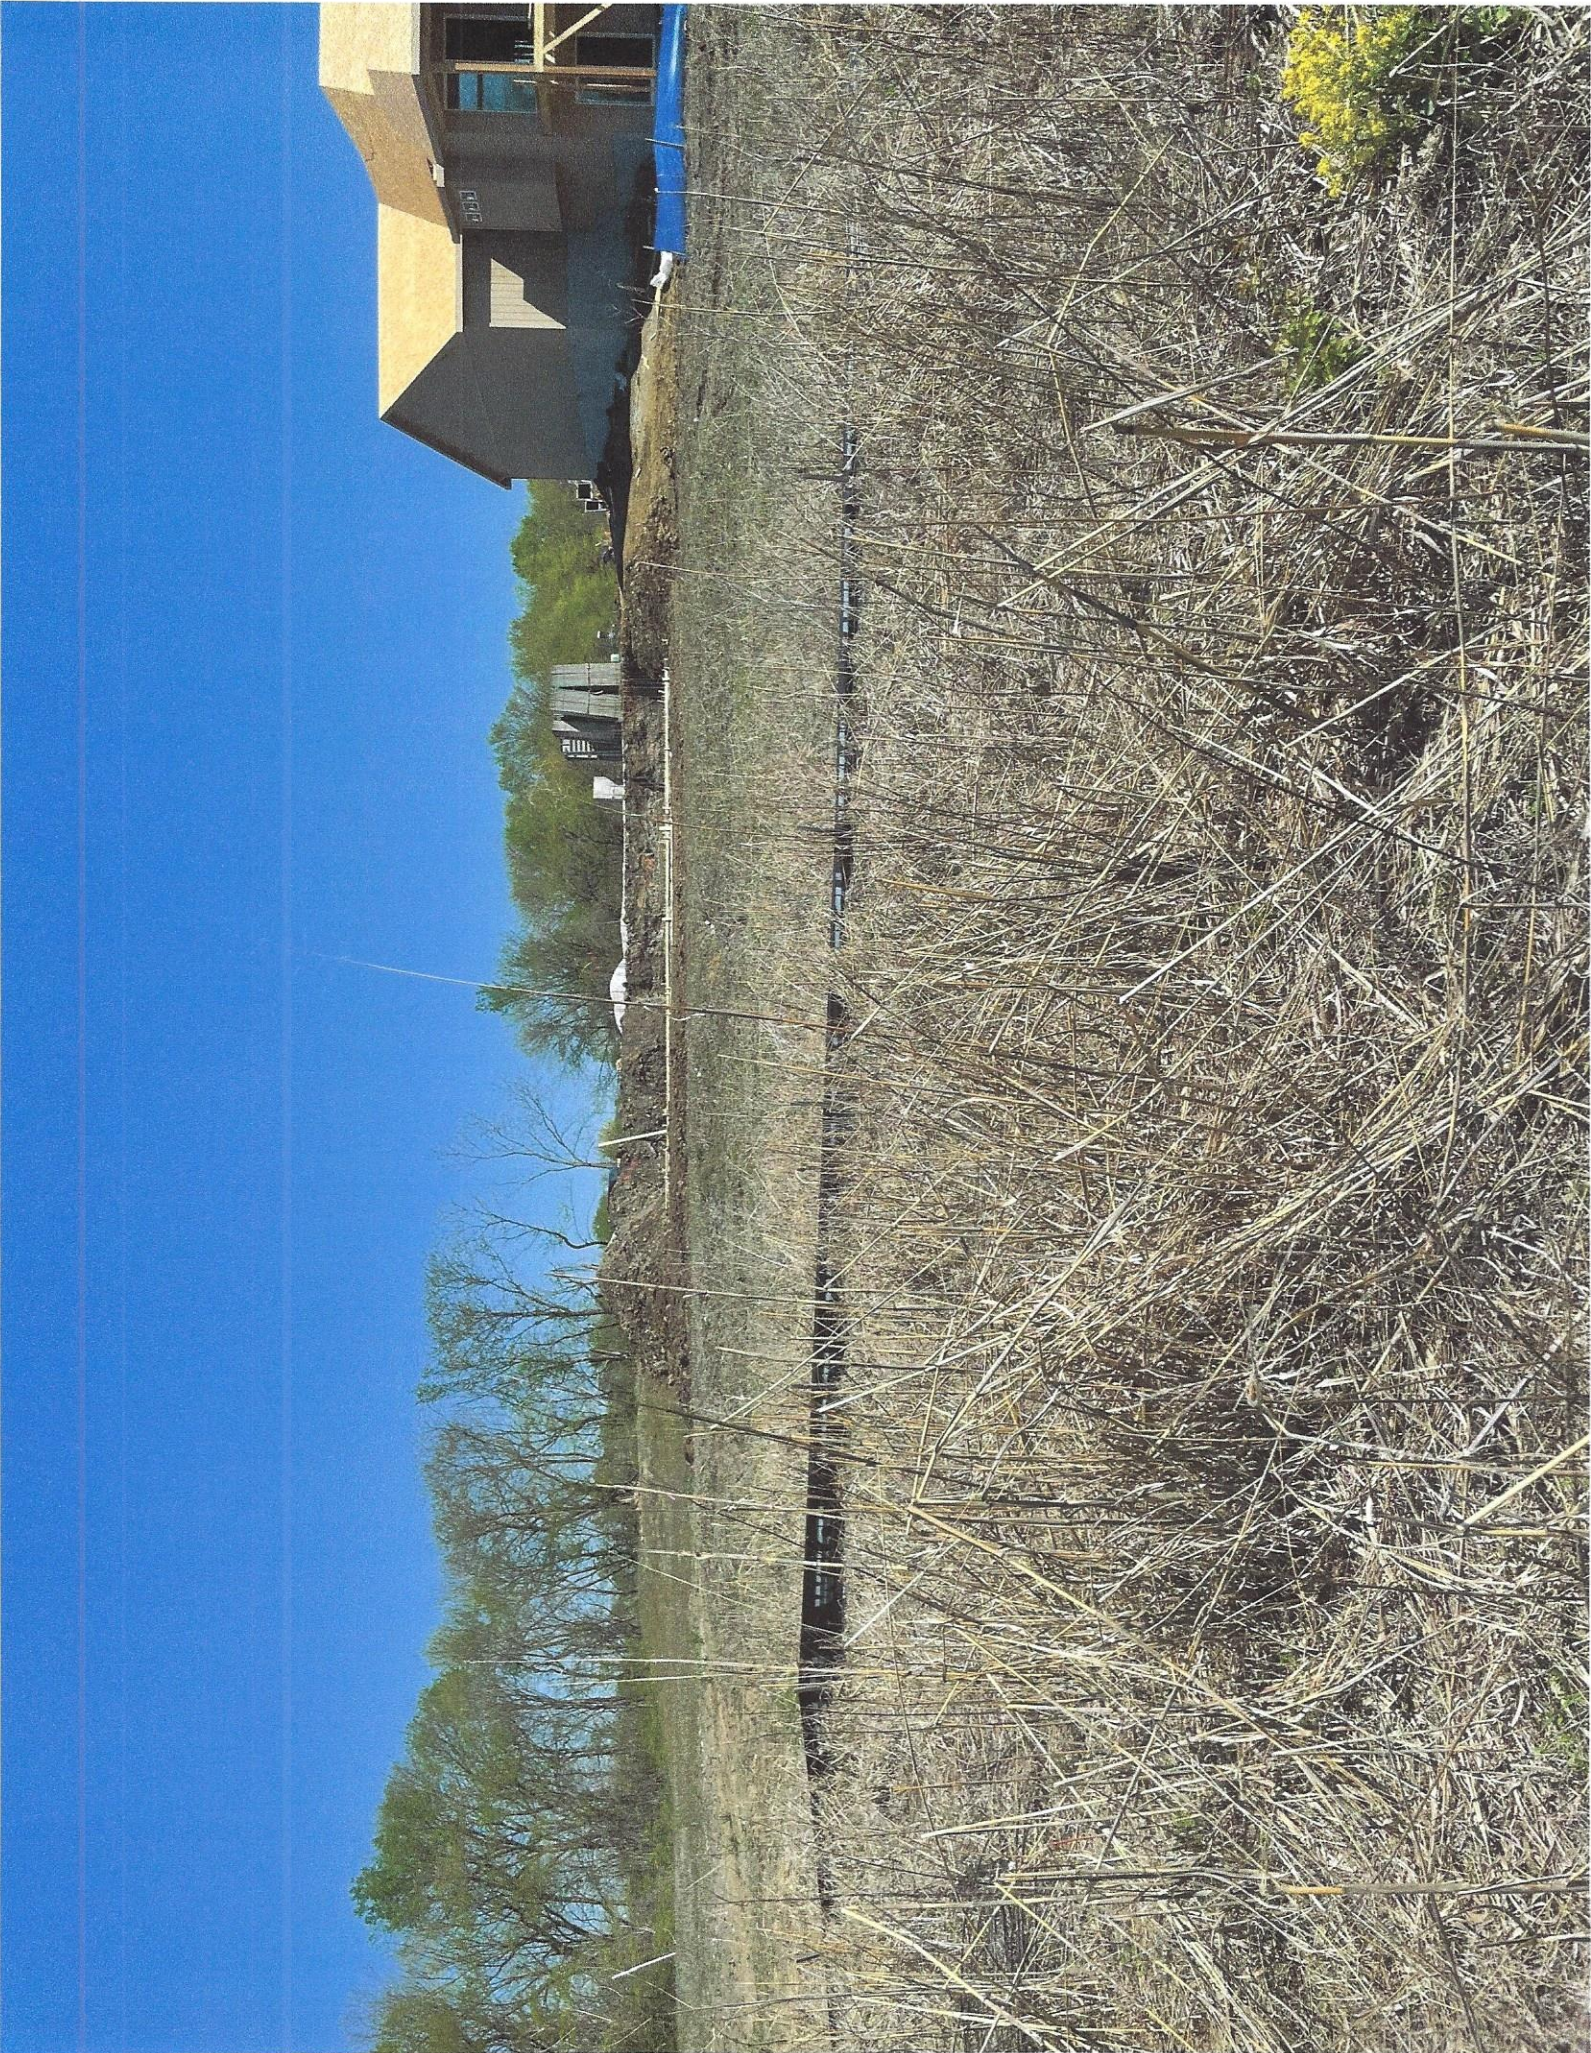
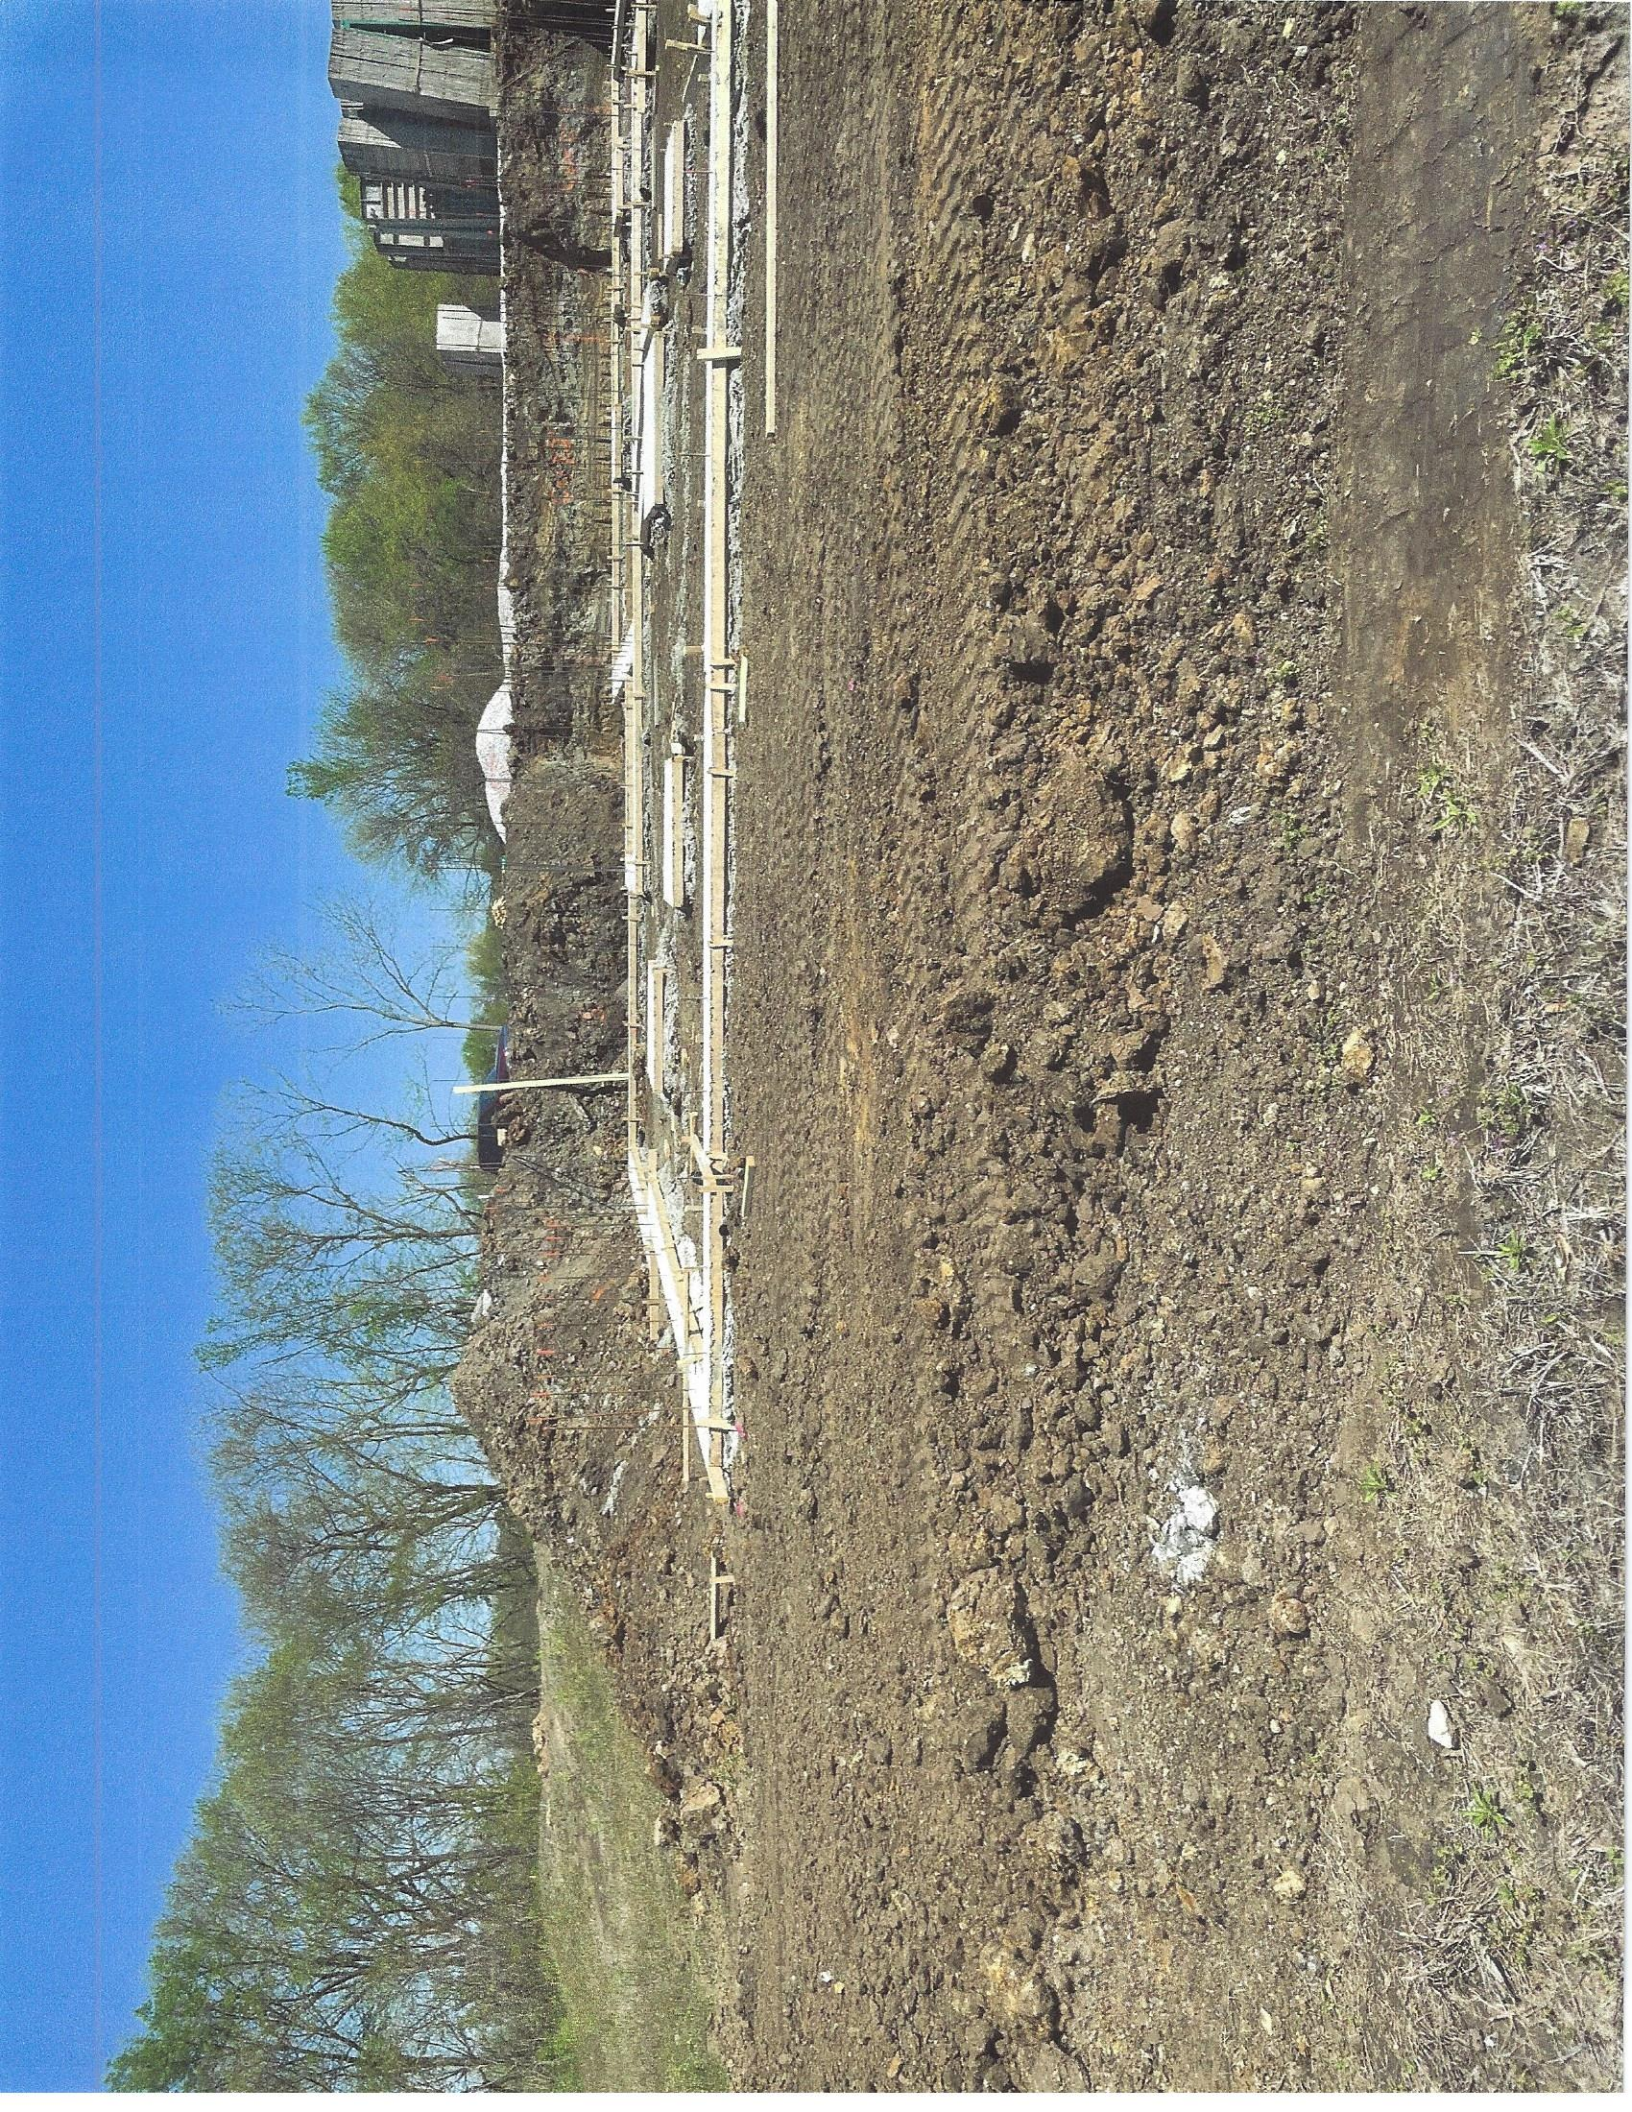
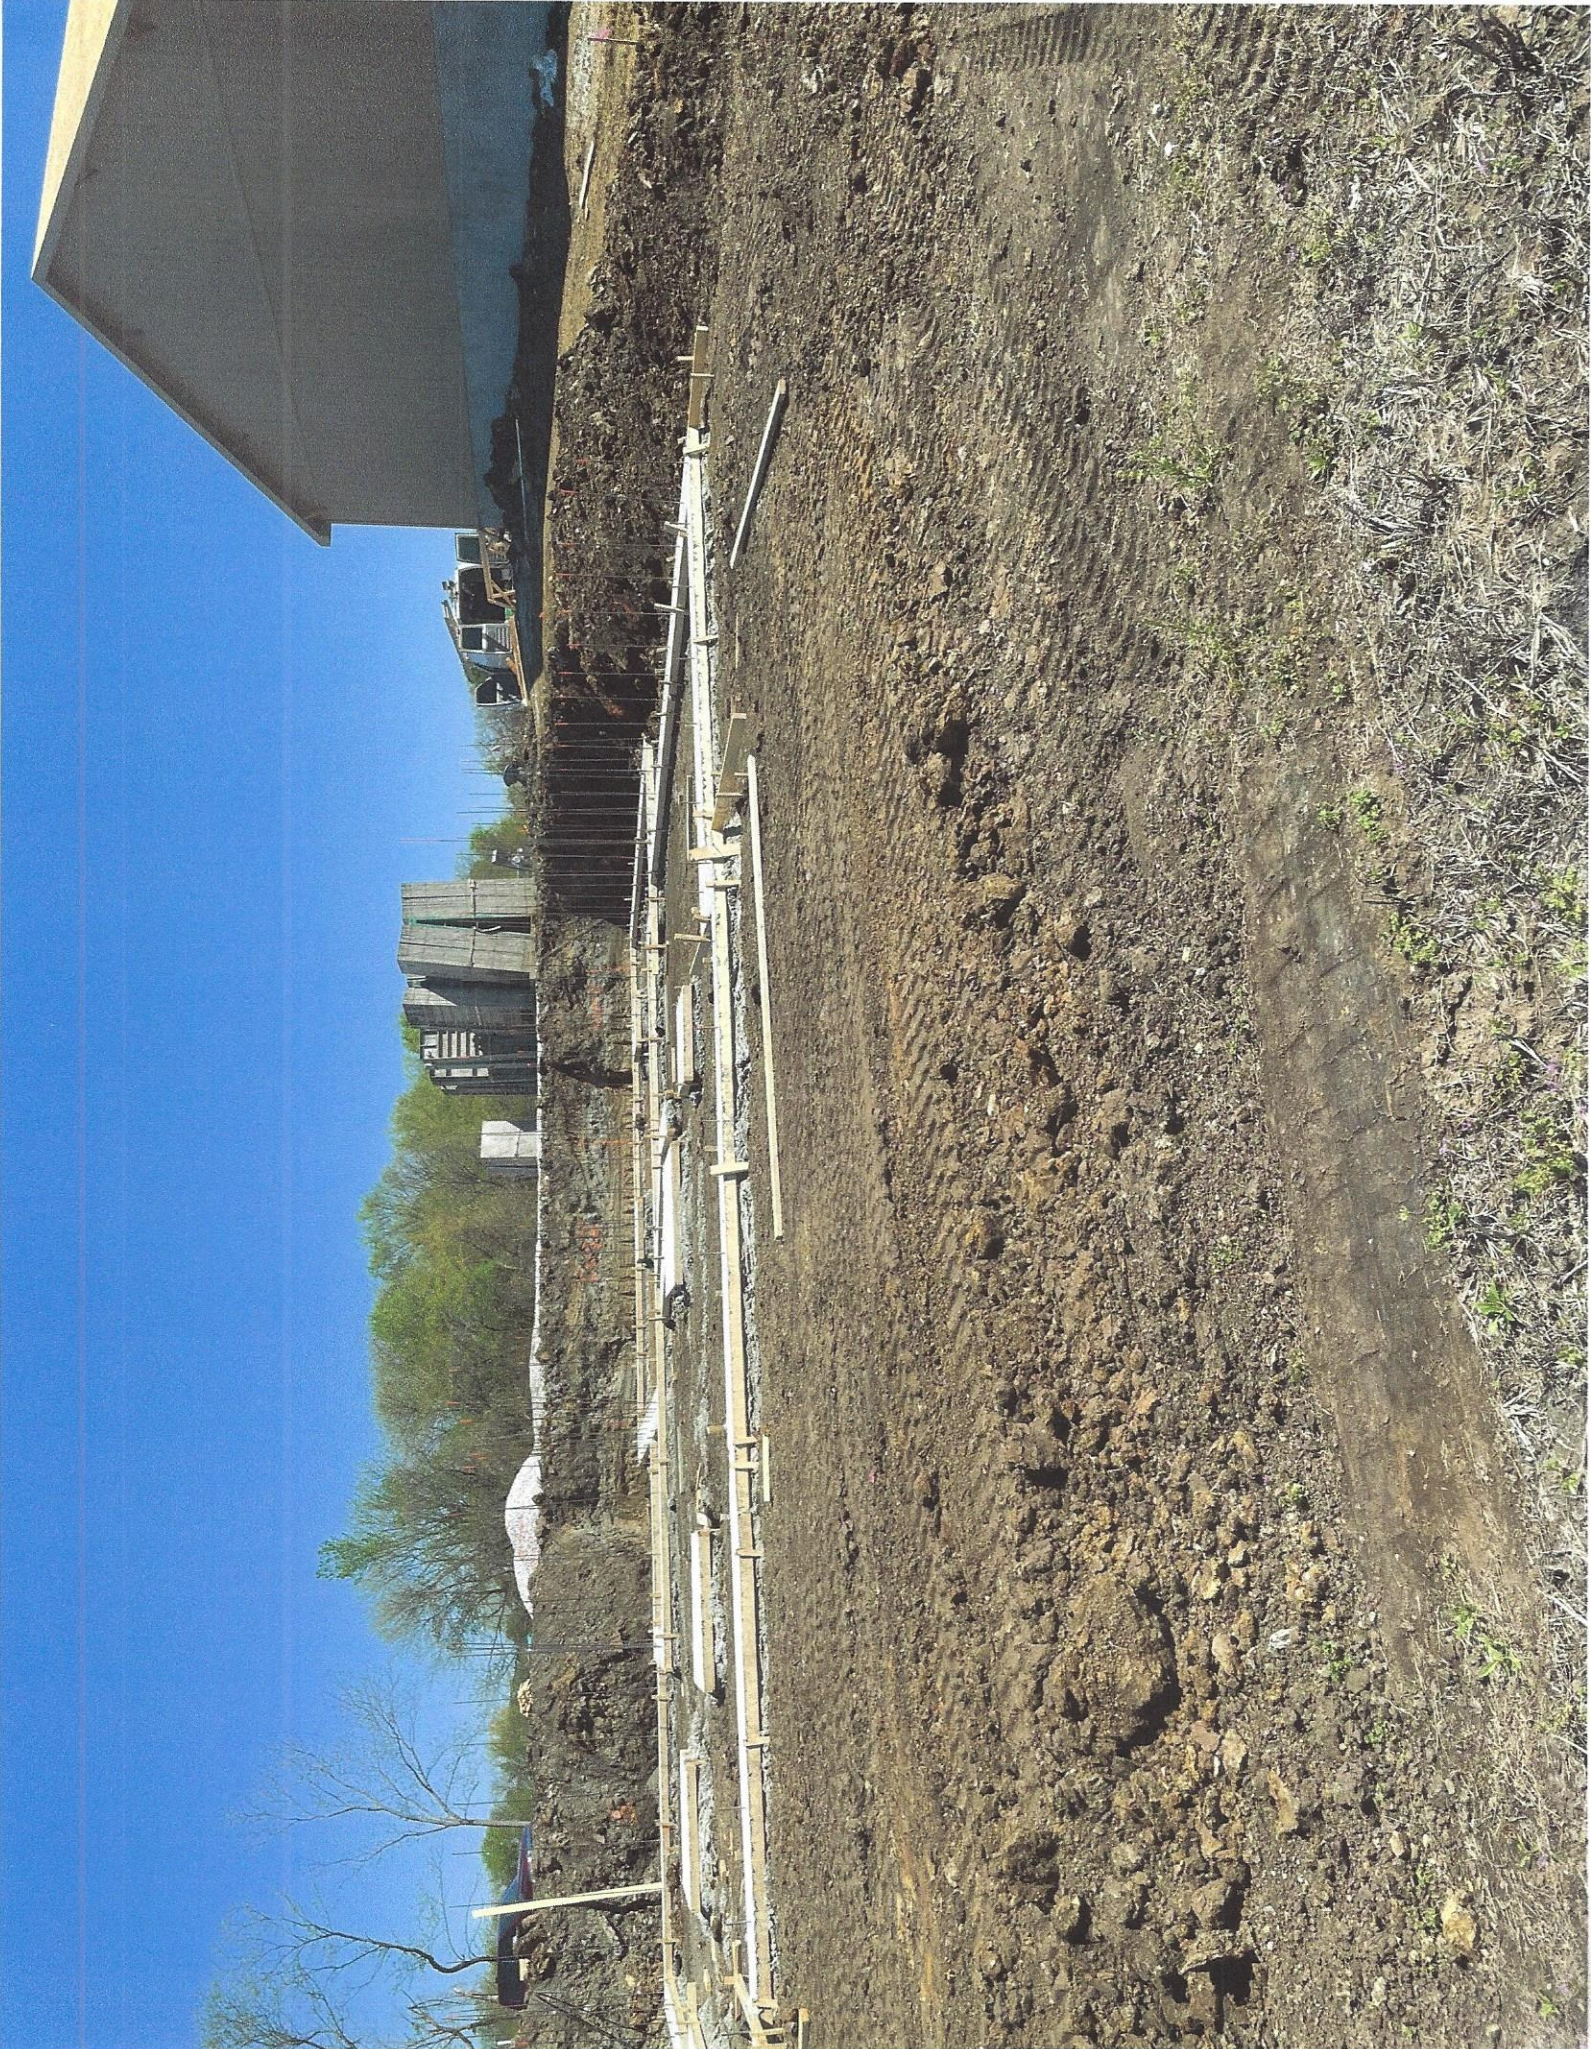
ATTACHED ARE 3 PHOTOS THAT SHOW EROSION CONTROL AT THE REAR OF THE PROPERTY AND THAT THE GRADE ON BOTH SIDES OF THE PROPERTY IS SUCH THAT EROSION CONTROL IS NOT REQUIRED ON THE SIDES.
