FRAMING INSPECTION ITEM RESPONSE

RE: Skelsey Residence
196 SW Winter Rd.
Lee's Summit, MO

STRUCTURAL REVIEW
HD ENGINEERING & DESIGN
HD: 42043 DATE: 11/2/2022

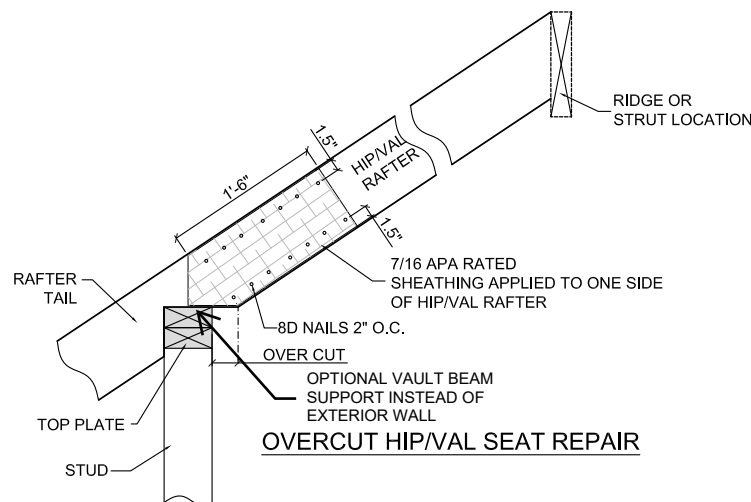
Over-Cut Hip at the Master Bedroom & Dining Room

The framer has over-cut the seat cut of the hip rafter in this area and set it on top of the box vault. The box vault beams at the Master and Dining Room are adequate to carry the hip loading as framed. At the Dining Room the LVL hip seat cut will transfer load as intended, in both sides of the Master Bedroom the unsupported portion of the seat cut will require additional reinforcement per the detail below.
