RE: Hook Farms 2<sup>nd</sup> Plat Lot 114 – 2115 SW Hook Farms Dr., Lee's Summit, Missouri

Vista Structural Engineering, LLC was asked to address the following inspection items for the project located at above referenced address. Please see the following responses w/ attached partial plan mark up, calculations, and site photos for reference.

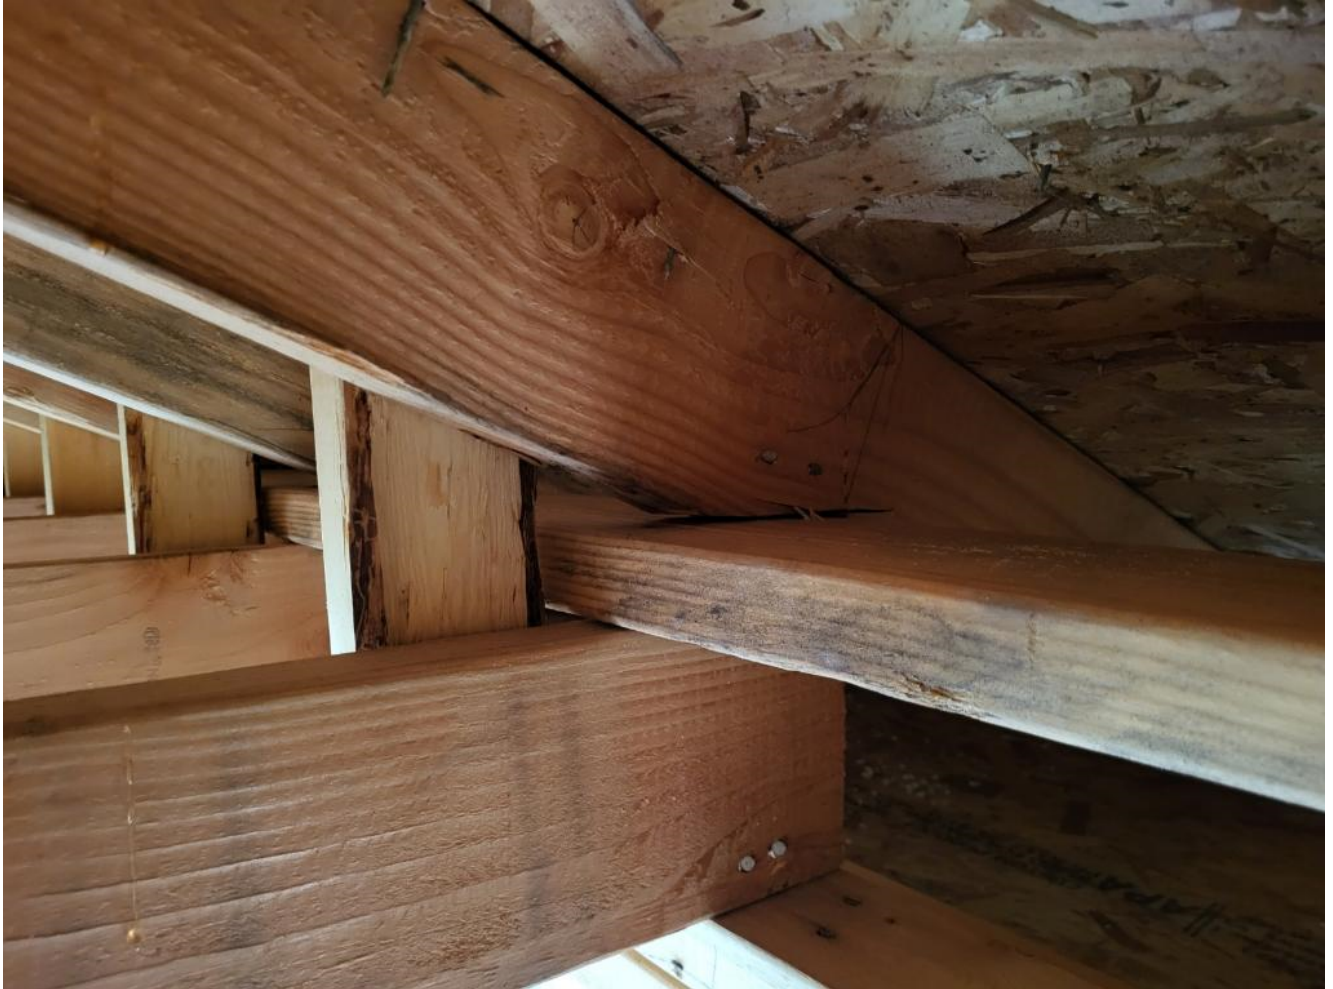
- 1) **Inspection comment:** Address rafter bearing not to plan.

**Vista Structural's response:** Roof rafter bearing is constructed per detail 7/S3.0. 2x4 brace is set vertical and rafter is bearing on an additional flat 2x6 plate, bearing on ceiling joist at the bearing wall end. GC to verify ceiling joist is toe nailed to wall plates w/ (3) 8d toenails as specified in detail 7/S3.0. **Vista recommends approval of the current framing if toenails are installed.** (RE. Photo 1 on pg. 2).

**PHOTO 1: RAFTER BEARING CONDITION PER  
DETAIL 7/S3.0**

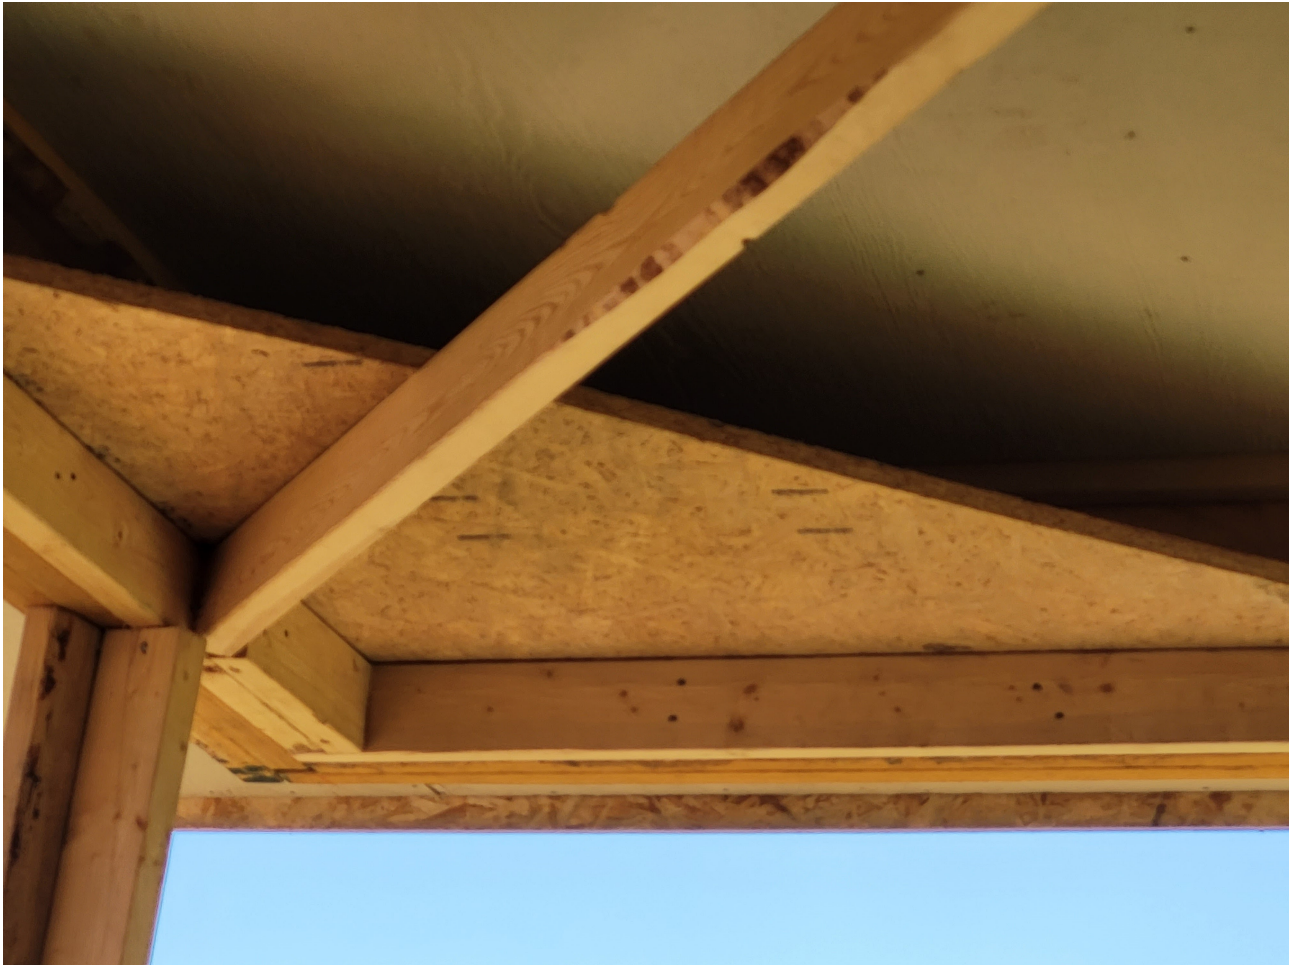
- 2) **Inspection comment:** Most exterior double LVL at covered patio plans call to be continuous to corner.

**Vista Structural's response:** Adjacent double LVL is notched to allow for fastening (RE. Photo 2 on pg. 3). LVL beams will be bearing on 6x6 post, there would be 2" min. of bearing for questioned double LVL beam which is sufficient by inspection. **Vista recommends approval of the current framing with no structural upgrade.**

***PHOTO 2: END DOUBLE LVL AT BACK PORCH***

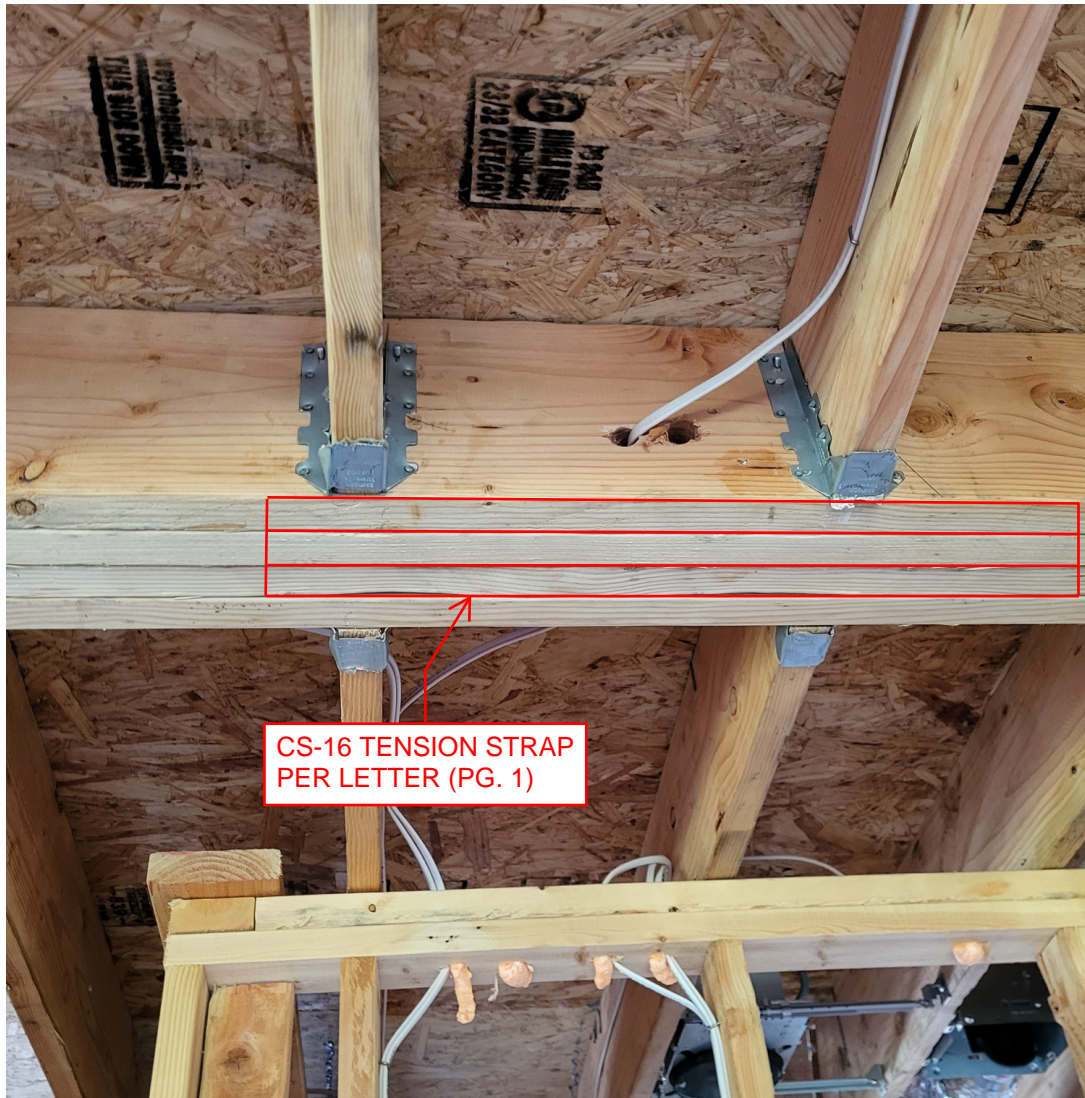
- 3) **Inspection comment:** Holes drilled too close together in (4) 2x10 above master bath.

**PHOTO 3: (4) 2x10 BEAM PENETRATION**

**Vista Structural's response:** Second hole penetration is through approximately two to three 2x10s, RE. Photo 3 on pg. 4. **GC to provide (3) Simpson CS16 tension strap fastened to the underside of first three 2x10s. Center strap on penetration w/ 13" end length each direction (26" total strap length); provide (11) 8d nails into each end length.**
