Re: Visual Structural Review
519 Southwest 3rd Street
Lee's Summit, MO 64063

Elevated concrete and steel walkway and stairway on south side of the building.

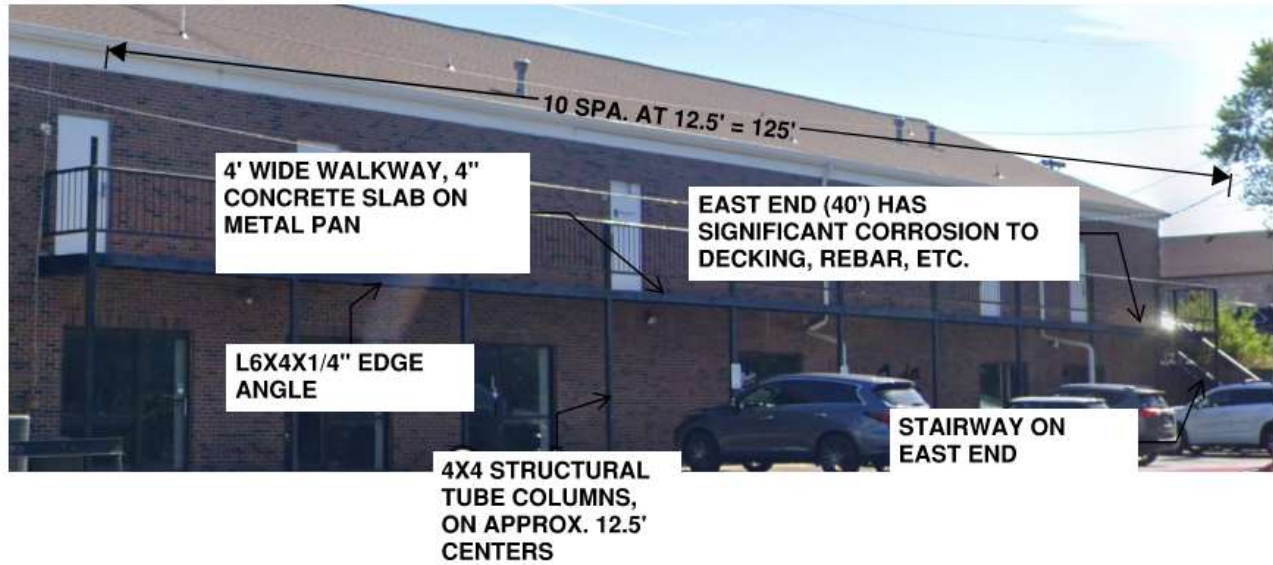
- The concrete walkway exhibited significant corrosion on the east 40' of walkway length. It is recommended that, at a minimum, this section of the walkway be replaced with new steel decking and reinforced concrete deck. It appears that 4x4 tube columns and L6x4 edge angles are in satisfactory condition and may be reused. Transverse support members are an extension of interior building bar joists bottom flange and are supported by CMU walls. Transverse members should be inspected closely for corrosion. If necessary, metal plates may be added to these members to reinforce them.

WALKWAY ON SOUTH SIDE OF BUILDING

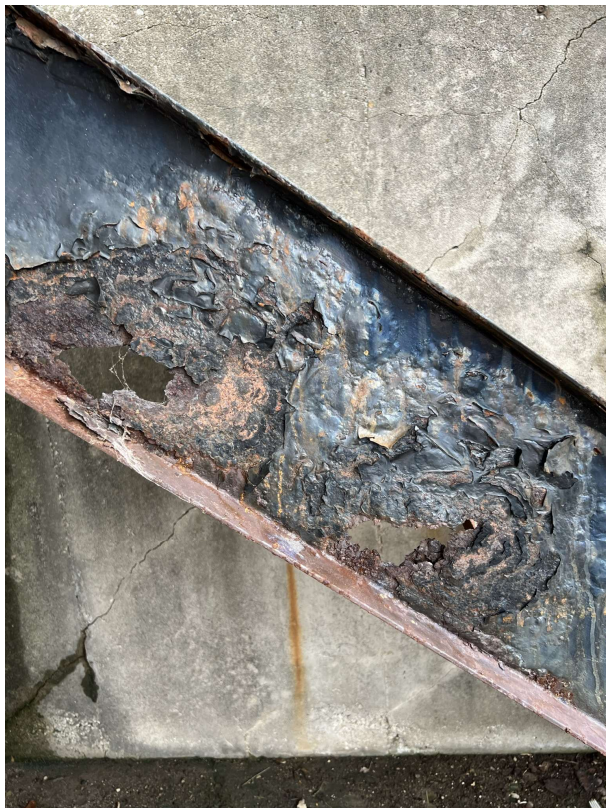
- Stairway on east end of walkway consists of C12 stringers and concrete metal pan stair treads.
- Significant corrosion of stairway structure was observed. It is recommended that stairway be replaced in its entirety.

Corrosion of Stair Stringer

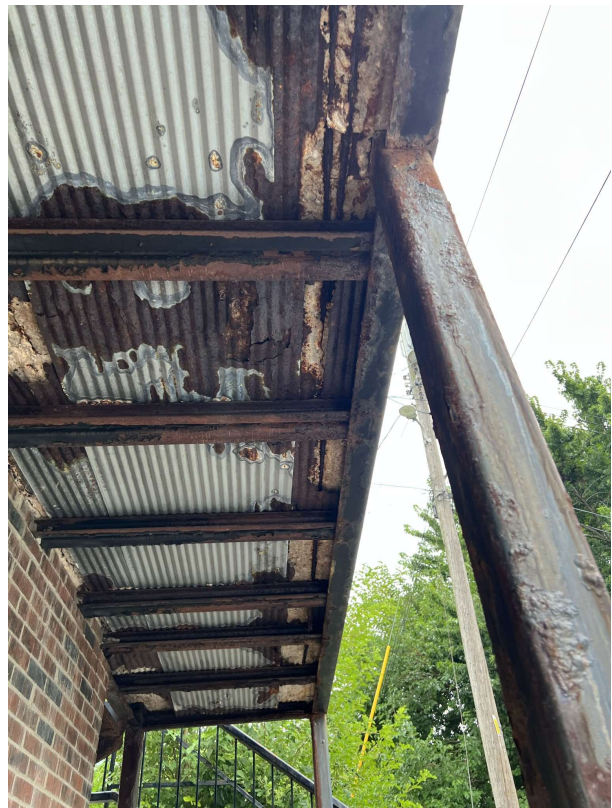
Corrosion of Steel Decking and Transverse Supports

- Members to be reused should have all rust and loose paint removed and painted. Additional member replacement may be identified during this process.
- Note that this review is for structural items only. It is recommended that a licensed architect be engaged to review other issues such as egress and stair rebuild for code compliance.
