# Inspection Report

## Hydro Physics Pipe Inspection

420 SW Longview Blvd, Lee's Summit, MO 64081

Inspection Date

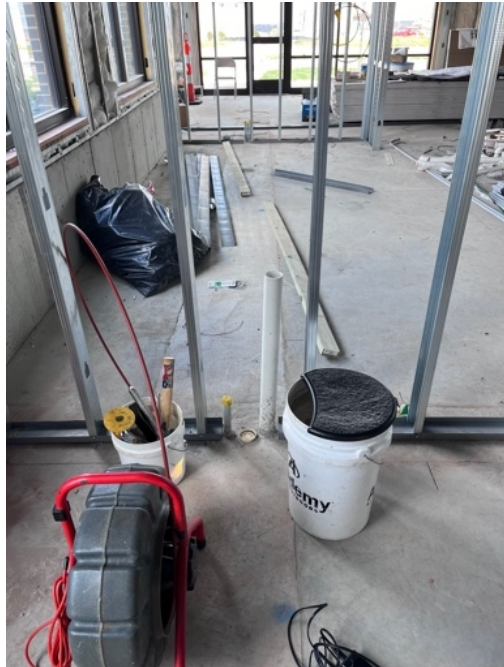
Run 1 was from 2 inch line center space North Wall south to floor cleanout

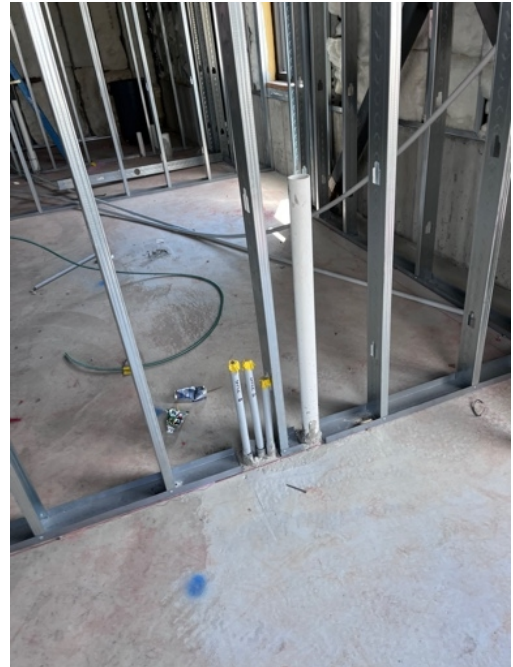
Run 2 & 3 was from 2 inch line Northwest space running south to main trunk line

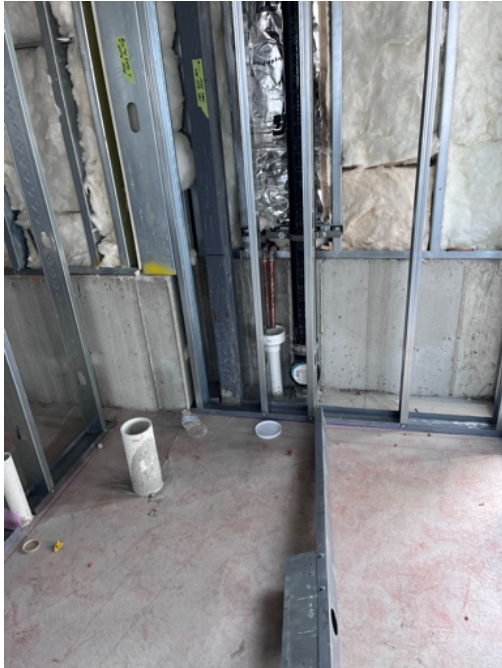
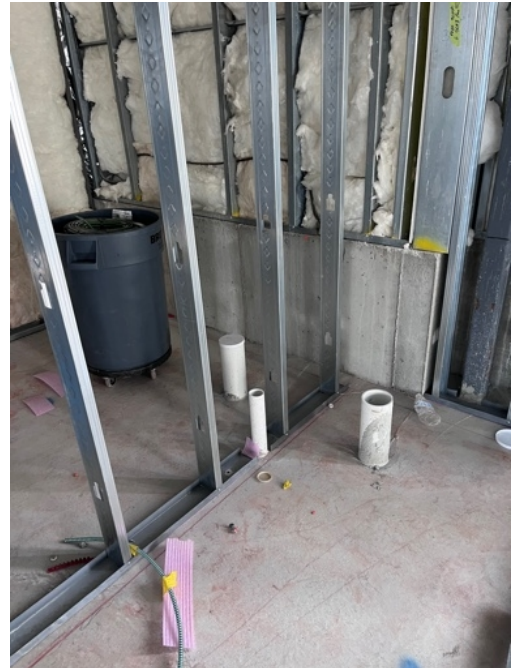
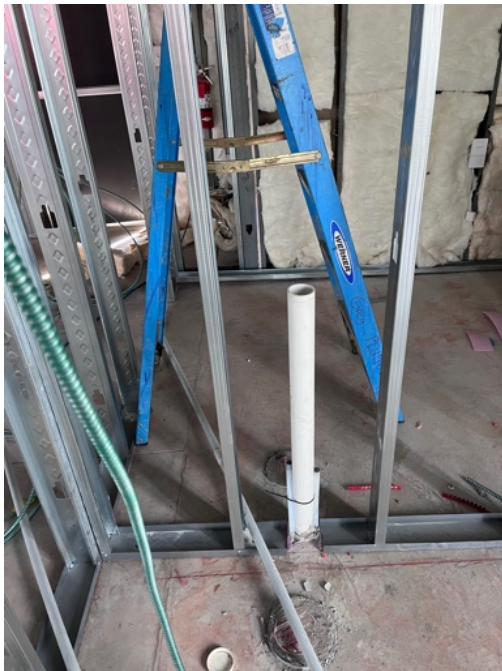
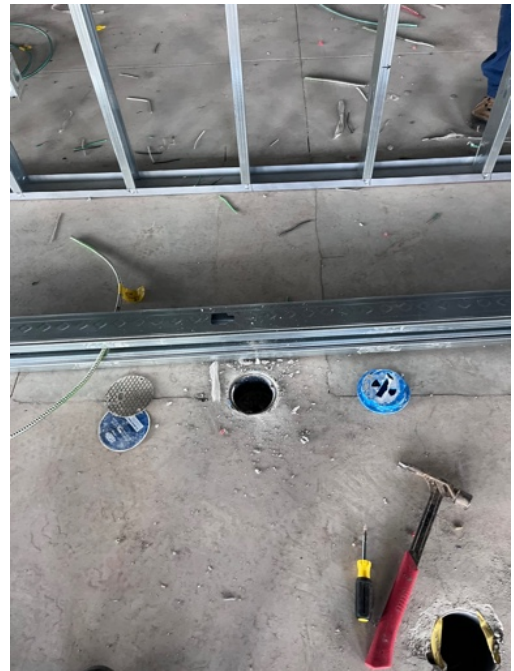
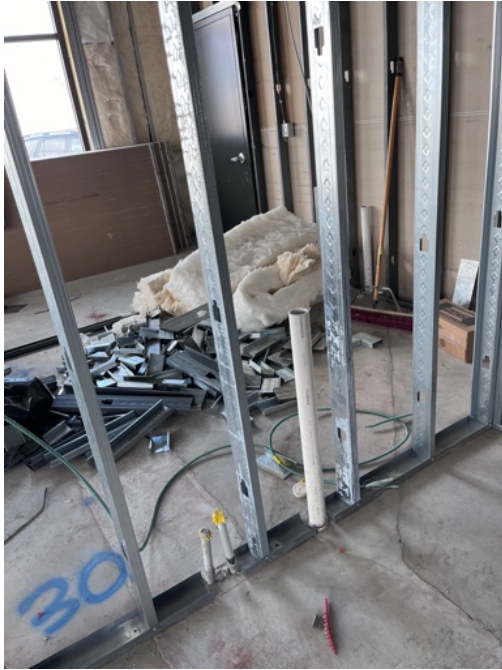
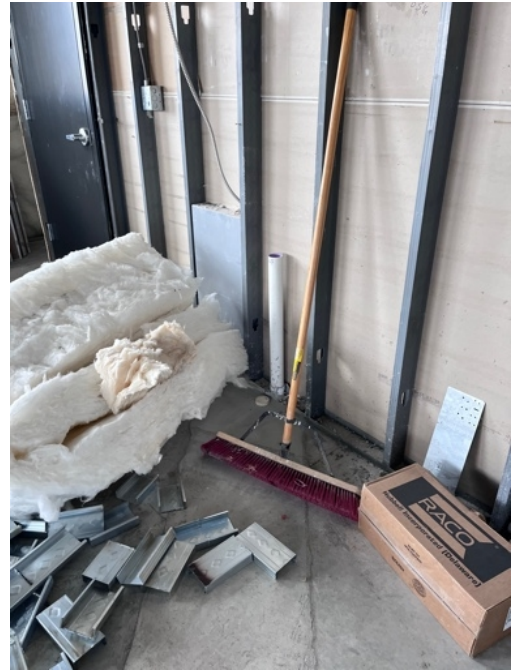
Run 4 was from south back to back toilet, running north to main trunk line, then east to floor cleanout, then south to next space.

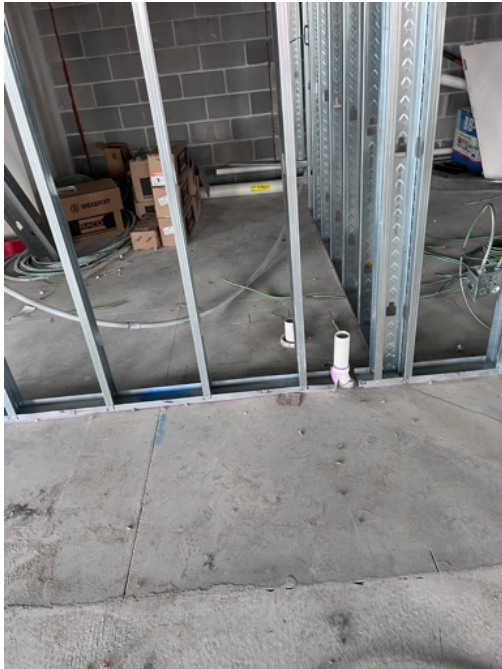
Run 5 was from 2 inch line near east wall running west to floor cleanout
