SUMMIT APARTMENT
LEE'S SUMMIT, MISSOURI
STEEL BEAM FIREPROOFING - INSPECTION

Activity Discrepancy

23-1037
Summit Square III Apts (Insp/Test)
800 NW Ward Road
Lee's Summit, MO

Site Observation Report

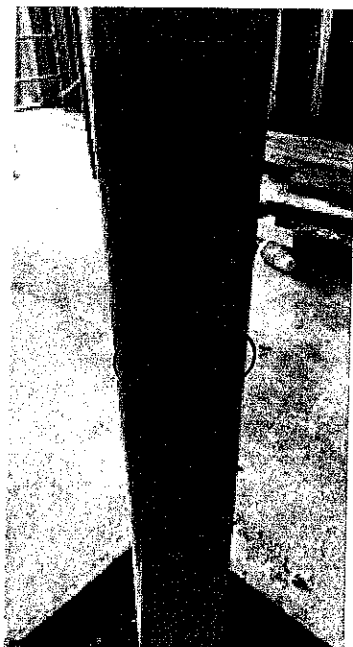
45

1st Floor Segment G middle column
along grid line 43.1

- chip in paint

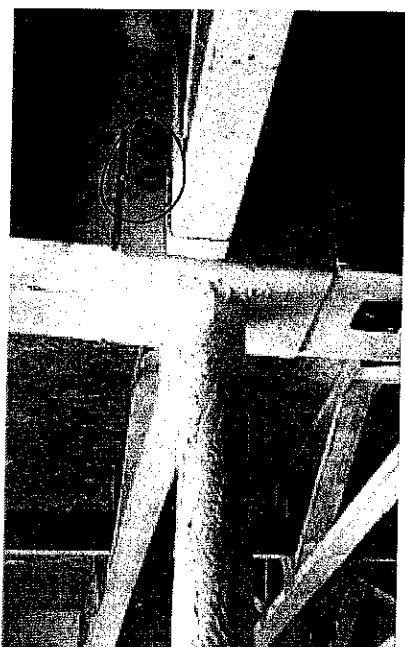
46

- Bolts need to be painted

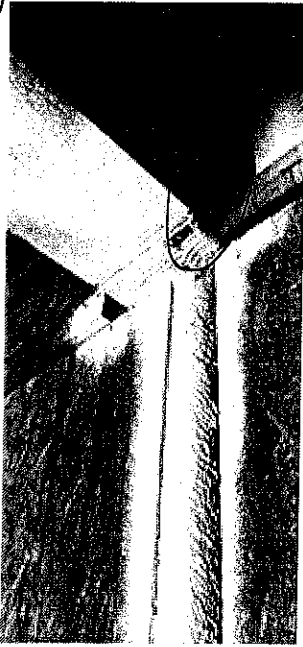
47

1st Floor Segment G west column
along grid line 43.1

- Bolts need to be painted

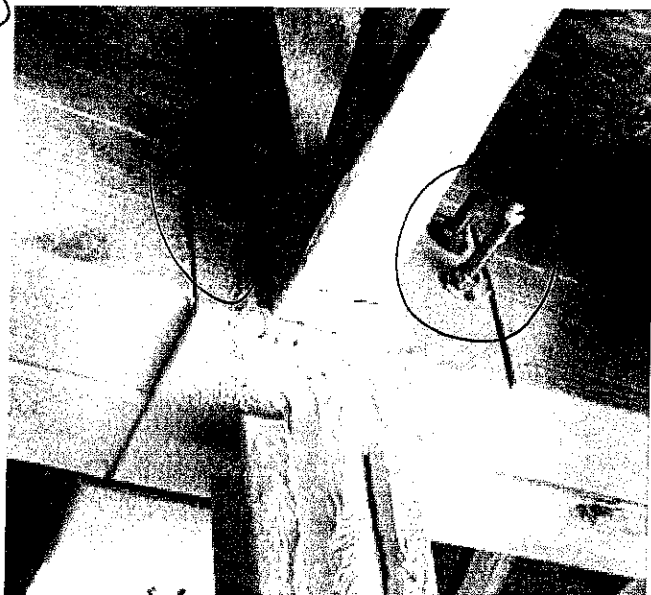
49

1st Floor Segment G west
column along grid line 43.1

- Bolts need to be painted

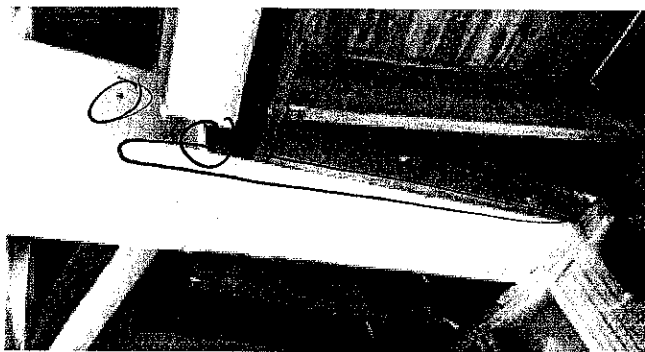
50

Basement Segment G along
~ grid line H.5

- chipped paint

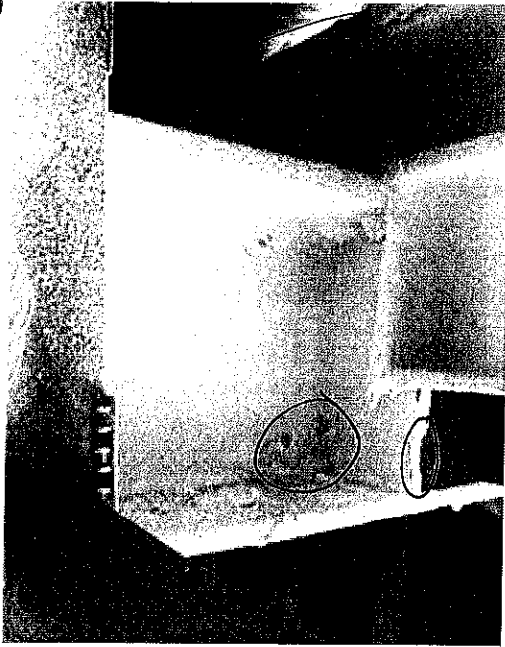
52

Basement Segment G where
three beams meet under the deck

- chipped paint
- Steel still exposed
- Bolts need to be painted

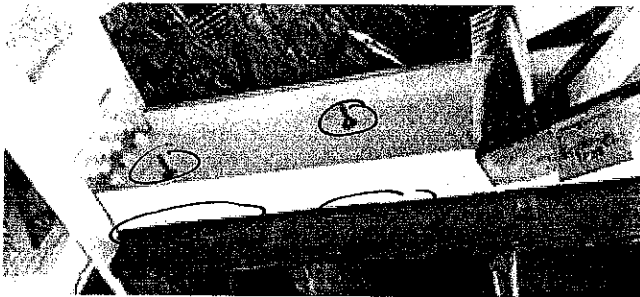
53

Basement Segment G along
grid line 1

- Bolts need to be painted
- chipped paint

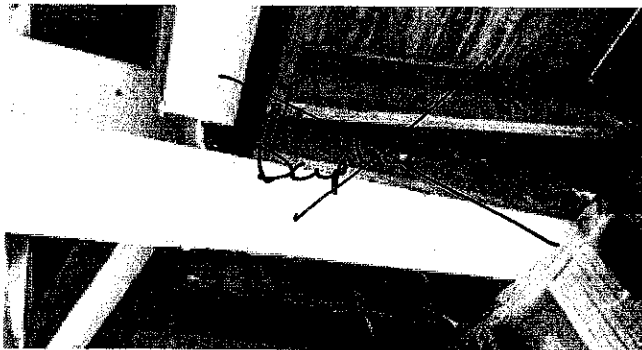
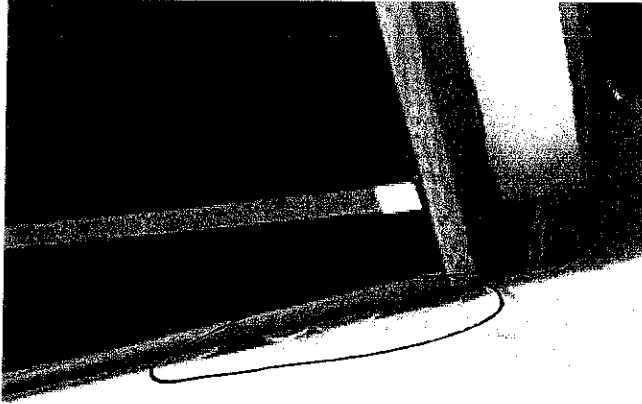
54

Basement Segment 6 along
~ grid line H.5

- chipped paint

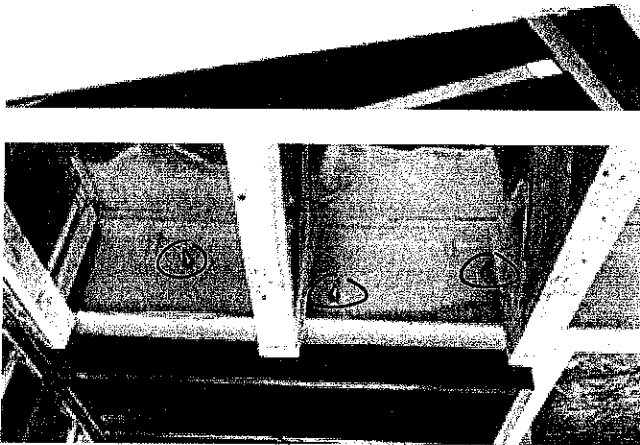
55

Basement Segment 6 along
~ grid line H.3

- Bolts need to be painted
on the beam

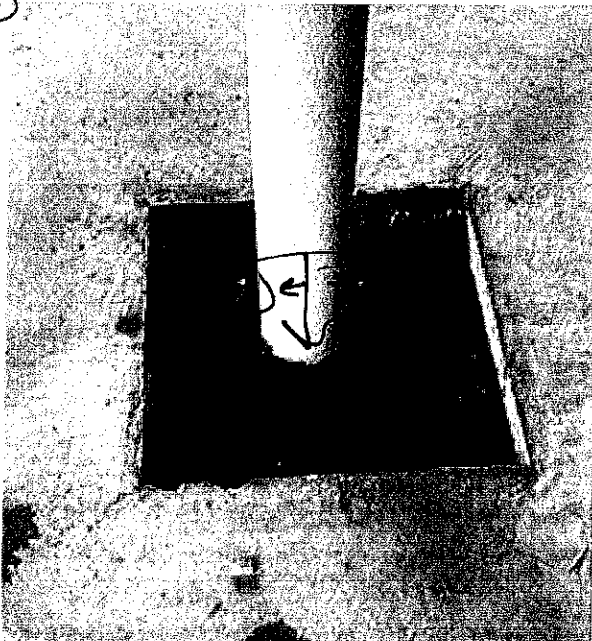
56

Basement Segment 6 column
on grid line H.1

- water needs to be pumped
out the the bottom/base
needs to be painted

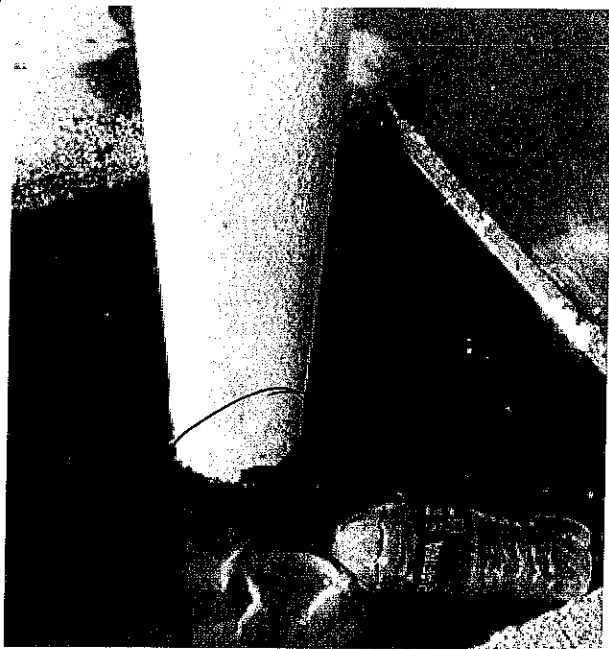
(57)

Basement cylinder 6
along grid line 12

— Water needs to be pumped
out & base needs to be
painted

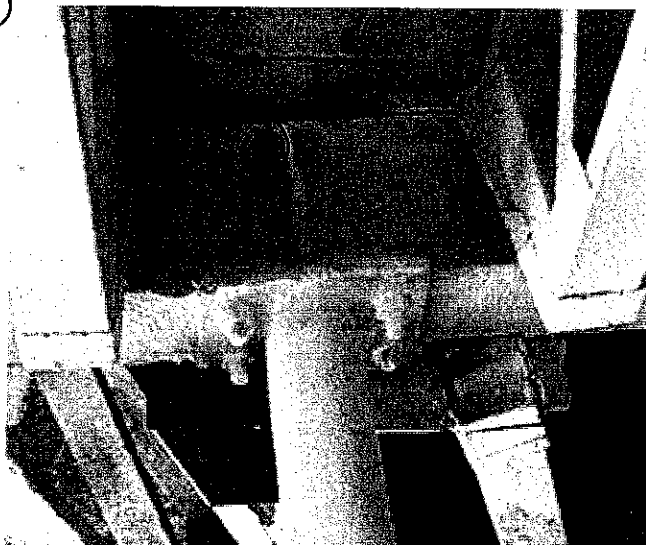
(58)

— Exposed steel

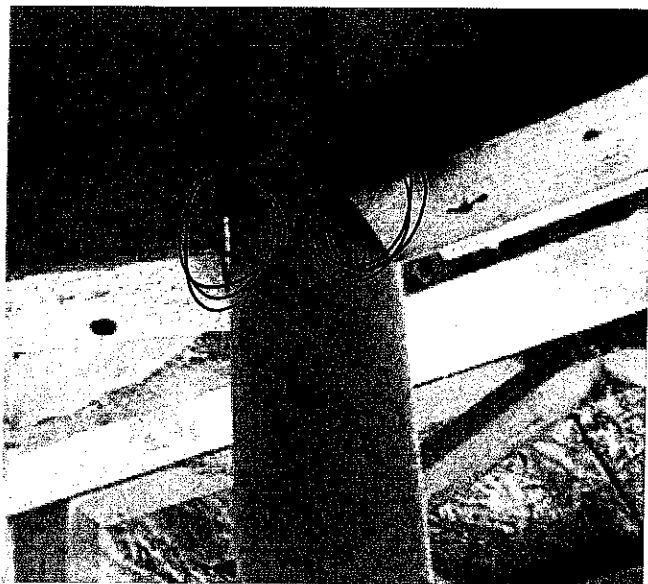
(61)

Basement Segment G
east column in hallway wall

- Exposed steel at wood
beams at top of
column
