FOUNDATION OBSERVATIONS REPORT

Report Number: 02231387.0001

The Summit Church Maintenance Facility
3381 NW Chipman Road
Lee's Summit, MO 64081

Project Number: 02231387

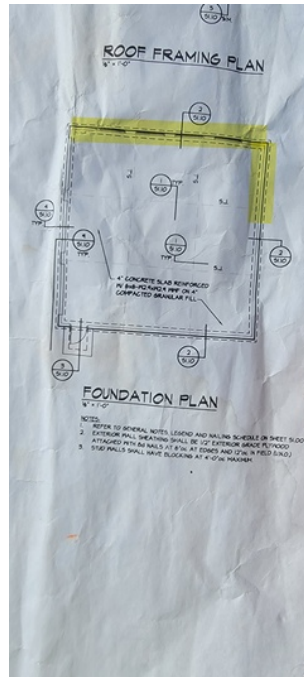
Test No./Element/ Location	Test Results	Bearing Strata	Status	Comments
(1) Continuous Footings/ Maintenance shed	1,000 psf on north footing turning east half way down....2000 the rest of footing	Moist Fatty cohesive brown reddish clay with some silt and sand loose to very stiff Native	DOES NOT Comply	Footings are 24 inches wide and range from 24 inches to 36 inches deep *DEVIATION* Bearing Pressure: North section and half the east section of footing only reached 1000 psf and is loose down to 2 feet where it is suitable. Cleanliness: Footings have spoils and cave-ins and have sloughed in ,

(P1) Yellow highlighted area is of loose and inadequate bearing pressure that should be under cut 2 feet and backfilled with concrete

Deviation No.	Report No.	Service	Service Date	Description/Comments	How Resolved	Date Resolved	Status
D000001	0001	Foundation Observations	10/20/23	Maintenance shed - Bearing Pressure: North section and half the east section of footing only reached 1000 psf and is loose down to 2 feet where it tightens up Cleanliness: Footings have spoils and cave ins in them and have sloughed in			Open

Terracon recommends that the loose 2 feet as noted be removed in the north footing and the north half of east footing (based on the locations in photos) and backfilled with concrete.
