REINFORCING STEEL OBSERVATIONS REPORT

Report Number: 02231387.0008
Service Date: 03/11/24
Report Date: 03/14/24

The Summit Church Maintenance Facility
3381 NW Chipman Road
Lee's Summit, MO 64081

Project Number: 02231387

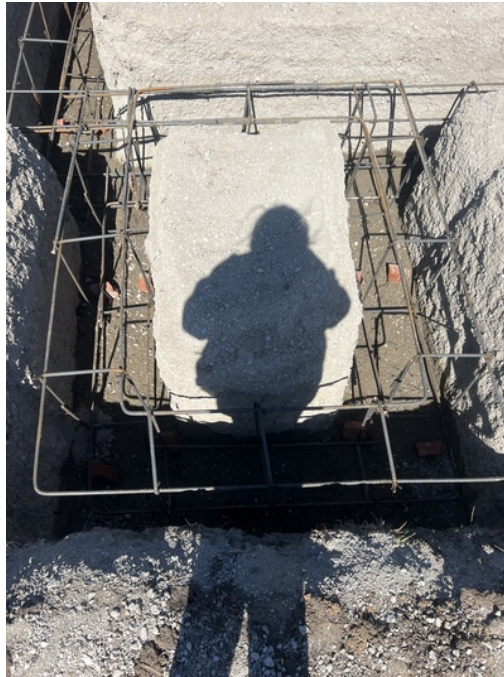
(P1) Footing for maintenance building

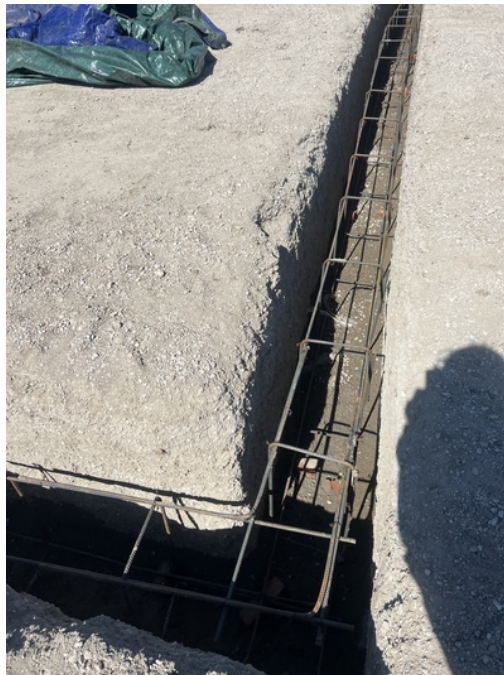
(P2) Footing for maintenance building
