Lot 81 Summer View Farms
2315 SW Serena Place
Lee's Summit, MO, 64082
Midwest Lumber

Foundation\Floor Joists\J2-16_ O_C_(i7573) (Joist)

BC CALC® Member Report

Repair is Required

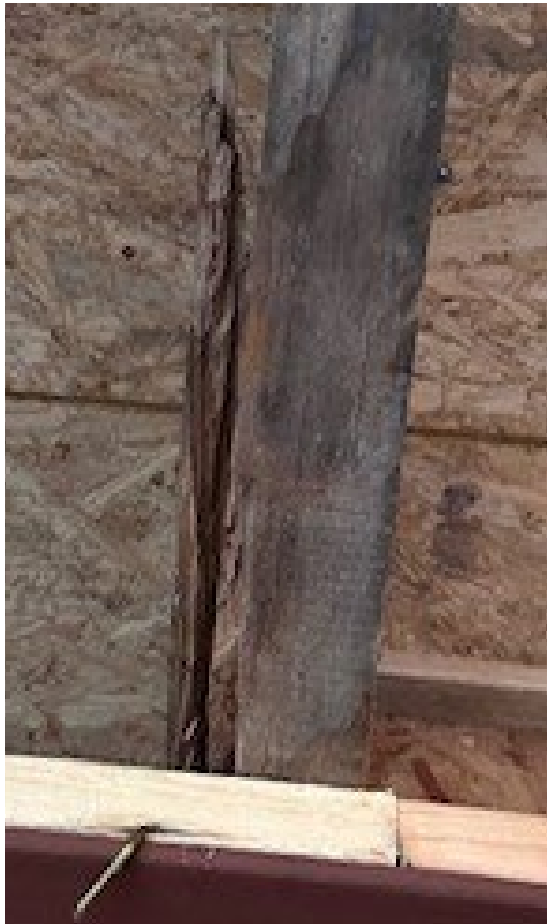
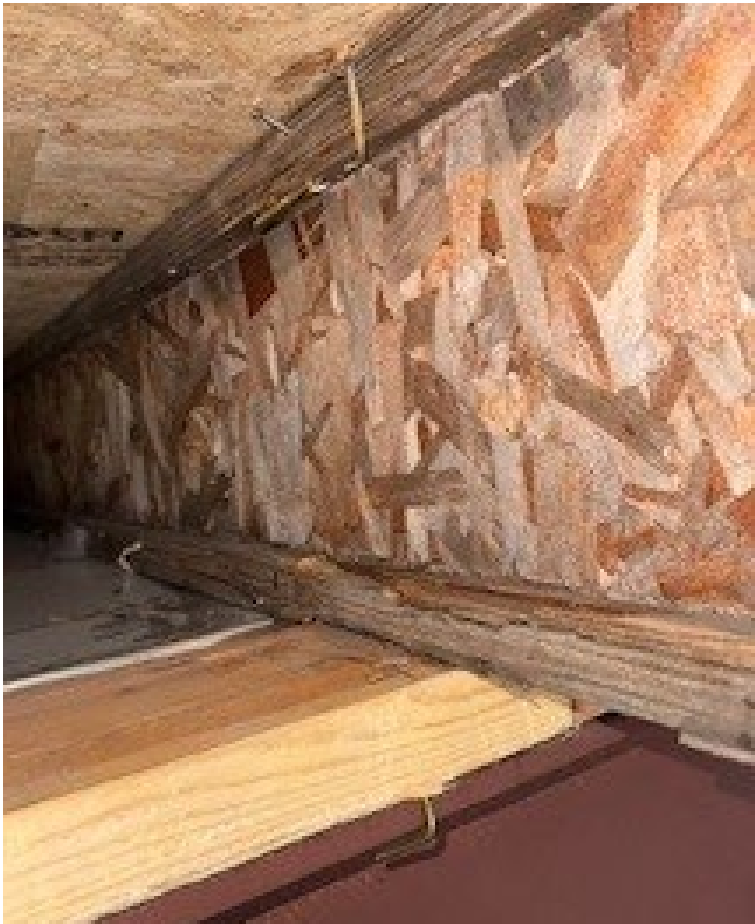
Photos:

**PASSES when
repaired as shown**

Required Repair: Jack up /shore up I-joist before repair installation.

Apply construction adhesive to cover all contact surfaces. **Backer:** Install 3/4" - 7/8" APA Rated Sheathing x (clear web depth - 1/4") x 2'-0" min. length backer tight-fit to the top of the bottom flange centered at the bearing opposite the damaged side. **Reinforcer:** Install 1 1/8" APA Rated Rim Board x 9 1/2" depth x 2'-0" min. length, tight-fit to the top of the bearing, centered at the bearing opposite the damaged side. **Through web:** fasten with 2 staggered rows 10d nails at 4" o.c., clinched downward where possible. **Through top flange only:** fasten with 1 row 8d nails at 6" o.c..

Apply construction adhesive to cover all contact surfaces. Min. 2x4 x (1'-6" min. beyond both ends of bottom flange damage) #2 & Btr. SPF & Btr. KD-19, or VERSA-LAM® LVL reinforcement damaged flange side of web, tight-fit to top of bottom flange

- 1) Center backer and reinforcer at the center of the bearing support.
- 2) Center 2x4 at the center of the flange damage and extend 1'-6" min. beyond the ends of the damage.
