# Special Inspection Daily Report

Report #: SIR-000001  
Report Date: 10/23/2024

Project:  
L22-05531  
LSMO Water Utilities Facility Canopies  
1200 Southeast Hamblen Road  
Lee's Summit, MO

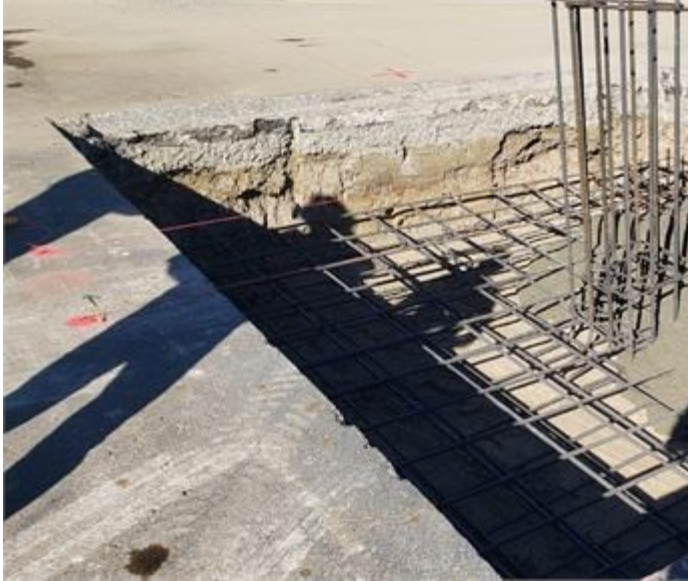
**Image Description:** SW. canopy footing
