April 9, 2025

Re: 2739 SW Heartland Road (Lot 191, Retreat at Hook Farms) – city inspection items

Vista Structural Engineering, LLC, was asked to address city inspection structural items for the new house being built at 2739 SW Heartland Road. The following are the inspection comments and our responses.

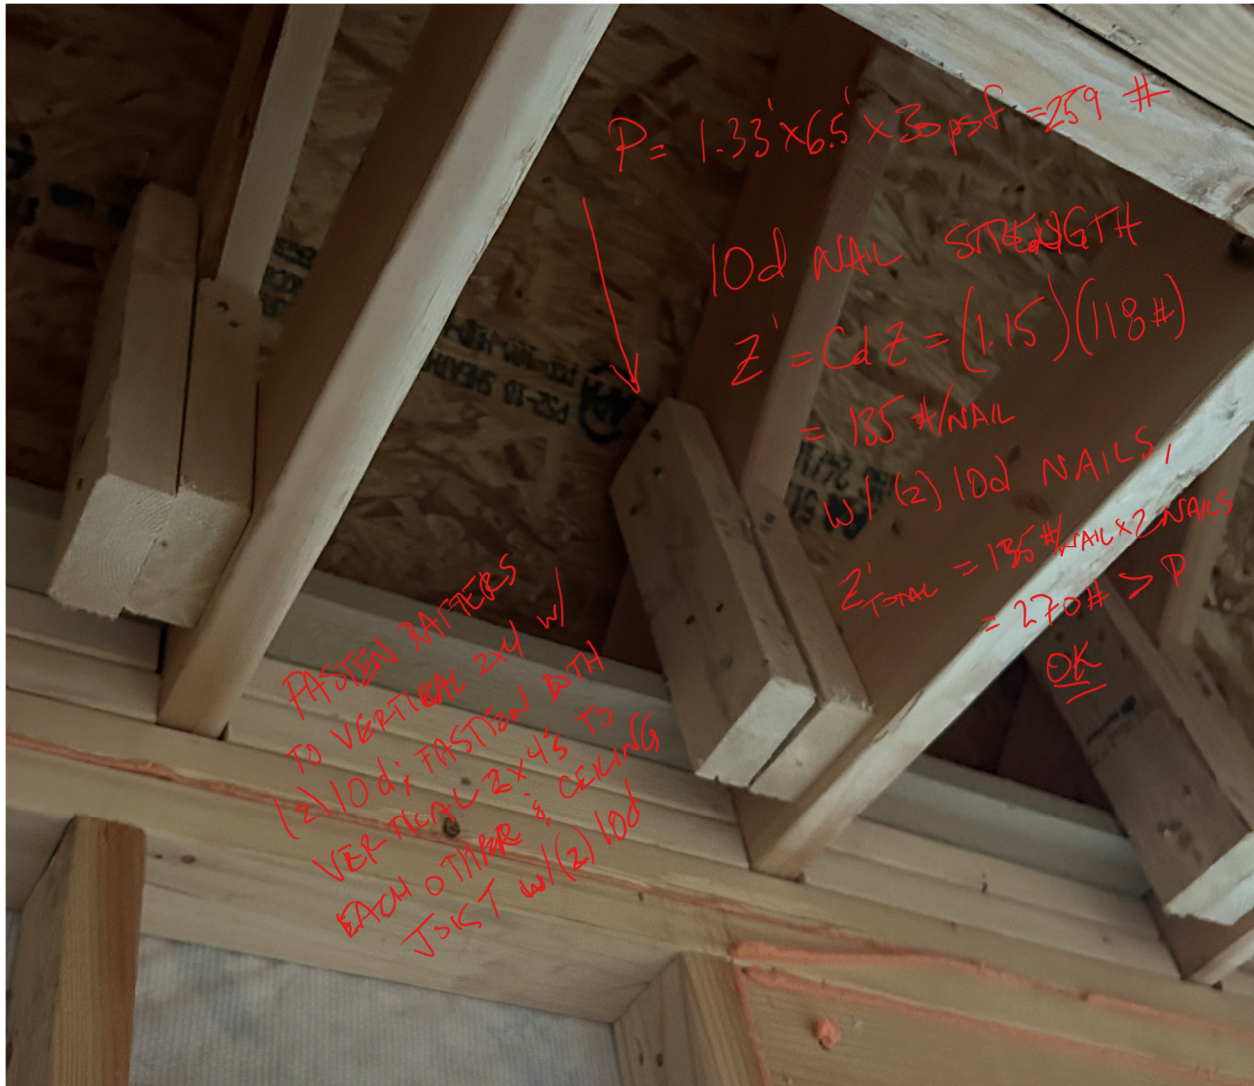
- 1) **Please address rafters landing on Smart Trim throughout sides of house on the second level.** As shown in Photo #1, each rafter is fastened to a vertical 2x4. This vertical 2x4 is fastened to a 2x4 located directly under the rafter. This 2x4 shall be fastened to the ceiling joists with a minimum of (2) 10d nails. The vertical 2x4 on the outside face of the rafter shall be fastened to the rafter with (2) 10d nails and to the adjacent 2x4 with (2) 10d nails. Due to this gravity support, there is minimal roof load on the rafter bearing point at the Smart Trim. The Smart Trim shall be fastened to the member below with (1) 10d nail @ 8" o.c., as shown in Photo #2. The rafters shall be fastened to the Smart Trim with (3) 8d nails, also as shown in Photo #2.

Photo #1 – fastening of rafters to vertical 2x4's and vertical 2x4's to ceiling joists

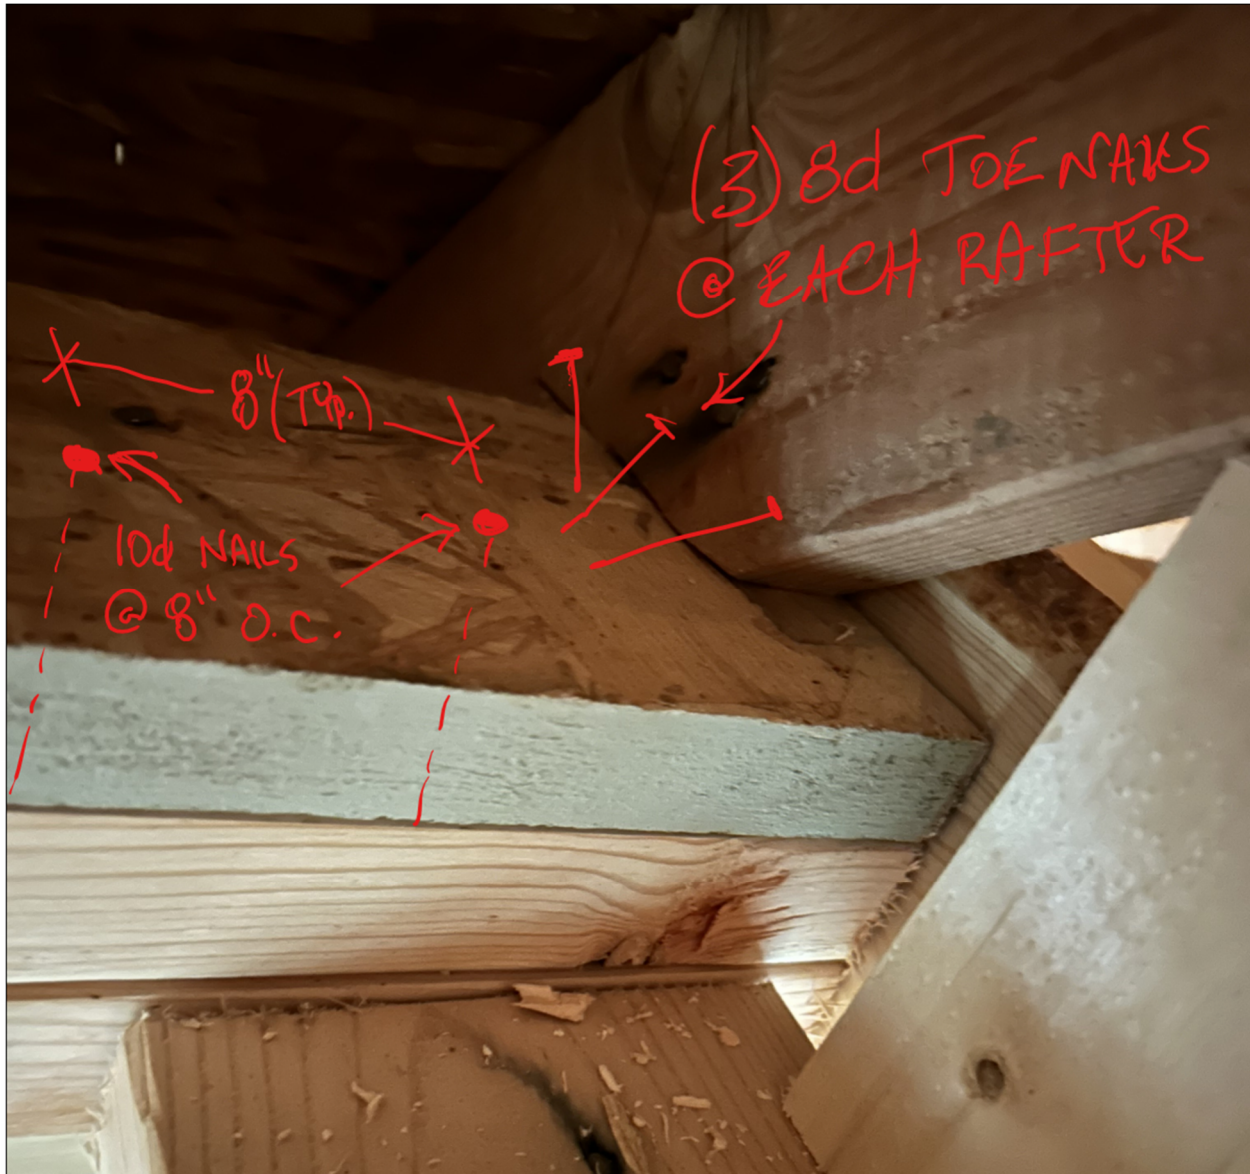
Photo #2 – fastening of rafters to vertical 2x4's and vertical 2x4's to ceiling joists

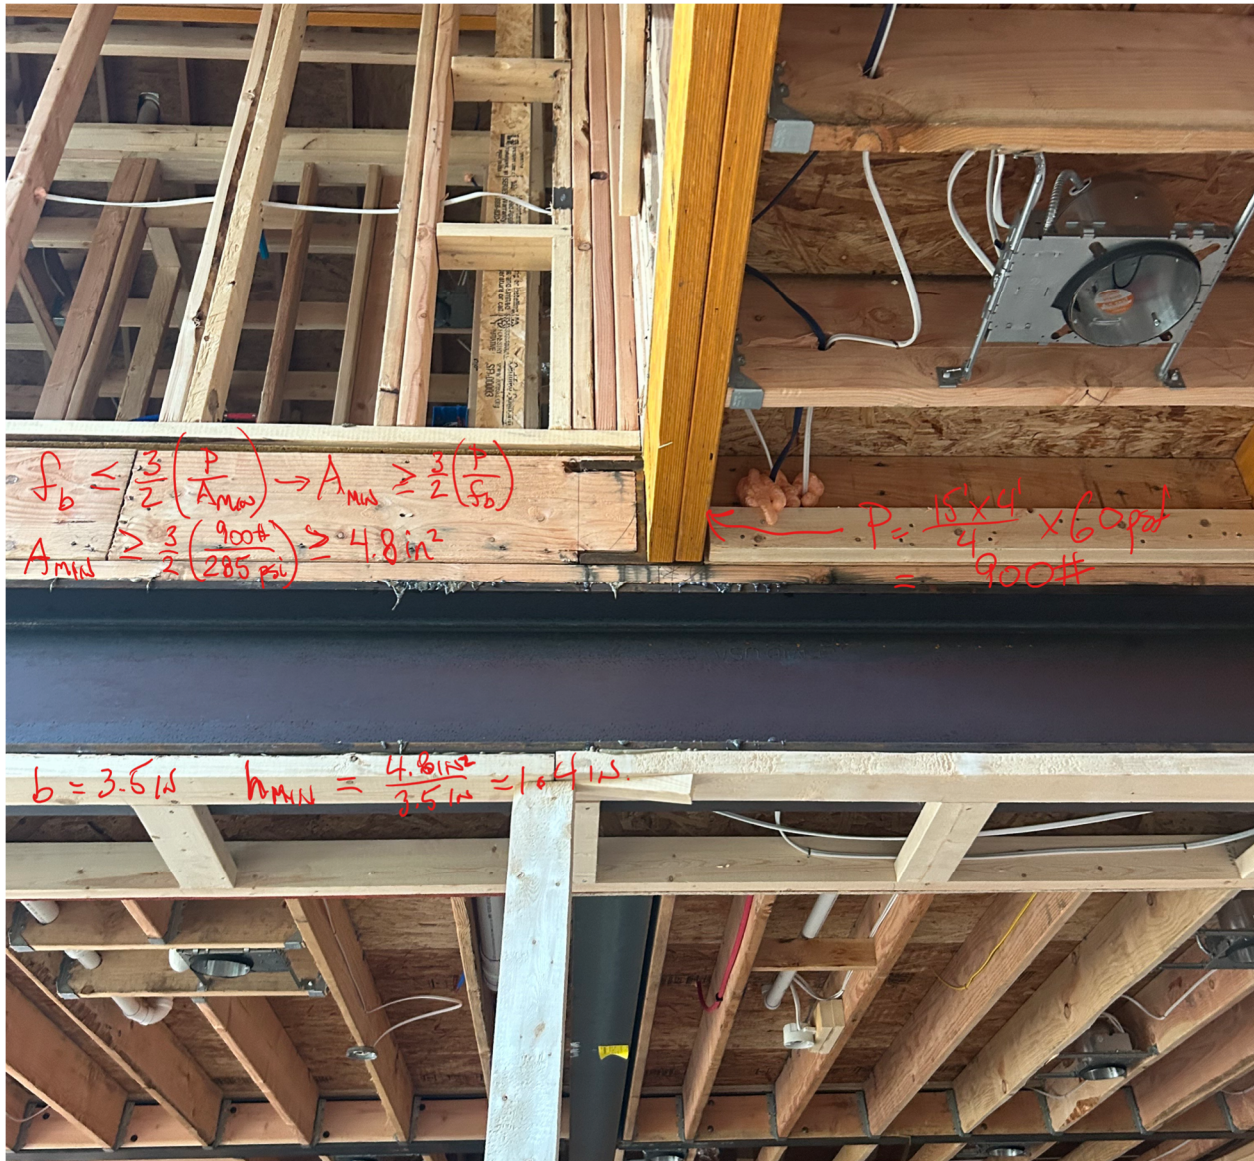
- 2) **Address beam separating kitchen and great room connection not to plans and LVL notched into I-beam.** We have determined that the connections are sufficient to support all applied design loading. The W8x48 steel beam bearing on top of the W12x50 is acceptable in lieu of the welded/bolted connection specified in detail 1/S3.4 shown on the plans. As shown in Photo #3, the reaction of the LVL beam above the W12x50 steel beam, based on design loads, is 900#. Given this loading, the minimum depth, per the calculation in the photo, is 1.4 inches. The remaining notched depth is significantly greater than 1.4 inches and, therefore, is adequate. The bearing length shall be verified to be a minimum of 1.5" on top of the W8x48 flange.

Photo #3 – Connection of beams above W12x50 steel beam

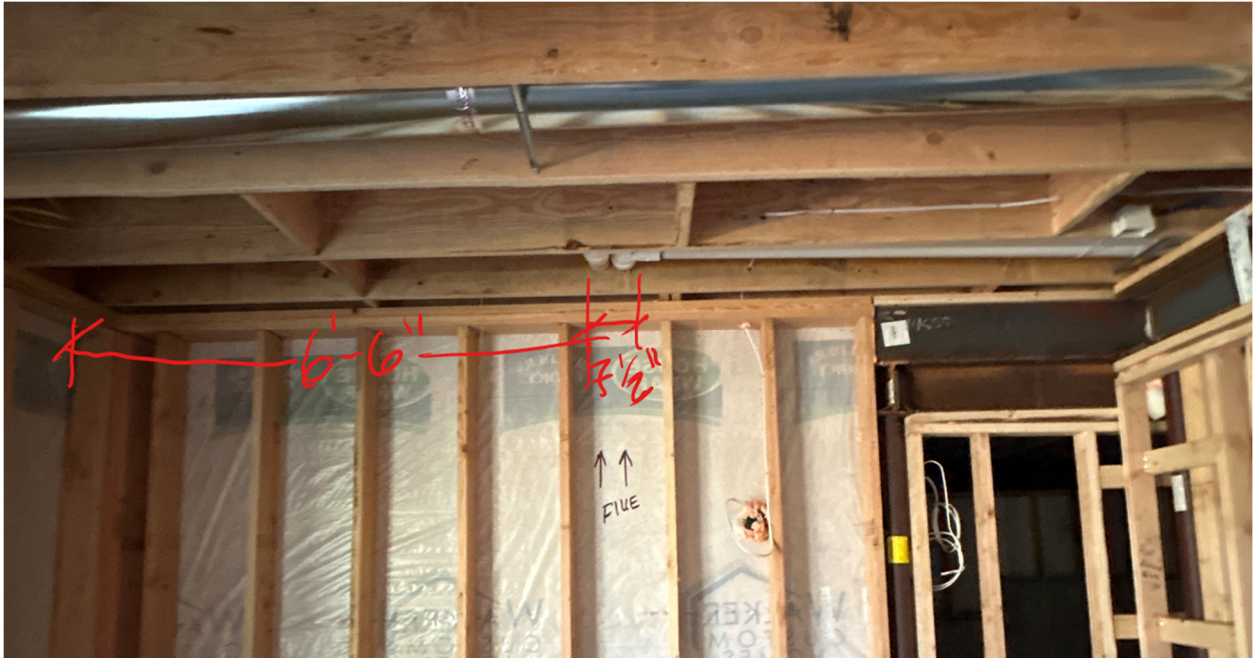
- 3) **Address holes drilled in joist for HVAC intake/exhaust located in lower level bedroom #5.** The holes in question are shown in photos #4 and #5. Per the attached calculations, we recommend scabbing on a 1 ½"-wide x 2"-deep x 36"-long piece of #2 Doug-Fir on both sides of the joist with holes, fastened to the joist with 10d nails @ 4" o.c., above the hole. No remediation is required below the holes. See Figure #1 for clarification.

Photo #4 – Dimensions to holes in question (item #3)

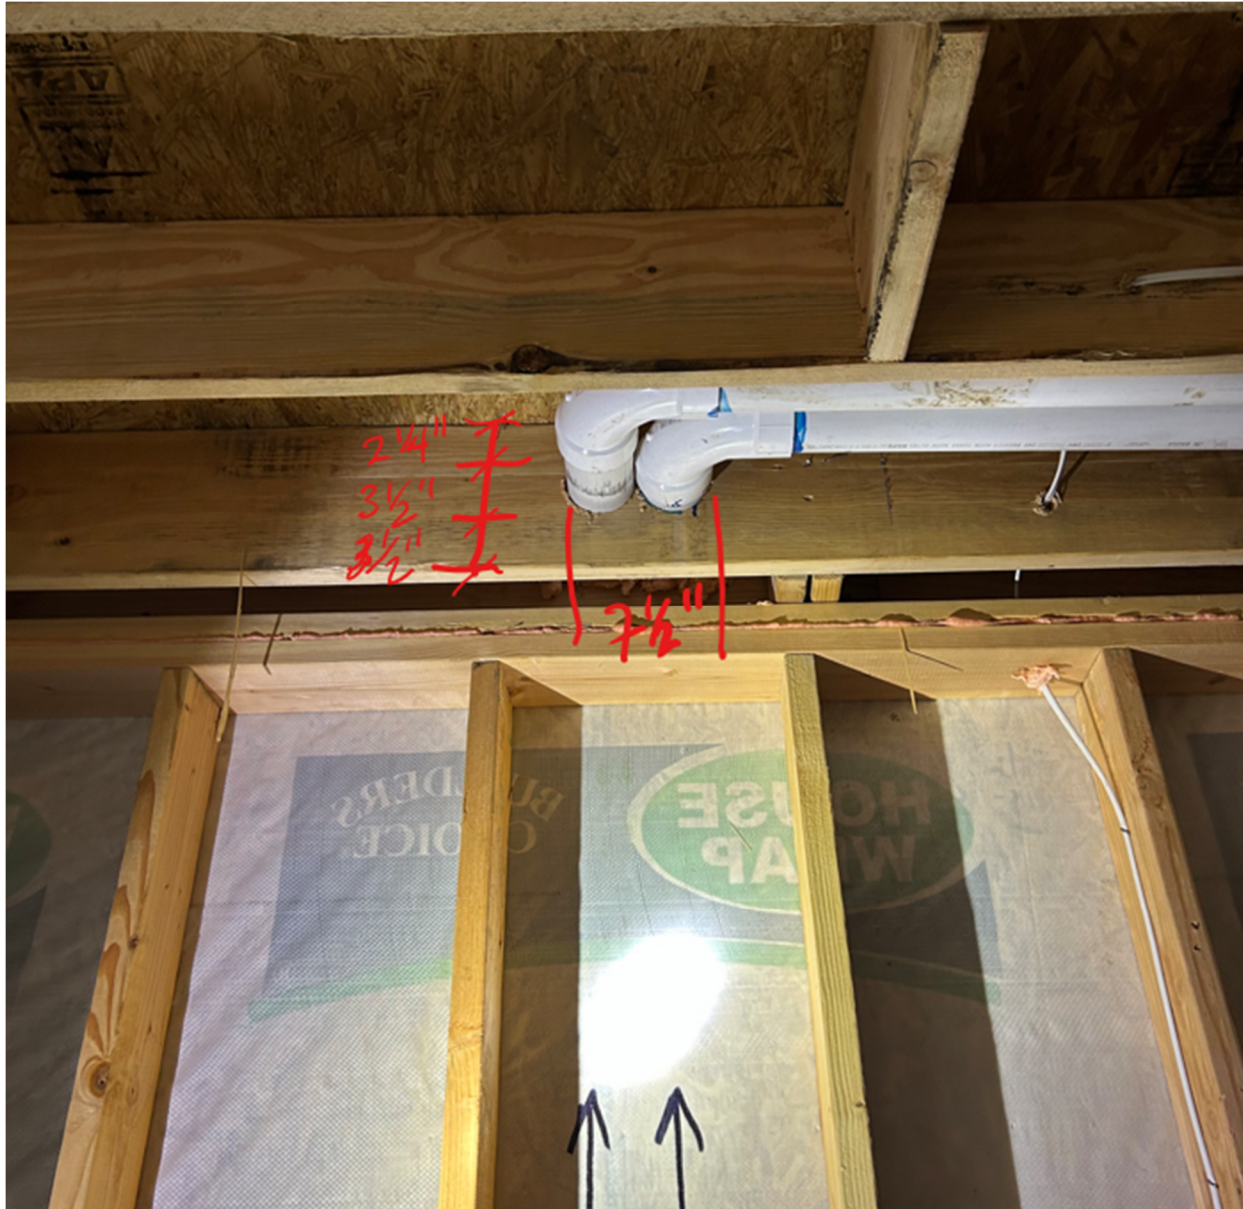
Photo #5 – Hole Dimensions (item #3)

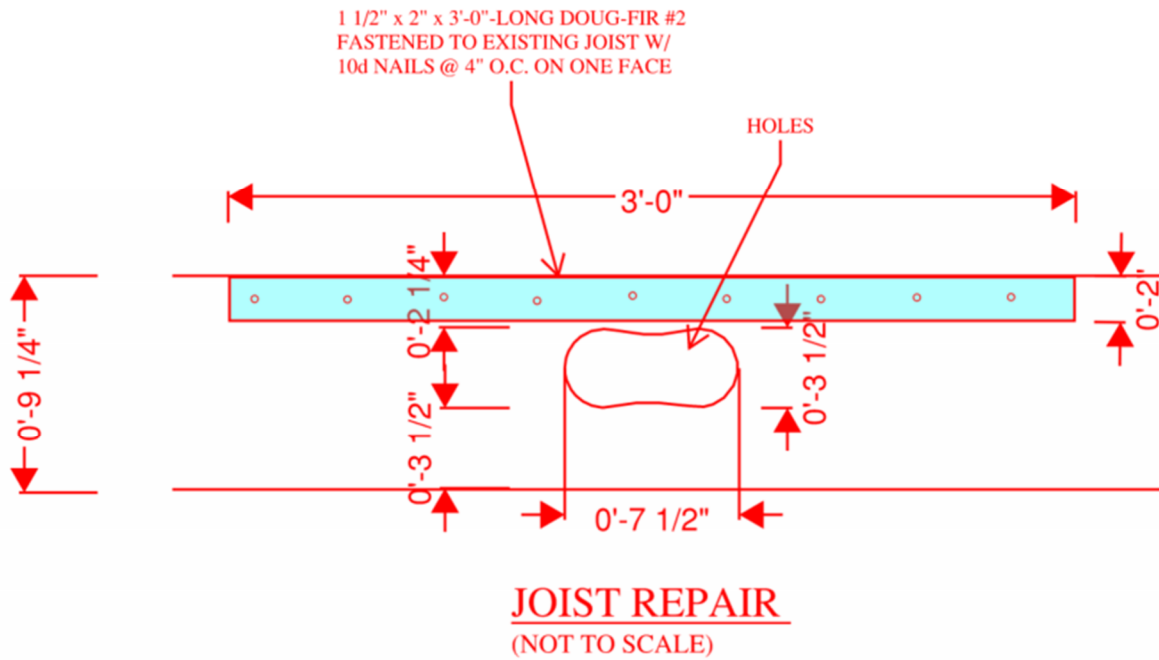
Figure #1 – Joist repair detail

INSTALL 3'-0"-LONG SECTION, CENTERED OVER HOLES, FASTENED W/ 10d NAILS @ 4" O.C. TO EXISTING 2x10 JOIST.
