## Stormwater Pollution Prevention Plan Inspection Report

**Project Name and Location:** Blackwell

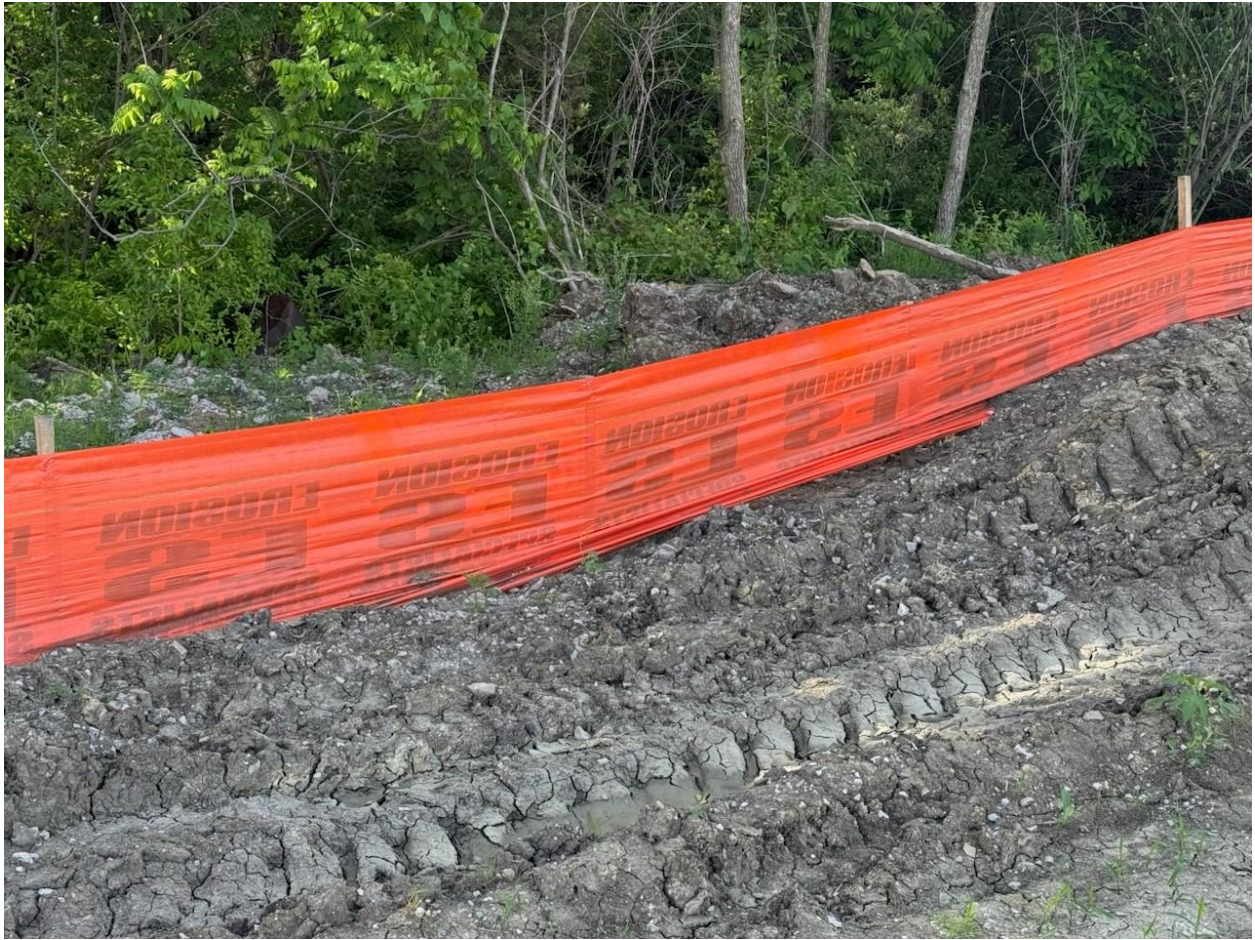
<b>BMP</b>	<b>Location</b>	<b>Observation, Effectiveness, &amp; Corrective Actions Ordered</b>
Silt fence	Along curb	Repair a few areas where the fence has been damaged
Stabilize	In-active	Stabilize all areas that have been inactive for 14+ days- Weeds are not considered vegetation.
Stabilize	Swale	Stabilize swale on North end as soon as possible if work is done- More silt build up near pond from swale
Stabilize	Detention Ponds	Stabilize detention ponds asap- weeds are not considered vegetation
Streets/Inlets	Throughout Site	Clean streets and curbs
Silt fence	Perimeter	Orange silt fence is not trenched in on East side of pond behind Residences- See picture below and noted on map
Rock Ent.	Construction Ent	Need more rock at construction entrance- tracking out

Have items noted on the last inspection been corrected? ☐ Yes   ☒ No (if no explain) : Need to stabilize in-active areas and det. ponds.
