Stormwater Pollution Prevention Plan Inspection Report

Project Name and Location: Blackwell

Weather: 66	
	□Cloudy ⊠Sunny □Rain □ Snowing/ Snow cover
Date of inspection: 5/20/25	
Inspectors Name: Jessica Ekster	
Type of Inspection: Regular Rain event Othe	er:
Rain in last 24 hrs (inches): .74"	
Owner/Permittee: Griffin Riley	
Current Site Condition: Active

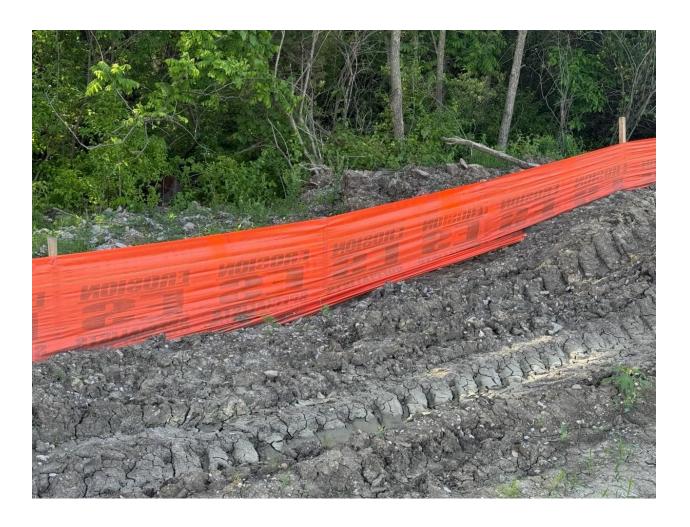
BMP	Location	Observation, Effectiveness, & Corrective Actions Ordered
Silt fence	Along curb	Repair a few areas where the fence has been damaged or un-trenched
Stabilize	In-active	Stabilize all areas that have been inactive for 14+ days- Weeds are not considered vegetation.
Stabilize	Swale	Stabilize swale on North end as soon as possible if work is done- More silt build up near pond from swale
Stabilize	Detention Ponds	Stabilize detention ponds asap- weeds are not considered vegetation
Streets/Inlets	Throughout Site	Clean streets and a few inlets with silt build up
Silt fence	Perimeter	Orange silt fence is not trenched in on East side of pond behind Residences- See picture below and noted on map
