## **Stormwater Pollution Prevention Plan Inspection Report**

**Project Name and Location:** Blackwell

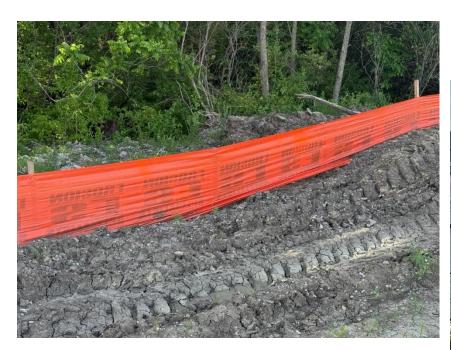
ВМР	Location	Observation, Effectiveness, & Corrective Actions Ordered
Silt fence	Along curb	Repair a few areas where the fence has been damaged- New areas
Stabilize	In-active	Stabilize all areas that have been inactive for 14+ days- Weeds are not considered vegetation.
Stabilize	Swale	Stabilize swale on North end as soon as possible if work is done- More silt build up near pond from swale needs cleaned out
Stabilize	Detention Ponds	Stabilize detention ponds asap- weeds are not considered vegetation
Silt fence	Detention Pond	Reset silt fence along detention pond behind Residences
Silt fence	Perimeter	Orange silt fence is not trenched in on East side of pond behind Residences- See picture below

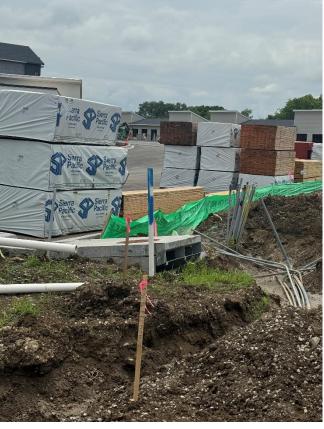
ВМР	Location	Observation, Effectiveness, & Corrective Actions Ordered
Rock Ent.	Construction Ent	Need more rock at construction entrance. Rock needs to be 3"-6"-tracking out
Concrete Washout	Throughout Site	Need more concrete washouts installed. Saw trucks cleaning out along curbs on 6/2
Grate Inlets	In soon to be streets/alley	Need to protect grate inlets- install silt fence inside grate
Silt fence	Along backfilled curb	Install silt fence along backfilled curb throughout site
Inlet	Parking lot	Back side of inlet needs wrapped in silt fence. Parking lot of Residences- picture below
Inlet/Street	Various	Clean out various inlets and streets
