| General Information<br>(see reverse for instructions) | | | |
|---|---|---|---|
| Name of Project | Discovery Park Lee's Summit | CGP Tracking No. | MODNR# MORA23630 |

Discovery Park Lee's Summit  
6/17/2025 Inspection

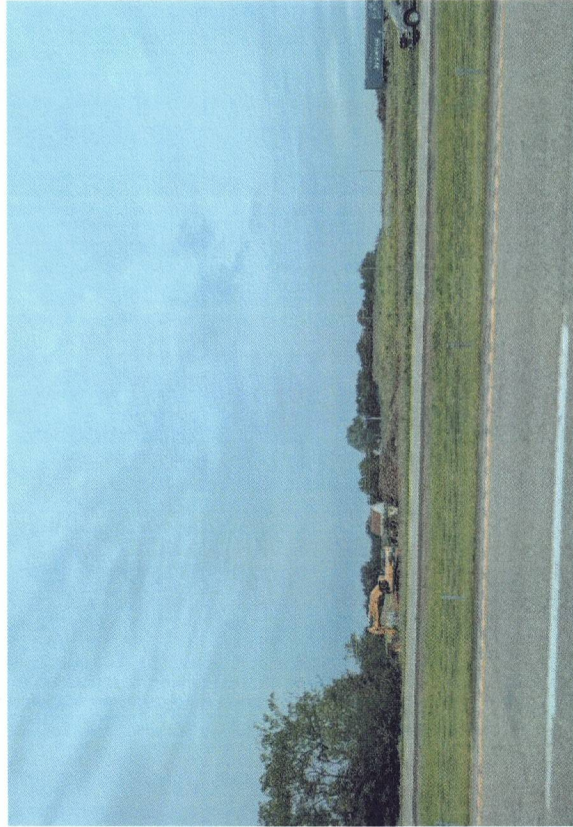
| Type/Location of E&S Control<br>(Add an additional sheet if necessary) | Repairs or Other Maintenance Needed?* | Corrective Action Required?* | Date on Which Maintenance or Corrective Action First Identified? | Notes<br>(See plan sheets and photo logs for additional information and locations) |
|---|---|---|---|---|
| 11. | | | | Should be noted City of LS now Colburn Rd project has a separate permit, contractor & LS is still doing utility work along I-470 in Zone 2 near blue line stream. |

Photo 1 – Zone 2 – LS still doing utility work along I-470 near blue line.

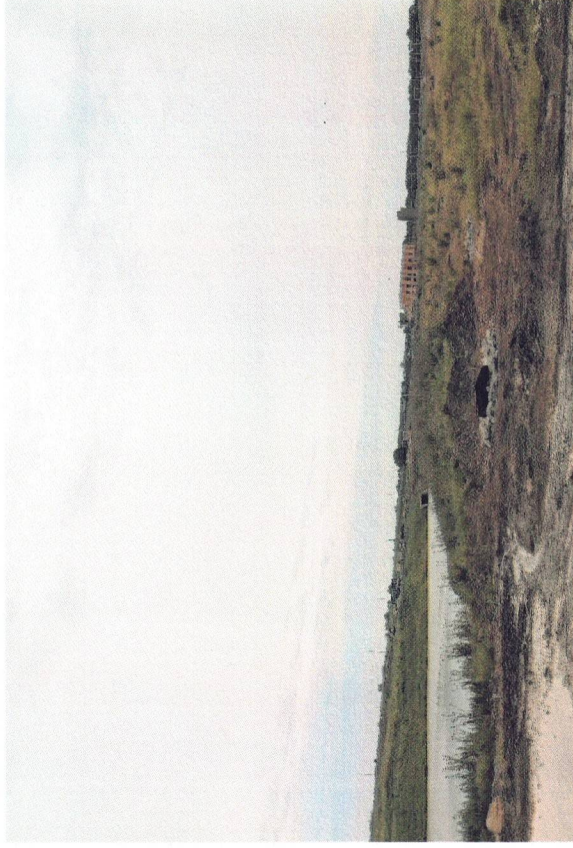
| Type/Location of E&S Control<br>(Add an additional sheet if necessary) | Repairs or Other Maintenance Needed?* | Corrective Action Required?* | Date on Which Maintenance or Corrective Action First Identified? | Notes<br>(See plan sheets and photo logs for additional information and locations) |
|---|---|---|---|---|
| 1. Silt Fence | <input type="checkbox"/> Yes <input checked="" type="checkbox"/> No | <input type="checkbox"/> Yes <input checked="" type="checkbox"/> No | | Inlet on back side of Lake needs the filter fabric wrapped all the way around it. |

Photo 2 – Zone 1 – Inlet into Lake needs filter fabric repaired.

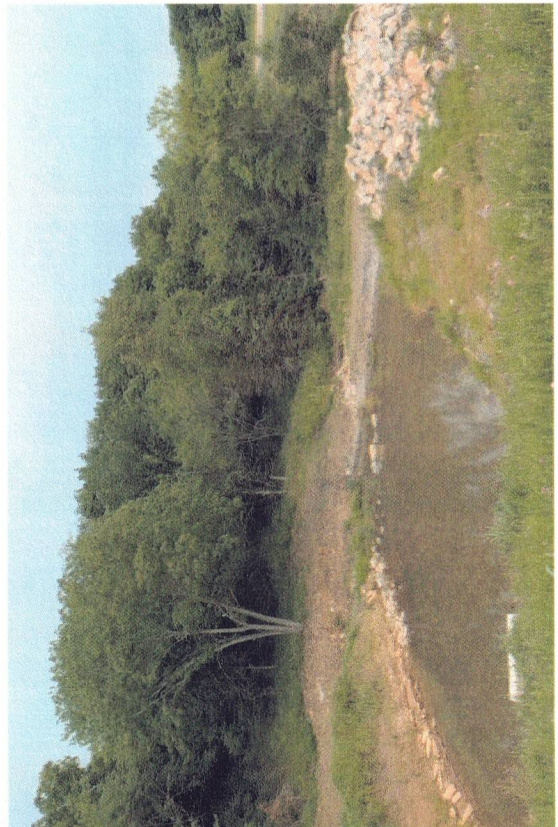
Clear

Photo 3 – Outfall 001 in Zone 1 – Clear discharge noted.

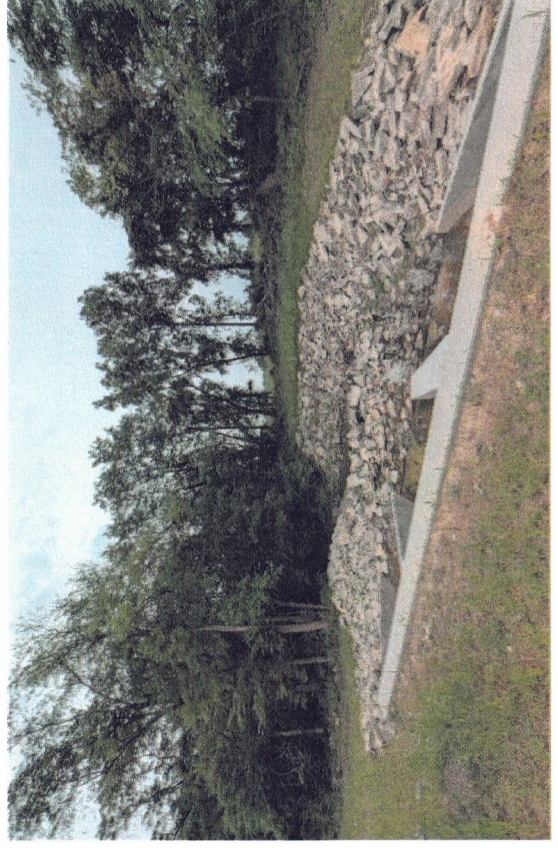
Clear

Photo 4 – Outfall 002 in Zone 3 – Clear discharge noted.
