REINFORCING STEEL OBSERVATIONS REPORT

Report Number: 02251170.0046
Service Date: 06/17/25
Report Date: 06/24/25
Task: 03 - Concrete Special Inspection & Testing

Waterway Lee's Summit
1000 NW Pryor Rd.
Lee's Summit, MO 64081

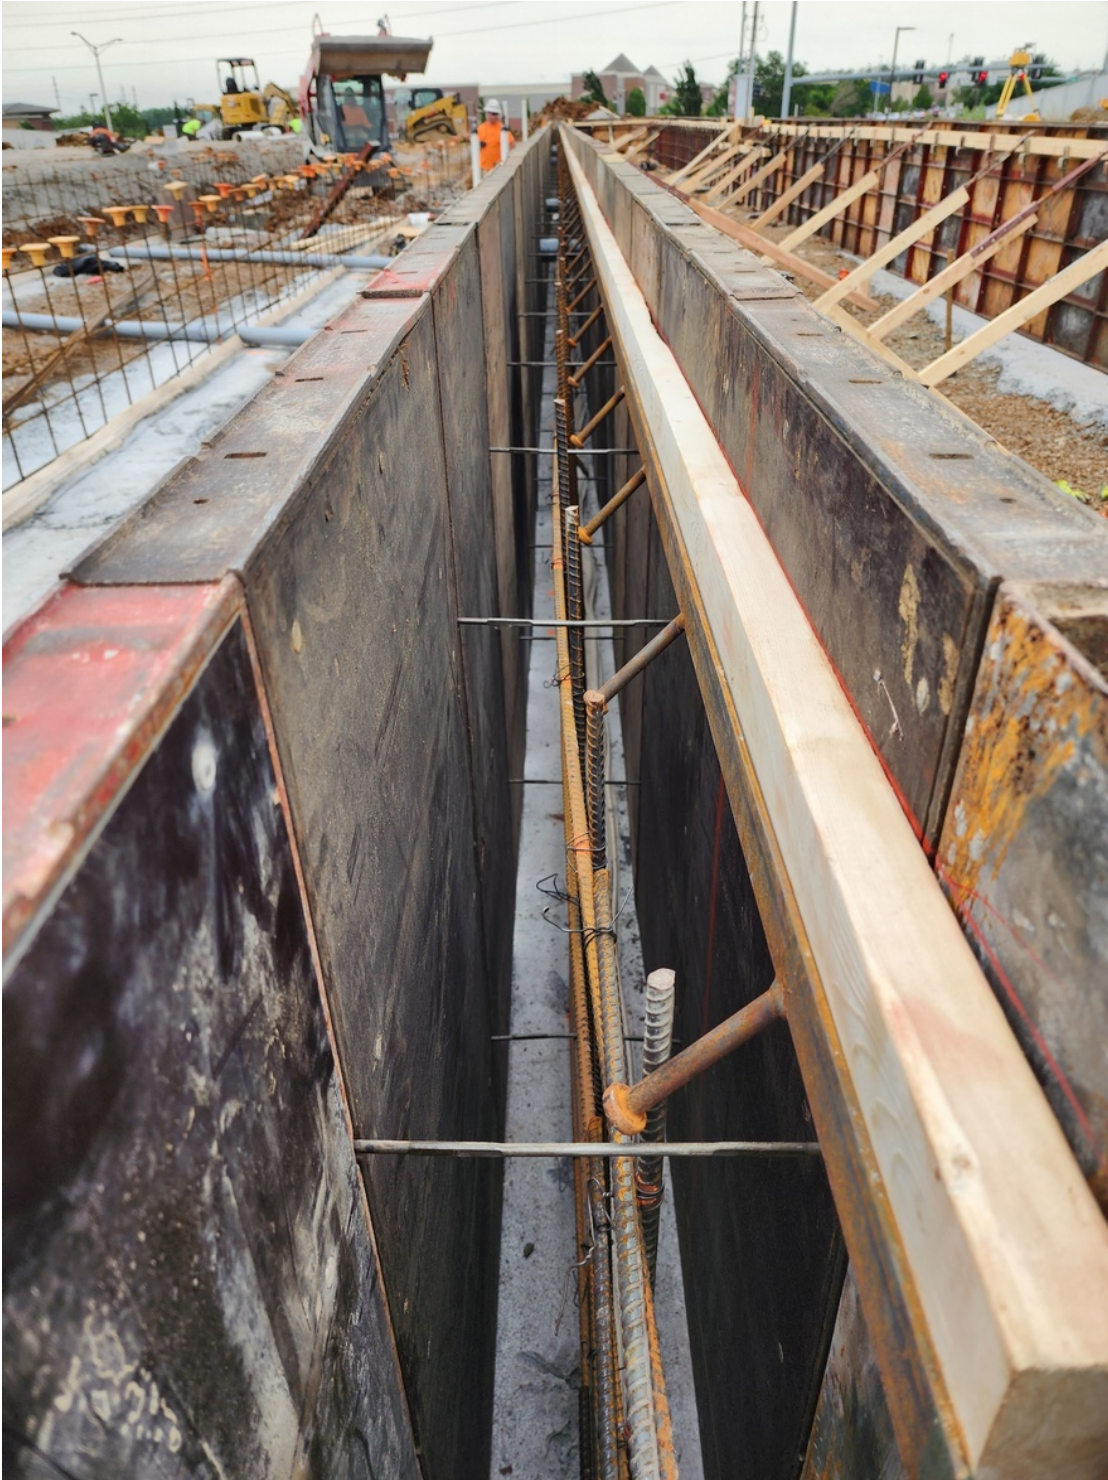
(P1) North line
