| Name of Project | Discovery Park Lee's Summit | CGP Tracking No. | MODNR# MORA23630 | Inspection Date | 6/25/2025 |

DISCOVERY PARK ZONE 1 & ARIA 1ST PLAT LOT 1  
SITE DISTURBANCE PLAN

Discovery Park Lee's Summit  
6/25/2025 Inspection

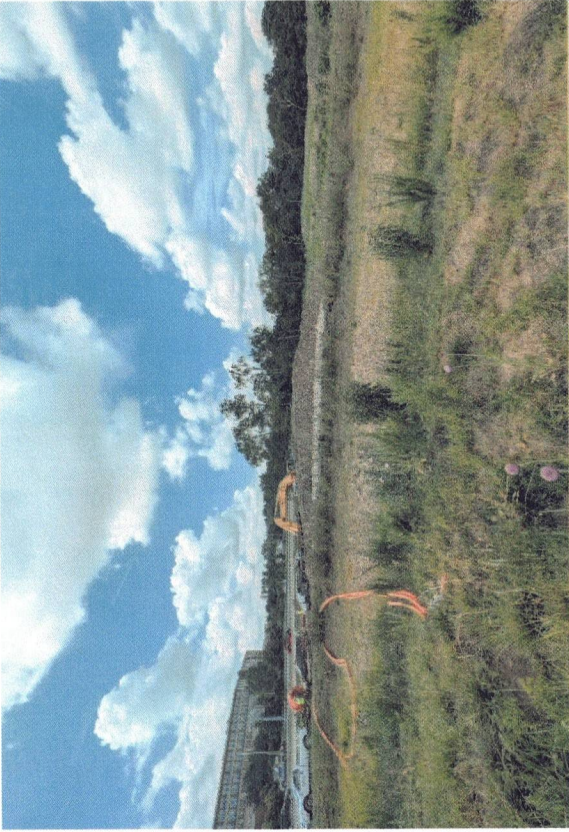
| Type/Location of E&S Control<br>(Add an additional sheet if necessary) | Repairs or<br>Other<br>Maintenance<br>Needed?* | Corrective<br>Action<br>Required?* | Date on Which<br>Maintenance or<br>Corrective Action First<br>Identified? | Notes<br>(See plan sheets and photo logs for additional information and locations) |
|---|---|---|---|---|
| 1. Silt Fence | <input type="checkbox"/> Yes <input checked="" type="checkbox"/> No | <input type="checkbox"/> Yes <input checked="" type="checkbox"/> No | | LS Utility work along I-470<br>in Zone 2 mounded dirt<br>behind the rock check piling<br>at Discovery's sediment basin<br>so no longer functions as<br>designed. |

Photo 1 – Zone 2 – LS utility work along I-470 blocked basin spillway.

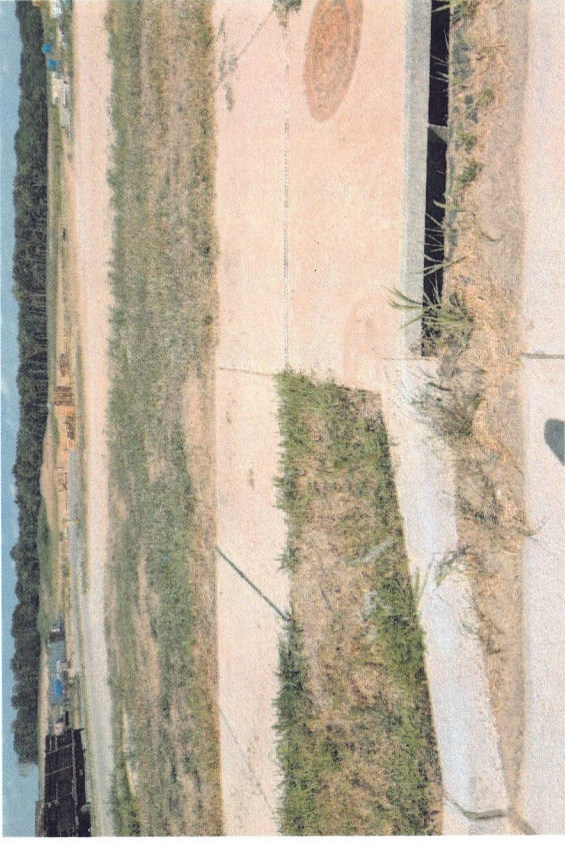
| Type/Location of E&S Control<br>(Add an additional sheet if necessary) | Repairs or<br>Other<br>Maintenance<br>Needed?* | Corrective<br>Action<br>Required?* | Date on Which<br>Maintenance or<br>Corrective Action First<br>Identified? | Notes<br>(See plan sheets and photo logs for additional information and locations) |
|---|---|---|---|---|
| 2. Rock Ditch Check | <input type="checkbox"/> Yes <input checked="" type="checkbox"/> No | <input type="checkbox"/> Yes <input checked="" type="checkbox"/> No | | Gutter-buddy near construction<br>entrance on Douglas needs cleaned out. |

Photo 2 – Zone 1 – Gutterbuddy clean up needed near construction entrance.

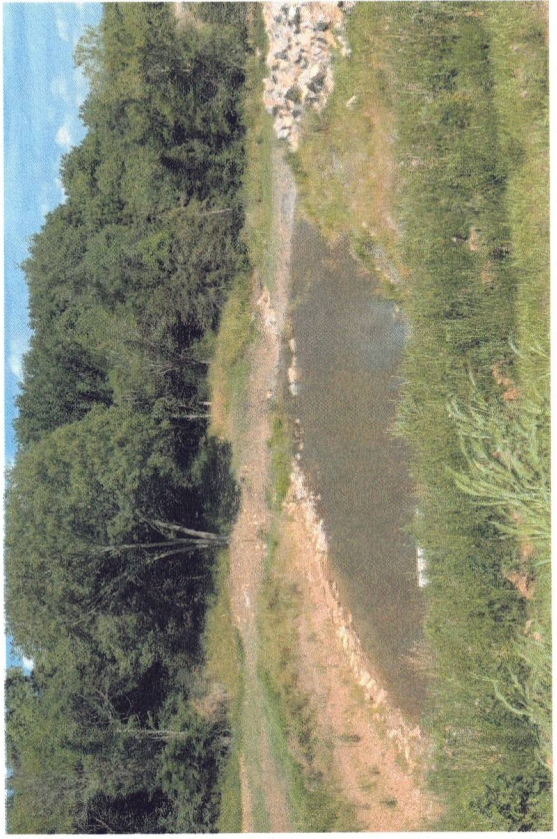
Photo 3 – Outfall 001 in Zone 1 – Clear discharge noted.

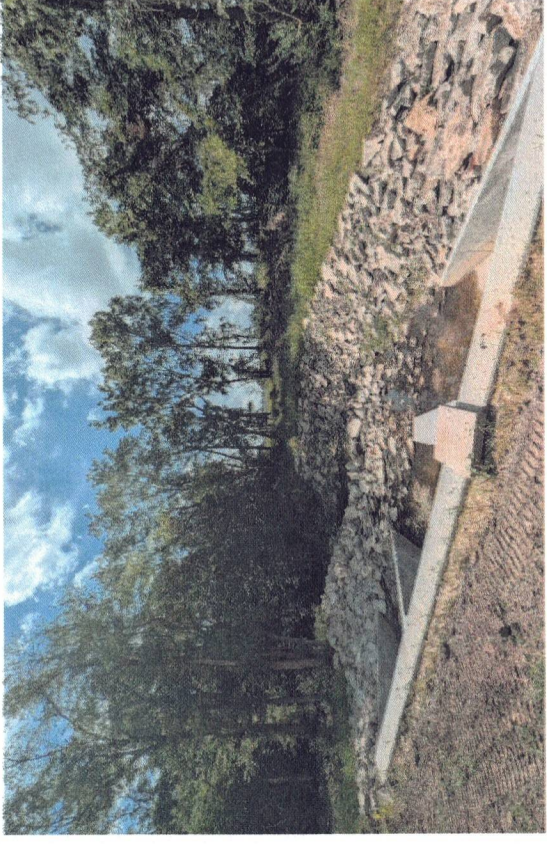
Photo 4 – Outfall 002 in Zone 3 – Clear discharge noted.
