TOWER CONDITION ASSESSMENT & MAINTENANCE INSPECTION

**GREEN (HTMO1589)
145' MONOPOLE
LEE'S SUMMIT, MISSOURI**

**EDGE PROJECT NUMBER:
#44838
SEPTEMBER 9, 2025**

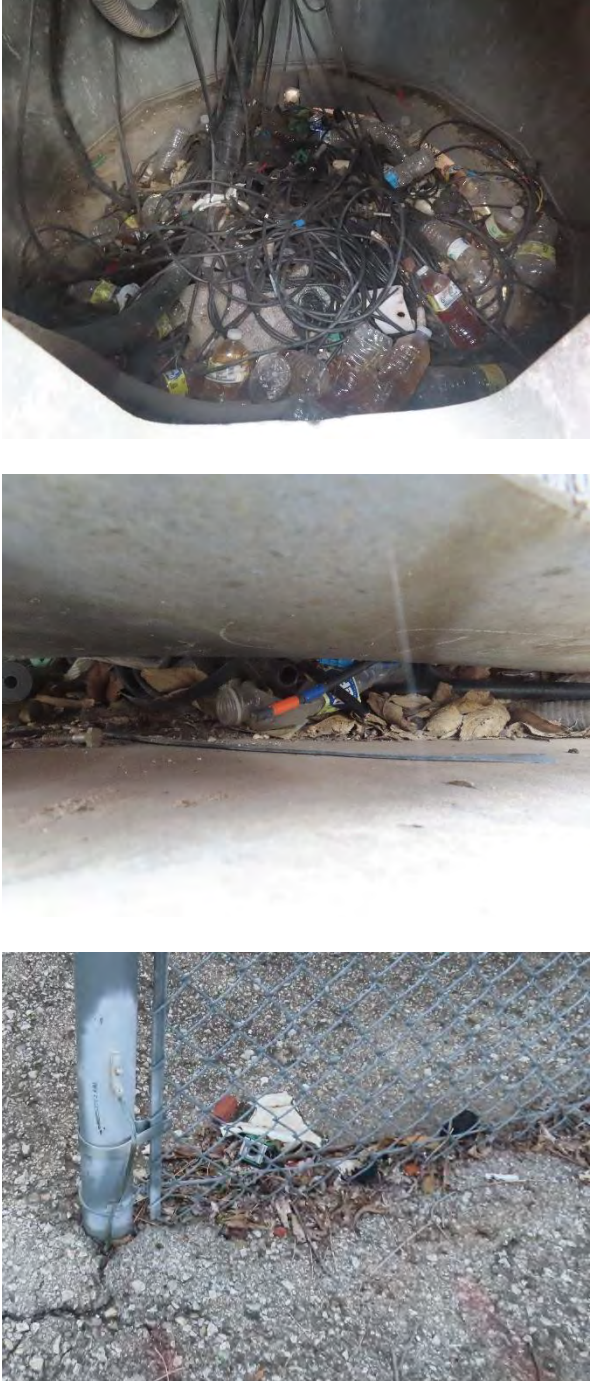
Category & Item Description	Non-Compliant Item & Recommendation	Photo
<p>2.2.1</p> <p>Construction Debris</p>	<p>Trash and construction debris are present inside the base of the tower and within the compound.</p> <p>Recommended to remove all trash and debris as part of future maintenance.</p>

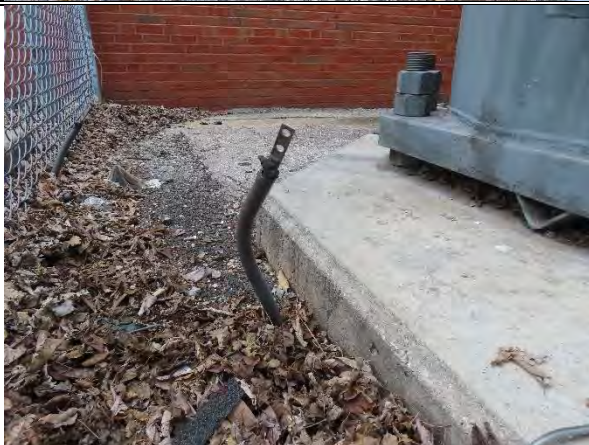
<p>2.2.2</p> <p>Grounding</p>	<p>Detached ground lead is present at the tower base.</p> <p>Recommended to be removed to prevent a trip hazard.</p>

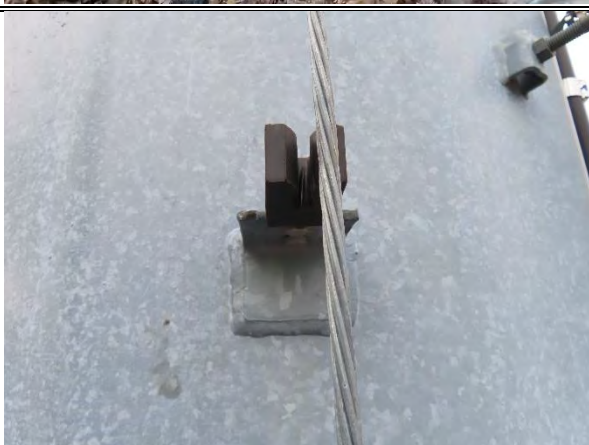
<p>2.2.3</p> <p>Safety Climb Cable</p>	<p>Safety Climb cable has become detached from cable keepers, causing damage to the tower galvanization coating.</p> <p>Edge Consulting personnel addressed the coating issues at the time of inspection and is noted in section 2.4 below.</p> <p>Recommend installing locking cable keepers to prevent future damage to the cable and tower.</p>

Category & Item Description	Non-Compliant Item & Recommendation	Photo
2.4.1 Tower	<p>The tower's galvanized coating has been damaged in multiple locations due to the climb cable coming loose from the cable keepers.</p> <p>Additionally, the tower's galvanized coating was damaged at multiple step bolt attachment points.</p> <p>Corrosion was cleaned with a wire brush and coated with a cold galvanizing compound by Edge Consulting personnel.</p>

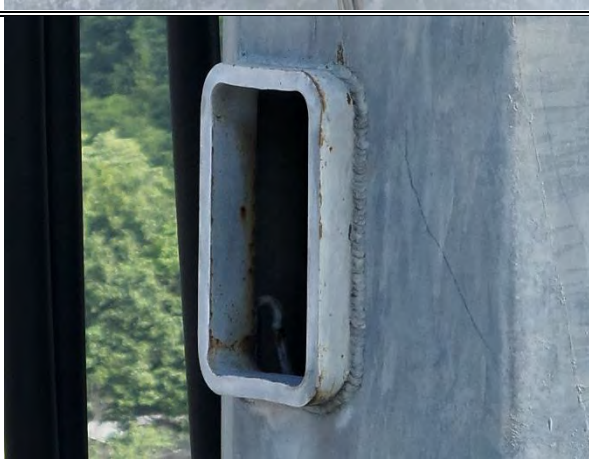
<p>2.2.4</p> <p>Tower</p>	<p>Corrosion is present at a coax port at approximately 110' opposite the climb face.</p> <p>Edge Personnel were not able to correct this issue at the time of inspection. Recommend clearing the corrosion and applying cold galvanizing compound as part of future maintenance.</p>

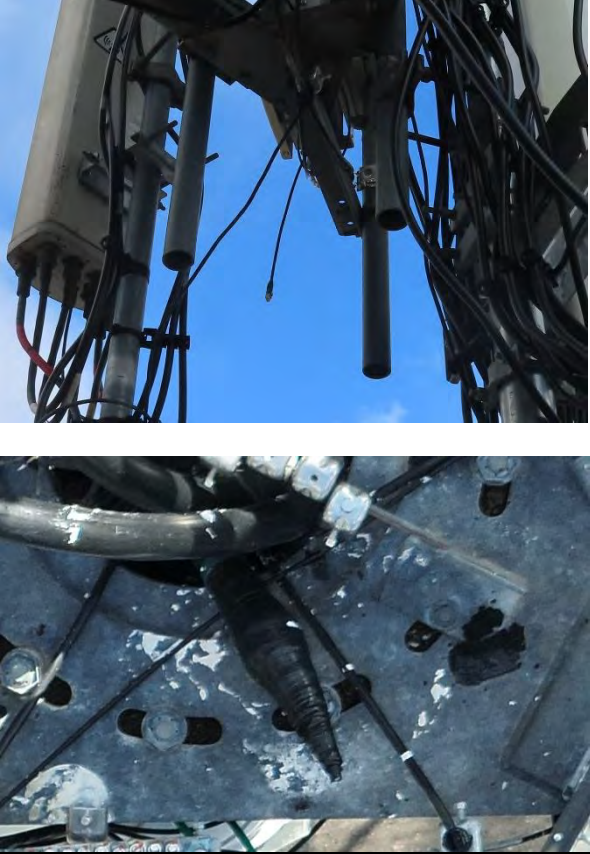
Category & Item Description	Non-Compliant Item & Recommendation	Photo
<p>2.3.1</p> <p>Cabling</p>	<p>Unused coax and RET cables are present at top of tower and on the antenna platform.</p> <p>Recommended to notify AT&T to remove all unused cabling.</p>

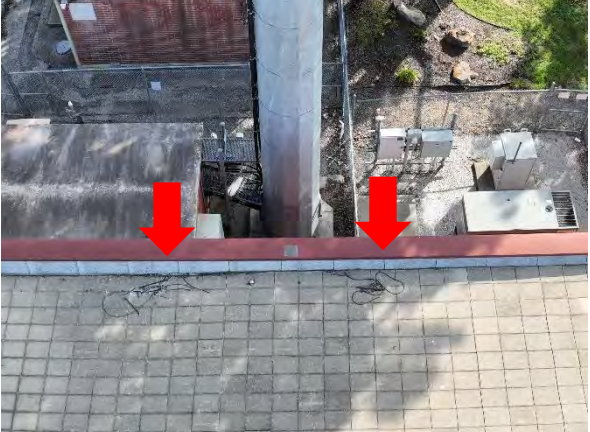
<p>The top photograph shows a close-up of a tower structure with several unused coaxial cables and RET cables hanging from the top. The bottom photograph shows an antenna platform with various cables and equipment, including some unused cables.</p>
<p>2.3.2</p> <p>Cabling</p>	<p>Decommissioned cables were present on the roof of a nearby building.</p> <p>Recommended to be removed as part of future tower maintenance.</p>

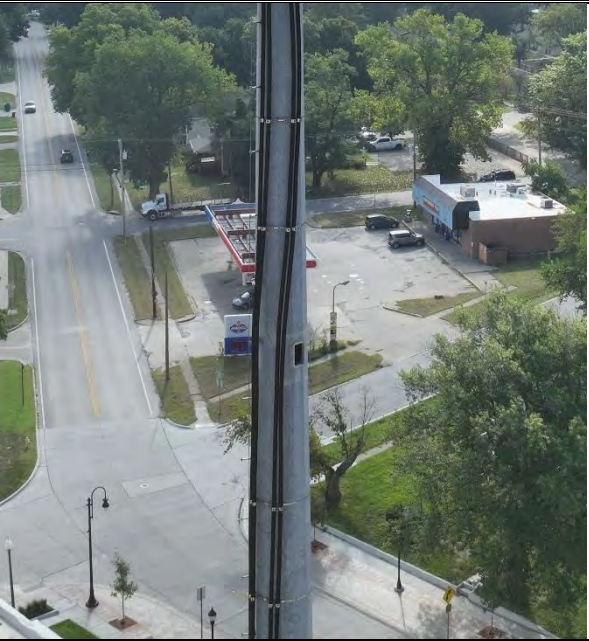
<p>2.3.3</p> <p>Cabling</p>	<p>AT&T cabling was not secured for approximately 20' on the tower.</p> <p>Recommended for additional coax support to be installed to ensure that all coax is supported every 5' as per TIA standards.</p>

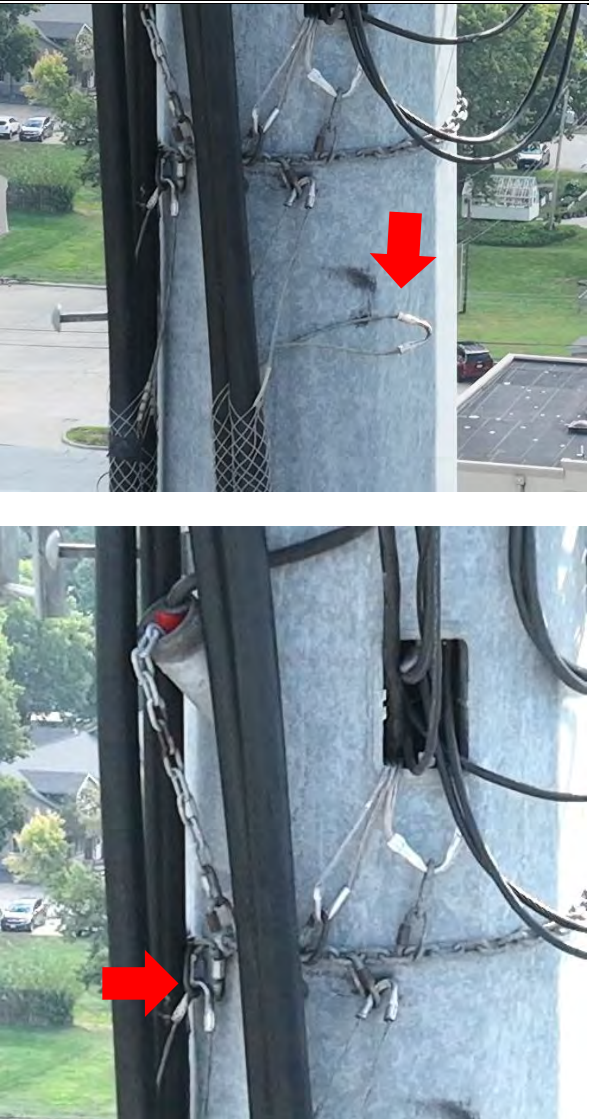
<p>An aerial photograph showing a tall, grey tower structure. Several black coaxial cables are visible running vertically down the tower. The surrounding area includes a paved road, green trees, and a building with a red roof.</p>
<p>2.3.4</p> <p>Cabling</p>	<p>A Kellum grip was not properly secured near the top of tower coax port at the time of inspection.</p> <p>Additionally, the locking carabiner for the coax support chain was not properly locked.</p> <p>Recommended to re-attach the unsecured Kellum grip and lock the carabiner as part of future tower maintenance.</p>

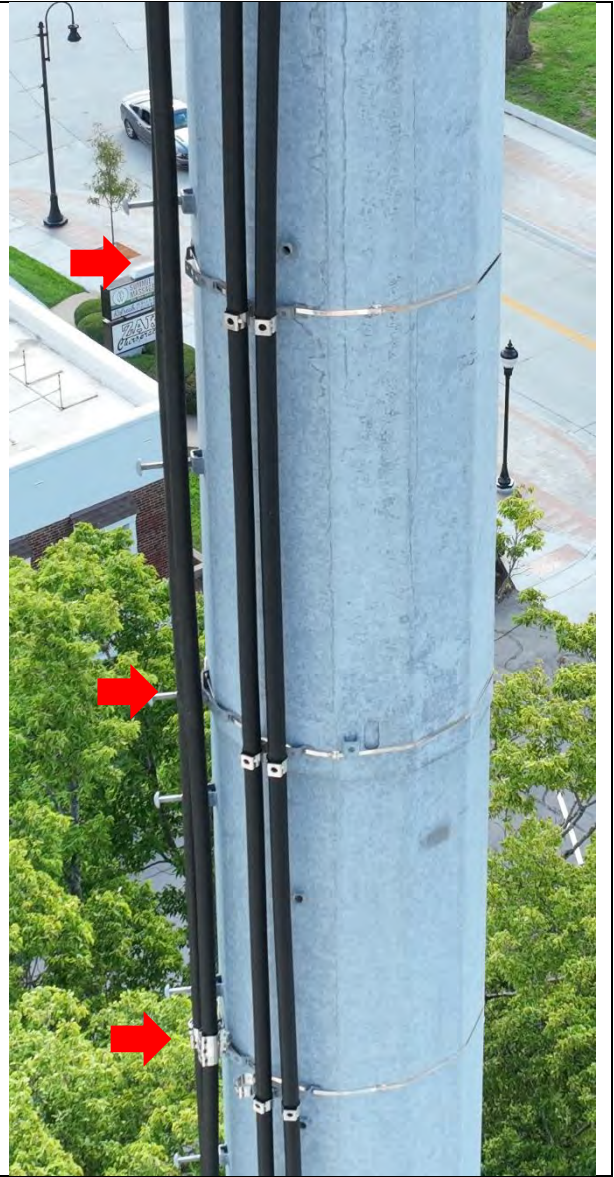
2.3.5

Coax snap-ins are not properly secured to the steel band straps at approximately 80-100'.

Recommended to re-secure the snap-ins in the near future.

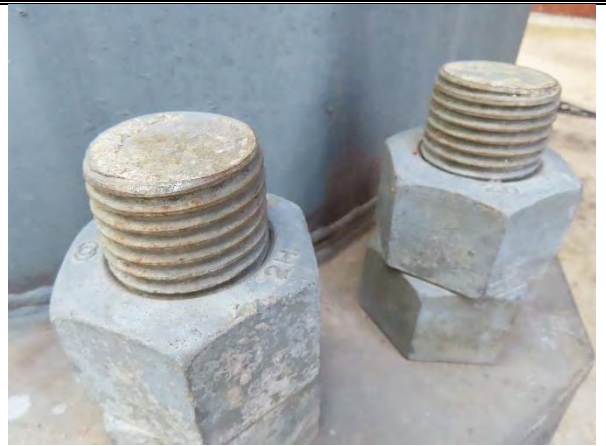
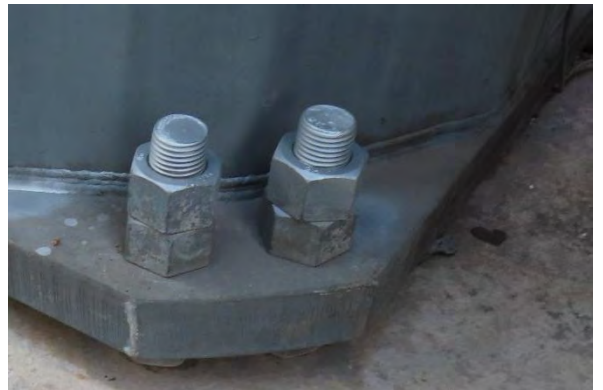
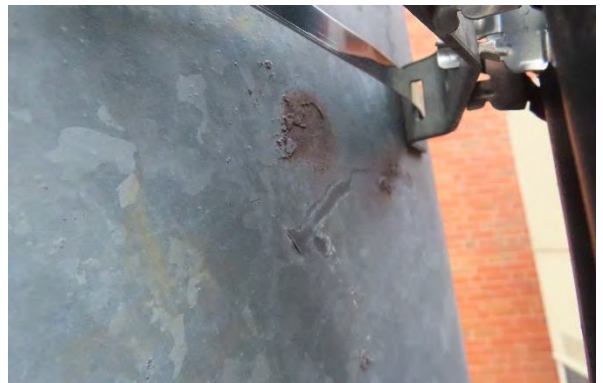
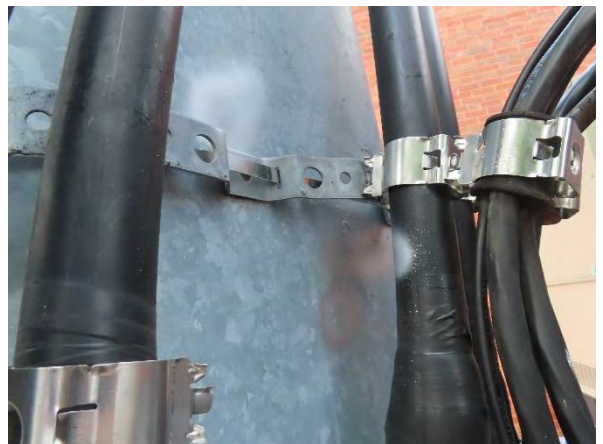
2.4.2

All tower anchor bolts galvanized coating is breaking down and the steel is beginning to corrode.

Additionally, the tower galvanized coating was damaged where the coax band straps were attached.

All visible corrosion was cleaned with a wire brush and coated with a cold galvanizing compound by Edge Consulting personnel.
