# TERRA TECHNOLOGIES

## **Old Longview Lake Rehabilitation/Restoration Study Lee Summit, Missouri**

**August 2017**

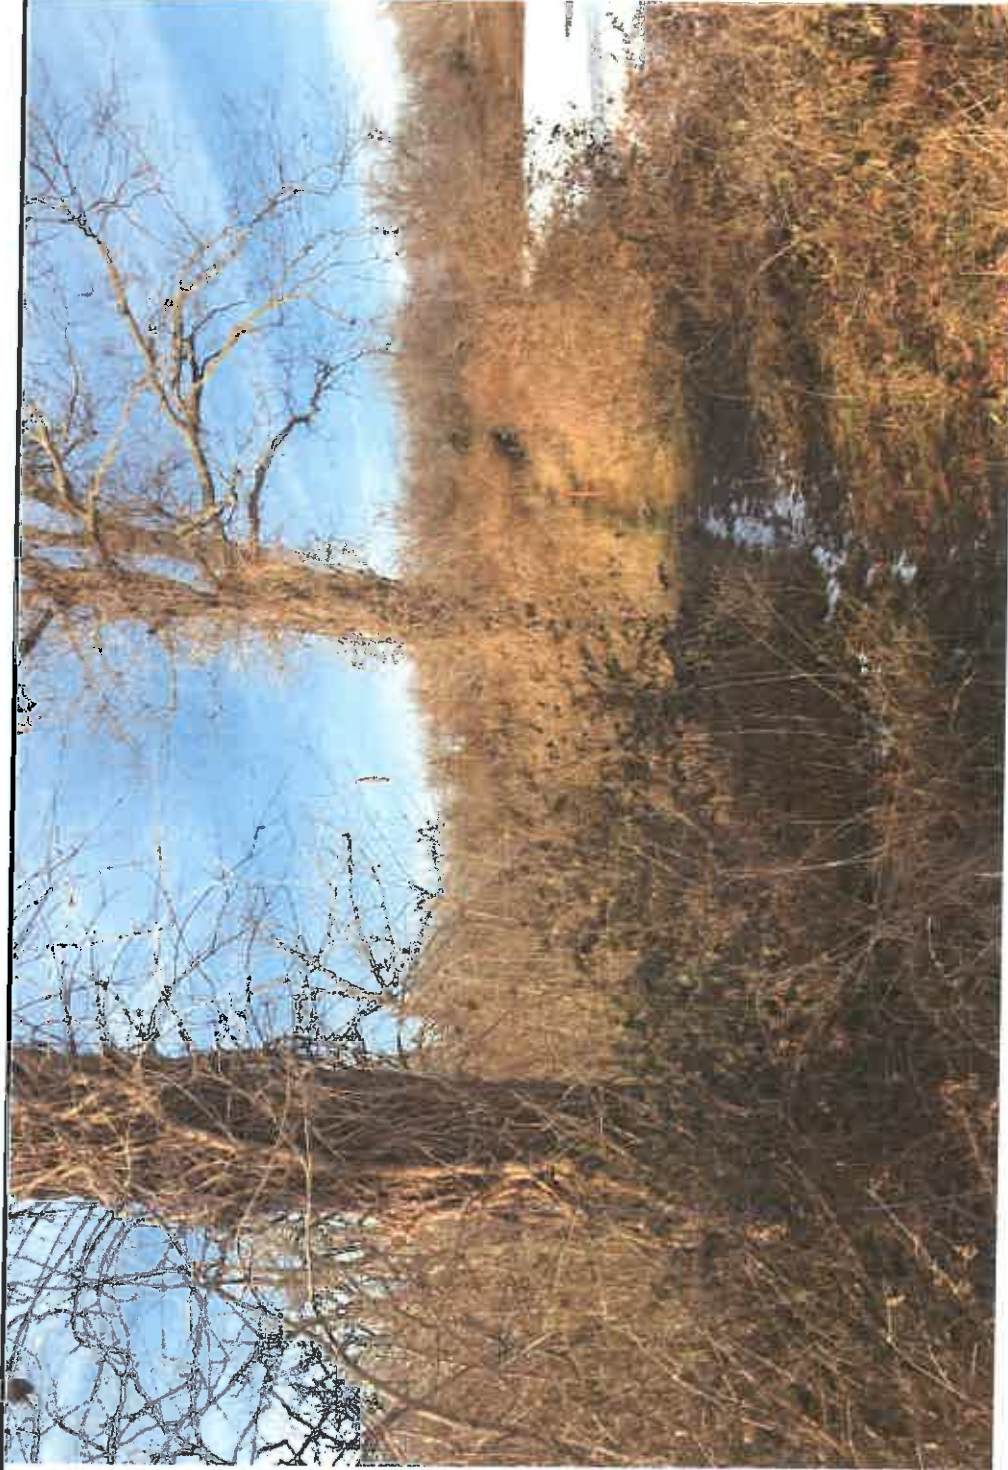
**Site Photograph #1**  
Longview Dam - North  
Lee's Summit, Missouri  
KCTE Project No. G20-16-310

Typical view of dam crest looking west.

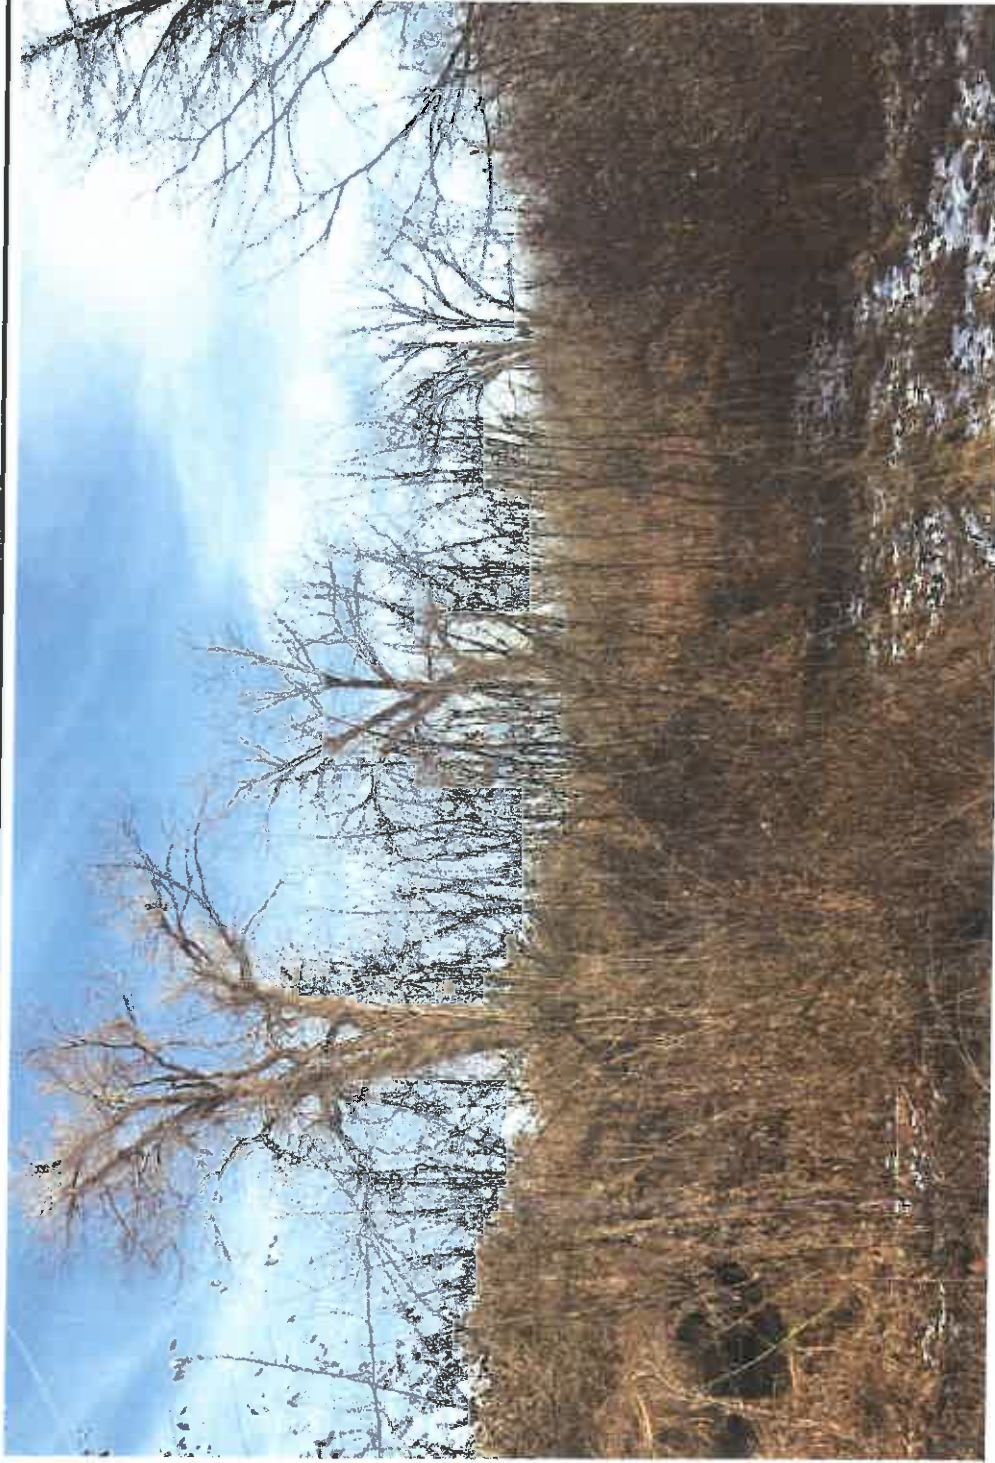
Dam stability and adequacy concerns have been caused by a lack of maintenance for a very long period of time. Woody vegetation has been allowed to grow on the dam with roots that potentially extend into the dam core. This has the potential to create hydraulic pathways within the soil, allowing greater volumes of water to seep through the structure. As hydraulic pressure

Typical view of woody growth on downstream face of eastern portion of dam.

Woody vegetation should not be allowed to grow and mature on dams. Roots can penetrate the embankment creating hydraulic pathways through the fill. Hydrostatic pressure can then build up within the embankment and create conditions whereby the dam may fail. Woody vegetation has been allowed to become established upon the dam top and downstream face. This vegetation should be removed and replaced with shallow rooted herbaceous vegetation such as turf grasses. Larger mature trees should be cut close to the ground and buried under fill. All other woody brush should be cleared and removed.

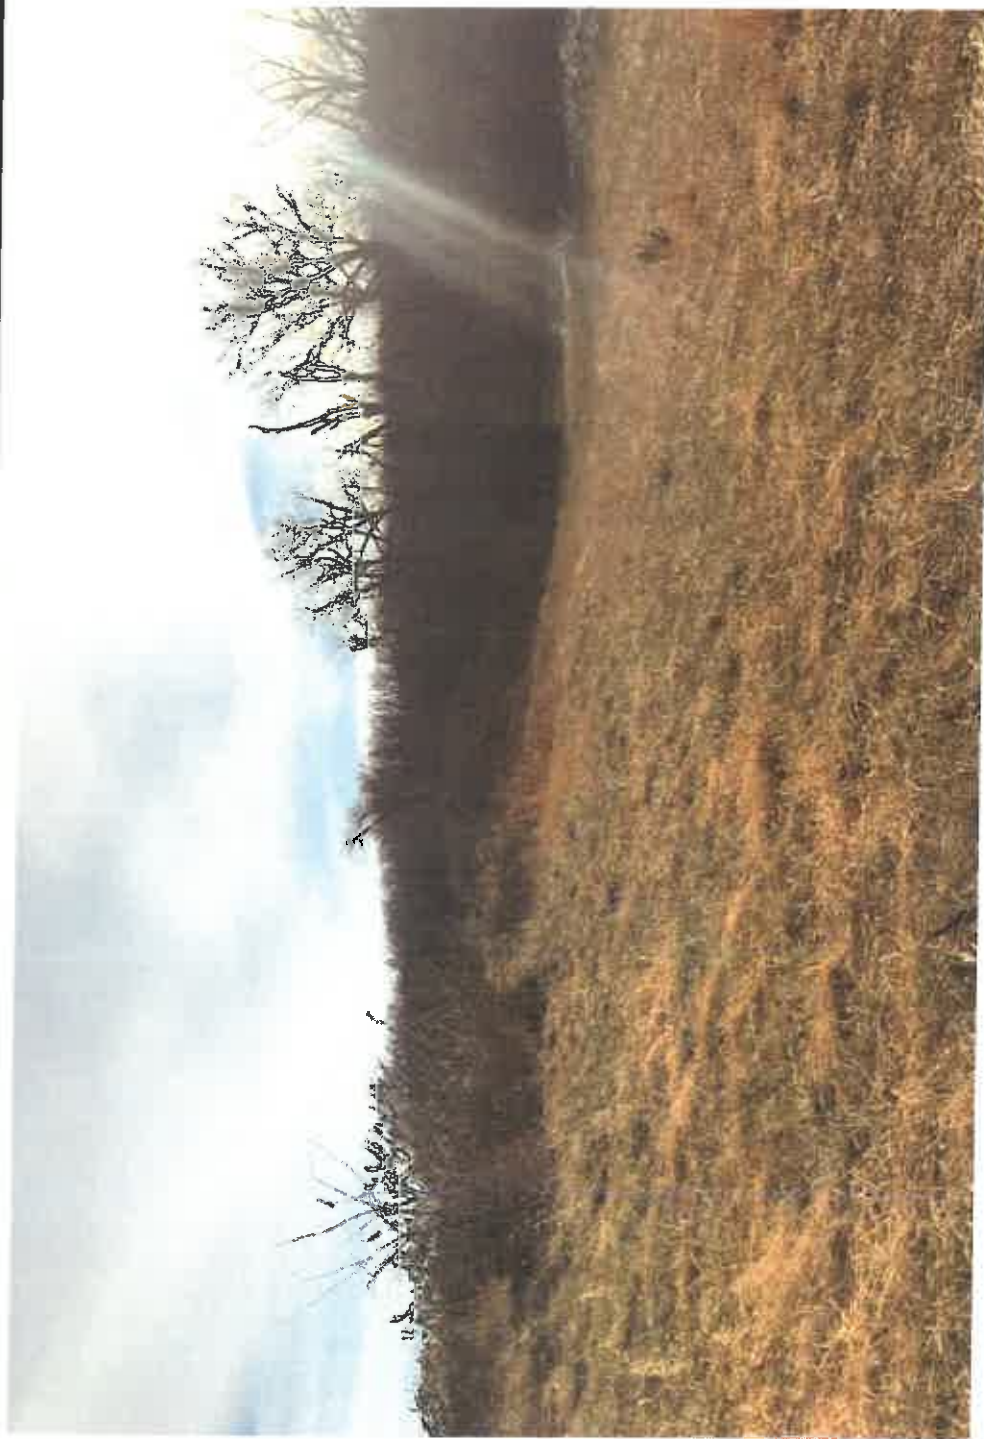
**Site Photograph #3**  
Longview Dam - North  
Lee's Summit, Missouri

Typical view of downstream face in western portion of dam, looking east.

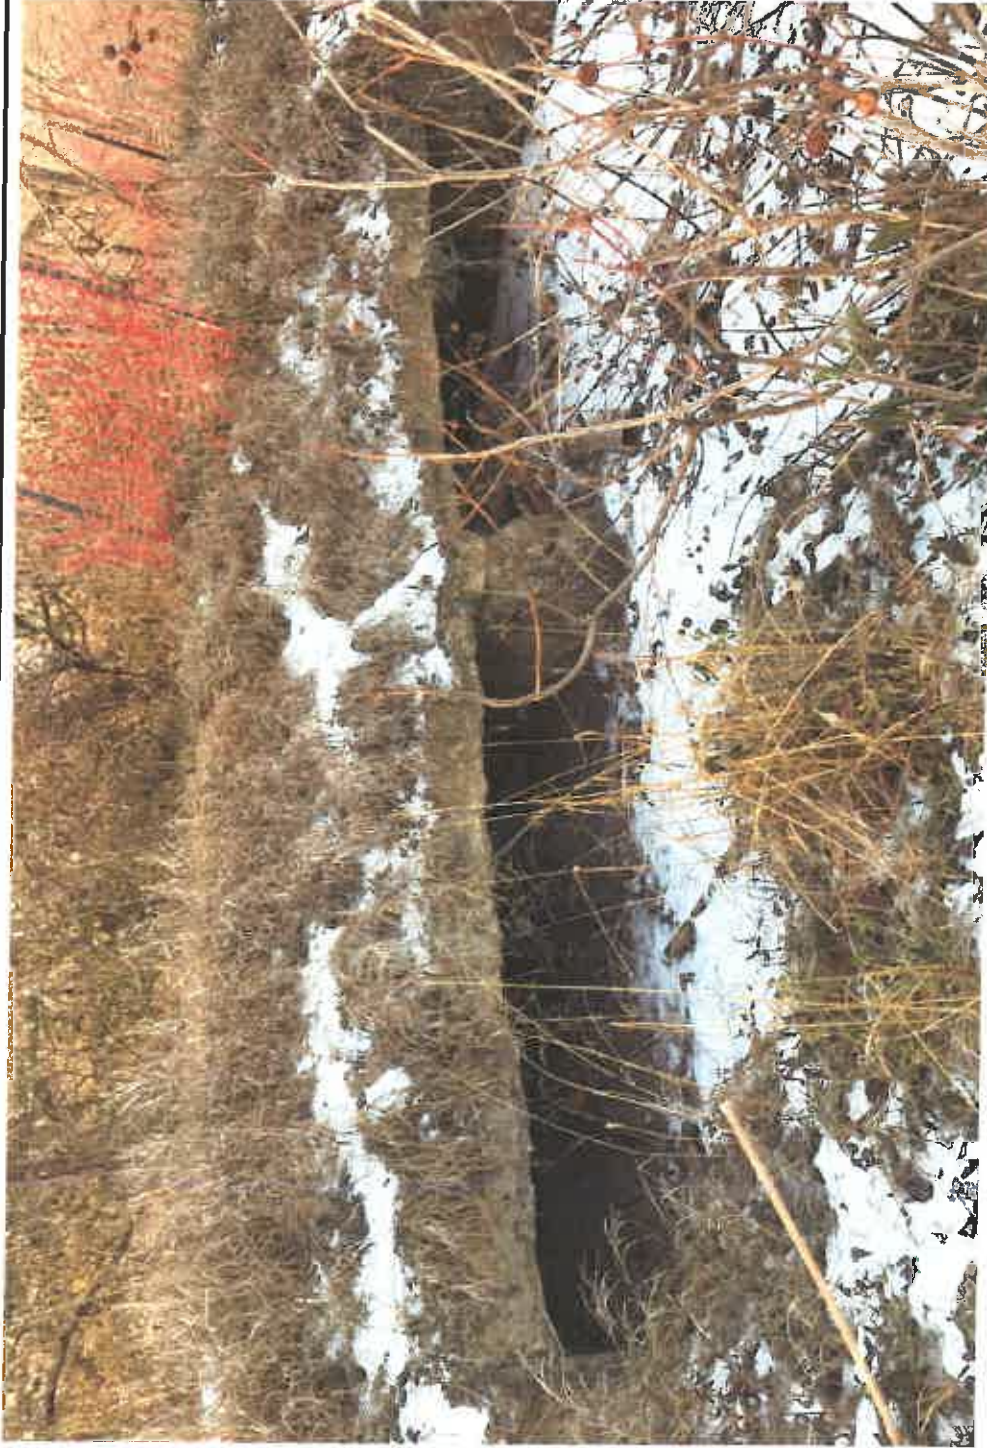
**Site Photograph #4**  
Longview Dam - North  
Lee's Summit, Missouri

Typical view of spillway structure, looking downstream from reservoir.

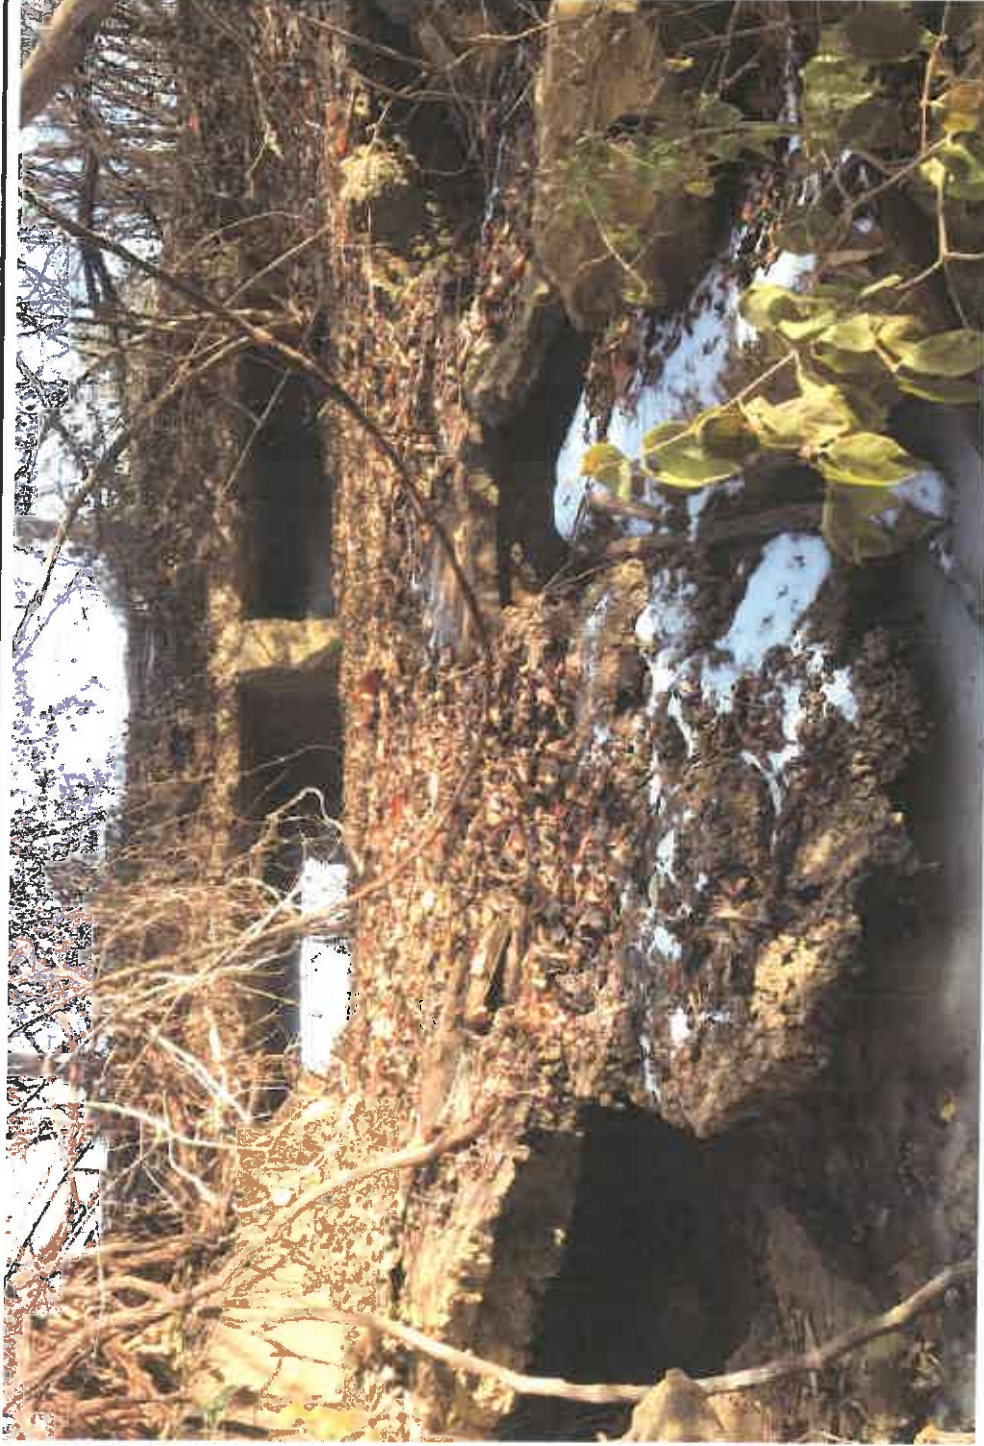
**Site Photograph #5**  
Longview Dam - North  
Lee's Summit, Missouri

Typical view of spillway structure, looking upstream from spillway channel.

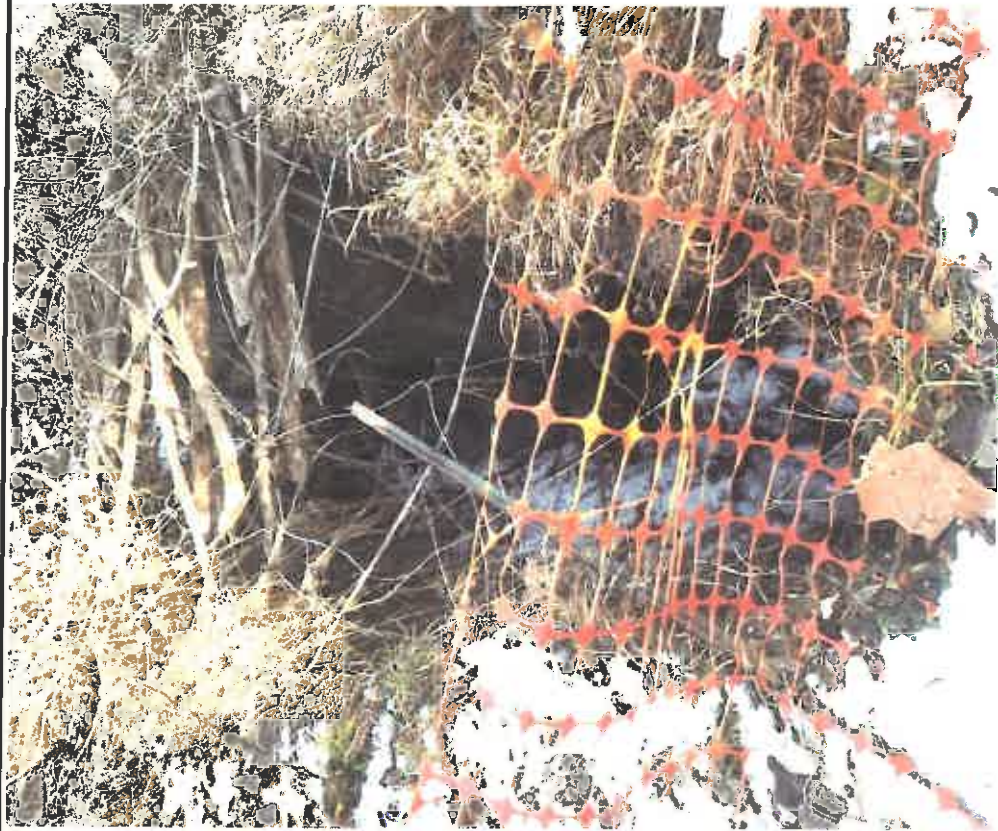
**Site Photograph # 6**  
Longview Dam - North  
Lee's Summit, Missouri

Typical view of erosional channel adjacent to spillway structure.

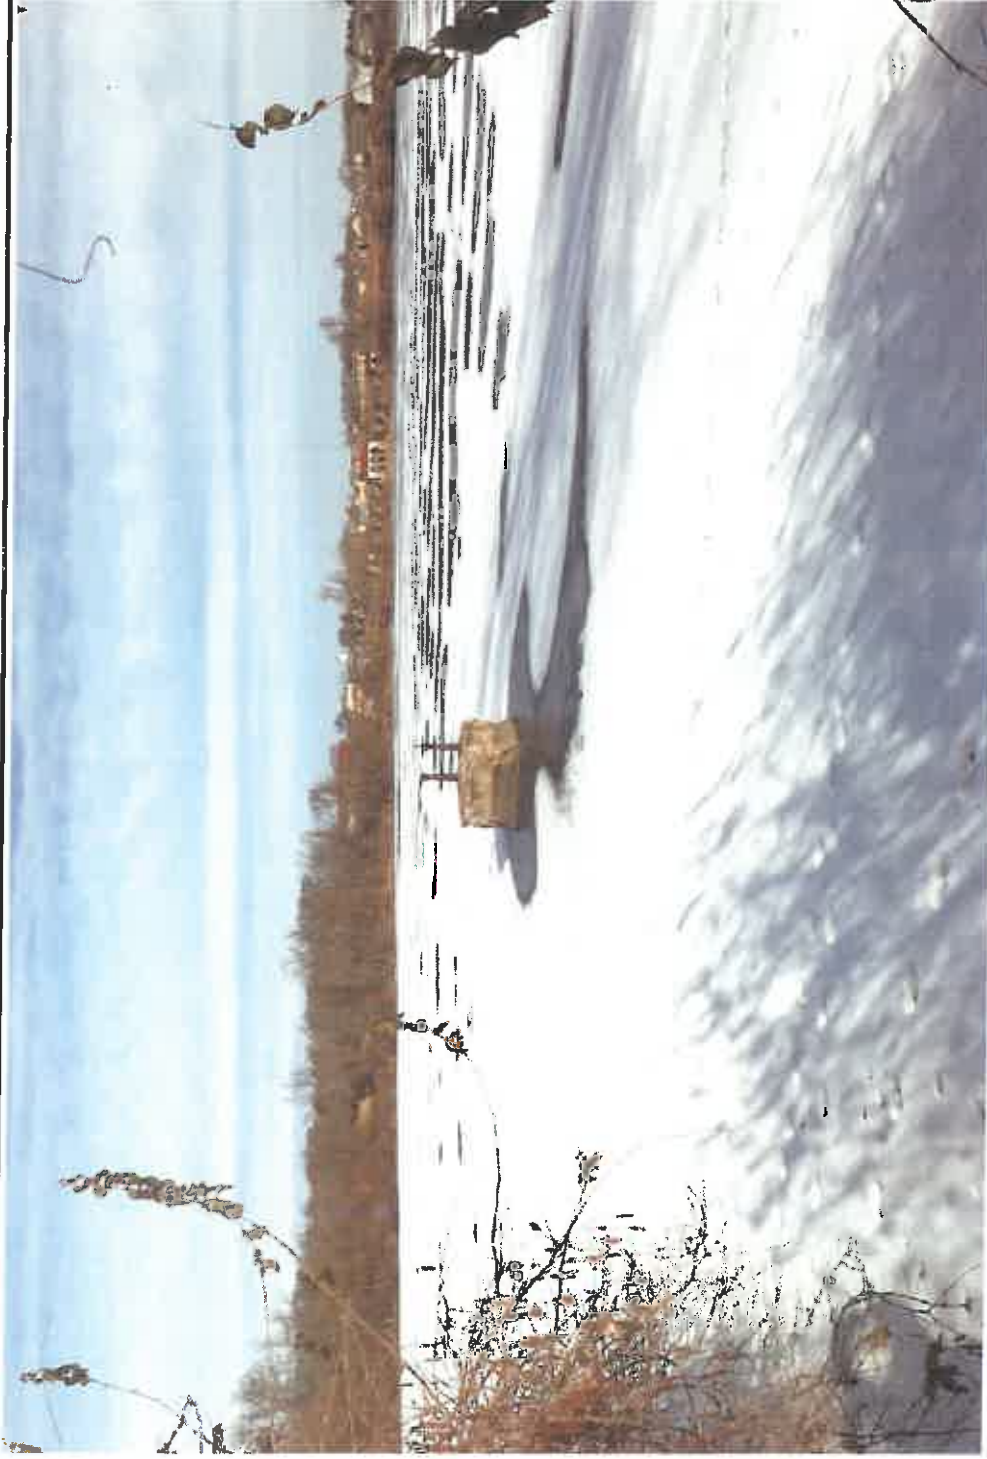
**Site Photograph #7**  
Longview Dam - North  
Lee's Summit, Missouri

Typical view of intake / gate house structure.

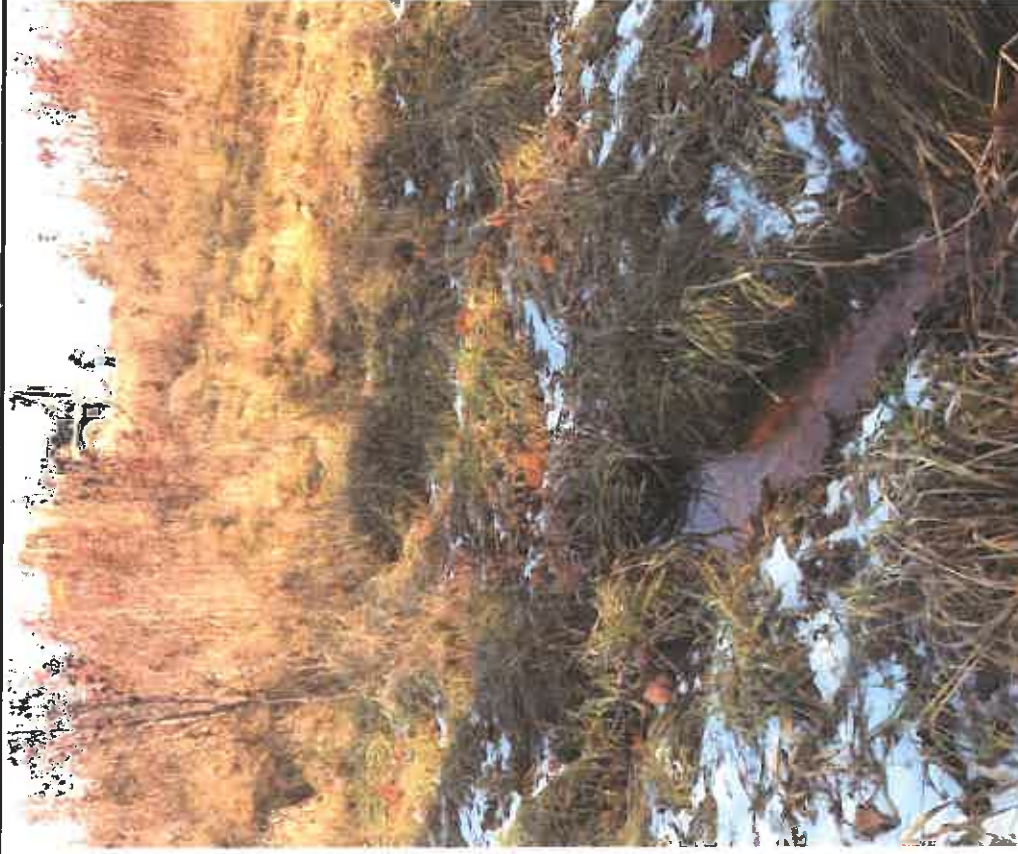
Typical view of water seepage at toe of dam.
