RE: Geotechnical Third Party Review  
Old Longview Dam Rehabilitation Project  
Old Longview Dam  
Lee's Summit, Missouri  
Terracon Project No. 02185014

## Geotechnical Third Party Review

Old Longview Dam Rehabilitation ■ Lee's Summit, Missouri

March 2, 2018 ■ Terracon Project No. 02185014

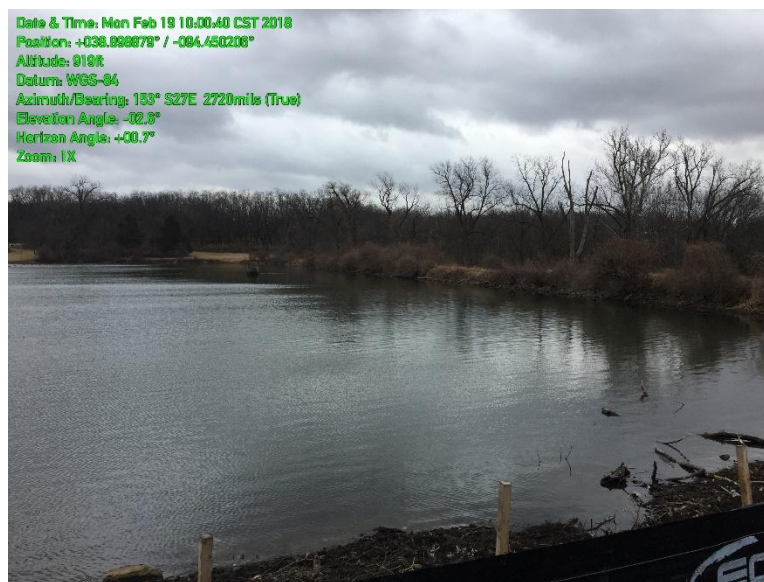
The dam is covered with grass along the downstream face, with heavy brush along the crest, and heavy brush and trees growing on the crest and downstream face of the eastern half of the dam. We did not observe any signs of seepage at the toe of the dam, which may be due to the ground still being frozen.

Photo 1- Looking at dam from western shore to the southeast

**Vegetation on the dam crest and face-** Clearing these trees and brush should be accomplished as soon as possible. It is important to have the geotechnical engineer provide recommendations for removal of root balls and replacement of the resulting excavations with proper engineered fill material.

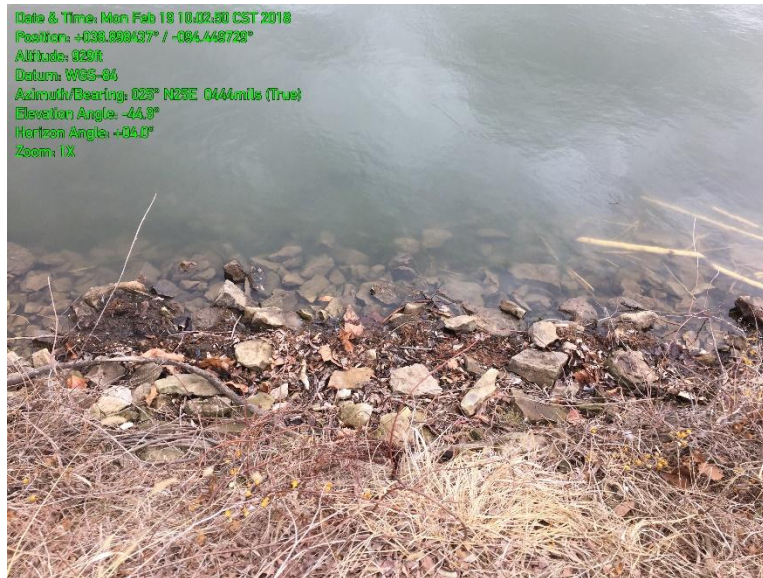
The upstream face appears to have rock fragments placed on it to control erosion (Photo 2). The freeboard area over the water surface does not appear to have any rock on its face and has experienced significant erosion (Photo 3).

**Photo 2- Upstream face rock "erosion control"**

Riprap- Photos 2 and 3 indicate the that upstream crest of the dam is eroding. Also, the rock fragments that were used for erosion control on the upstream side of the dam, do not have the size or durability to be used as Rip Rap per current Standard of Practice. This rock lacks the durability and size to provide adequate protection against wave action of the water.

The final restoration design should include adequate rip rap erosion protection along the upstream dam face. The final geotechnical design for any buttress fill or raising the crest of the dam should include toe keys/drainage and benching recommendations/details.

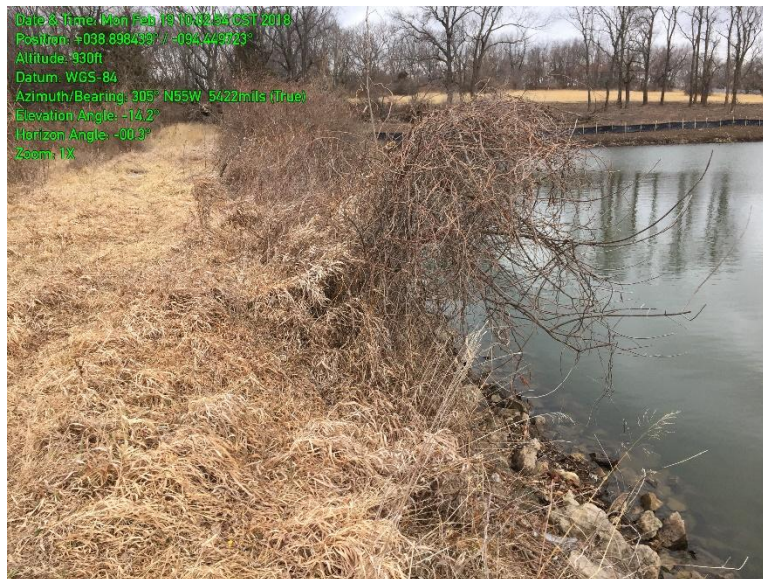
**Photo 3- Looking west at freeboard erosion of embankment**

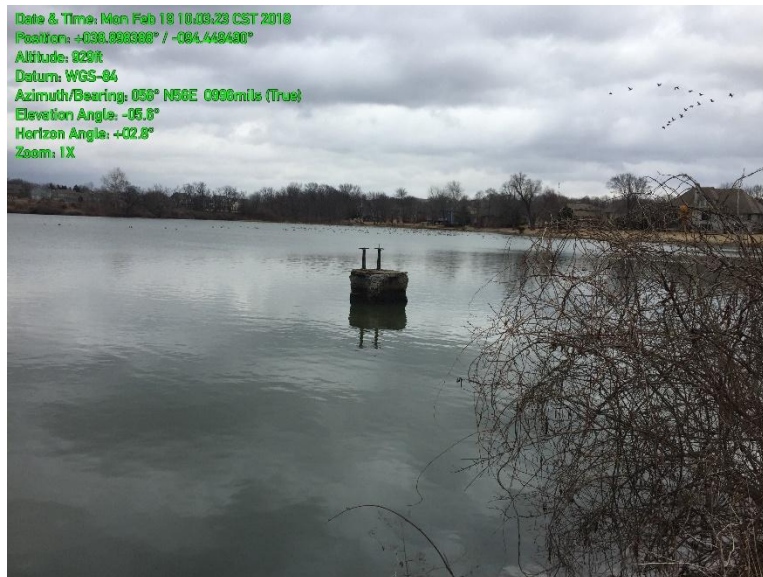
The primary spillway and outlets works appear to be in very poor condition, and is only accessible by boat, as there is no access walkway from the crest (Photo 4). The Terra Technologies report states that the outlet works valves and the spillway are inoperable. They could not find the outlet for this system, and Terracon could not locate the outlet during our site visits.

**Photo 4- Primary spillway and outlet works**

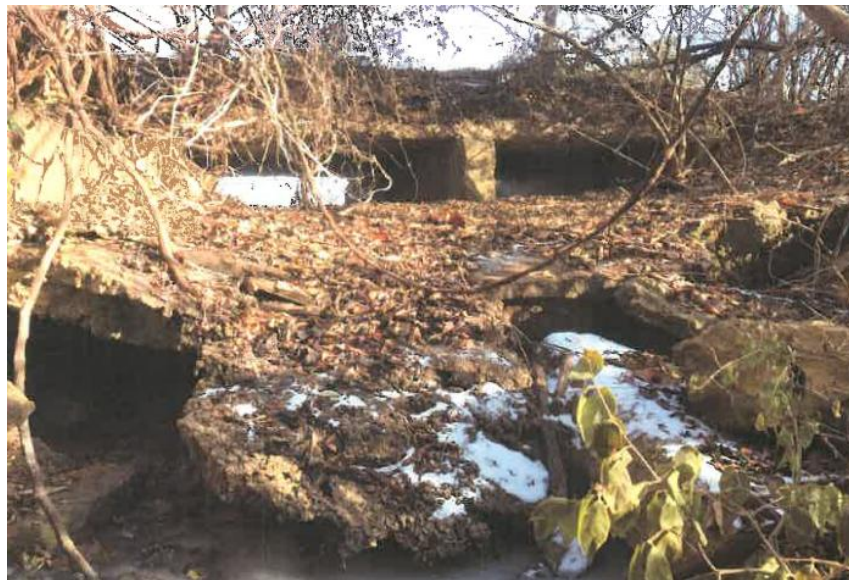
The emergency spillway was intact, but experiencing erosion that was undermining it when it was observed by KCTE (Photo 5). It has since collapsed (Photo 6) and we observed a steady flow of water (Photo 7) in the erosion channel coming from the lake.

**Photo 5- Emergency spillway in late 2016/early 2017 (from Reference 2, Photo 5)**

**Spillways-** In Photos 6 through 9 the current condition of the emergency spillway structure (which has collapsed) and the downstream drainage course can be seen. Compare this to the Photo #5 (from Reference 2), when the structure was still intact (though heavily eroded adjacent and below it).

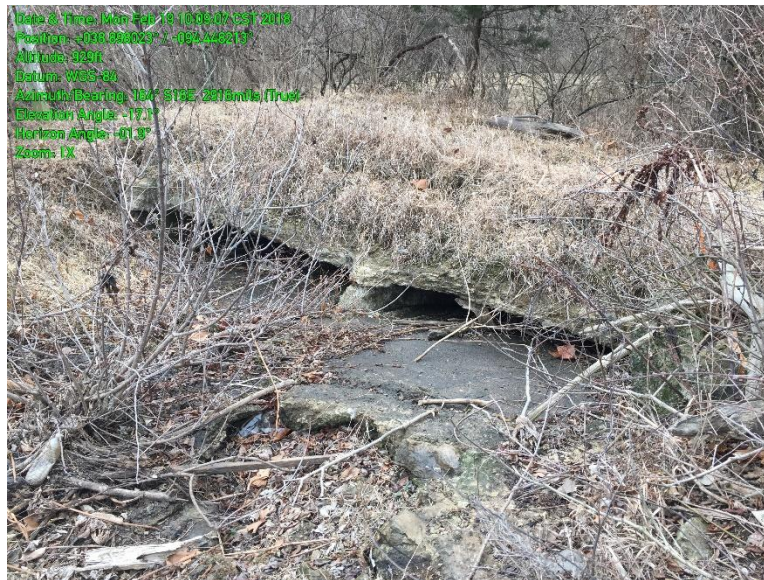
Photo 6- Emergency spillway February 19, 2018)

The condition of the emergency spillway is an immediate problem that should be addressed as soon as practical. We recommend that a civil engineer evaluate the spillway and provide recommendations for a temporary and/or permanent fix.

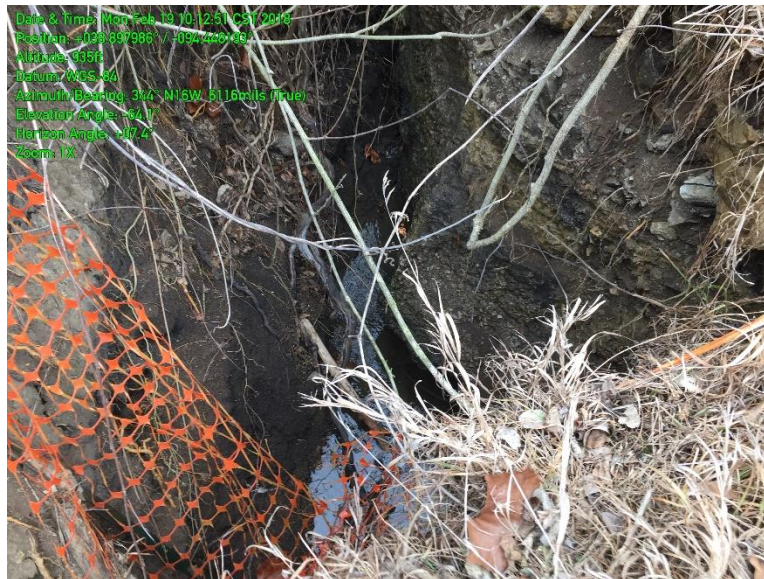
Photo 7- Seepage under emergency spillway

Note Photo 7 the seepage under the old emergency spillway and related/continuing erosion occurring at this location.

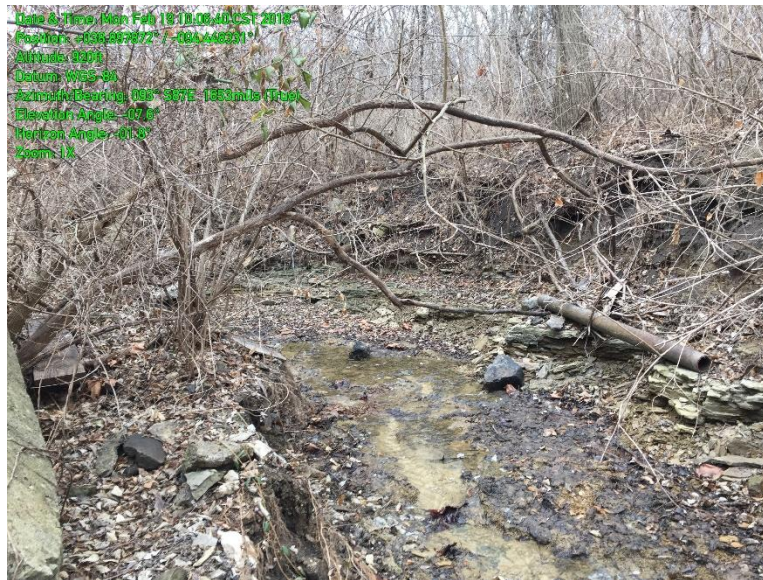
Downstream of the emergency spillway, significant erosion of the stream banks was observed during our visit (Photos 8 and 9).

Photo 8- Looking southwest from downstream side of emergency spillway

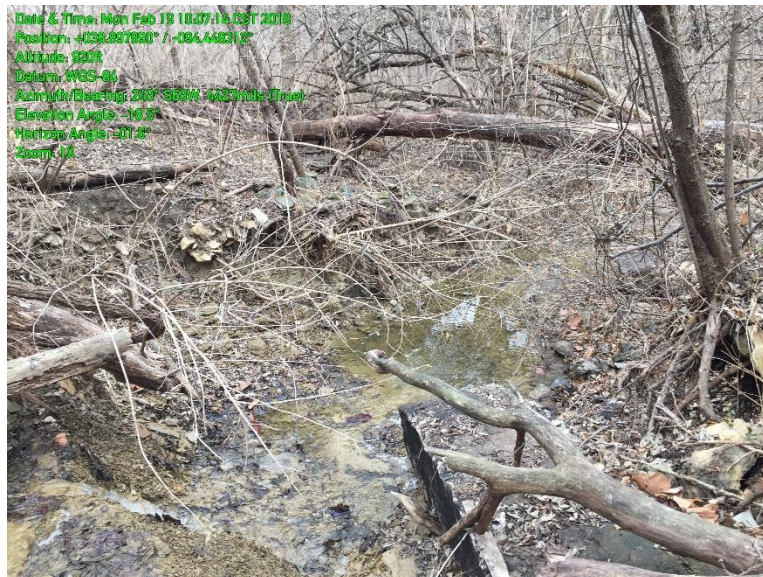
Photo 9- Looking south approximately 100 feet downstream from emergency spillway
