Re: Old Longview Lake - Dam and Spillway Observations and Preliminary  
Recommendations Letter  
Lee's Summit, MO  
Olsson Project No. 017-0305

An Olsson Associates (**Olsson**) Geotechnical Engineer visited the site on April 30<sup>th</sup>, 2018 to observe the existing dam and spillway. This letter discusses our observations and includes recommendations for temporary remediation to the dam and spillway. This letter does not address the future design or construction plans for the lake. Recommendations and opinions on future design and construction plans will be presented under a separate cover.

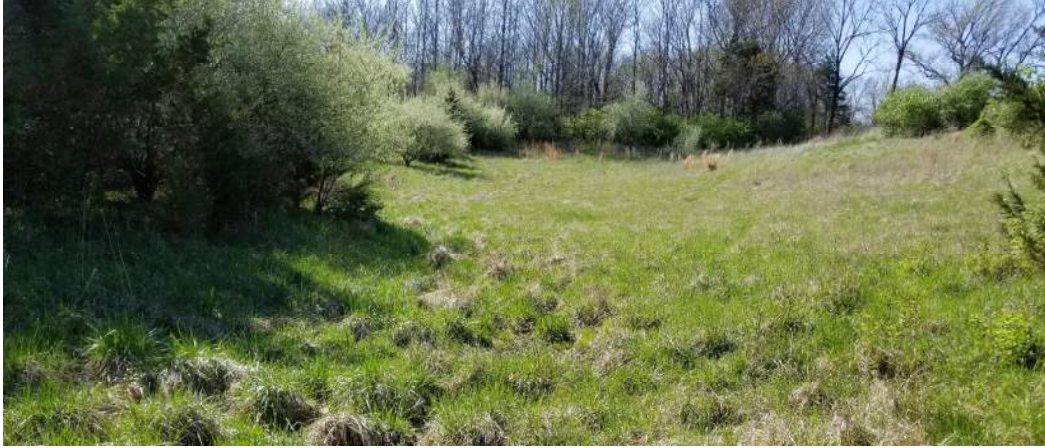
The west half of the downstream face of the dam slopes at an estimated 5H:1V and contains shallow rooted shrubs on the crest of the dam and shallow rooted grasses on the face of the slope. A photograph of the west portion of the dam is shown in Figure 3.

Figure 3: Photograph of West Portion of the Downstream Face of Dam

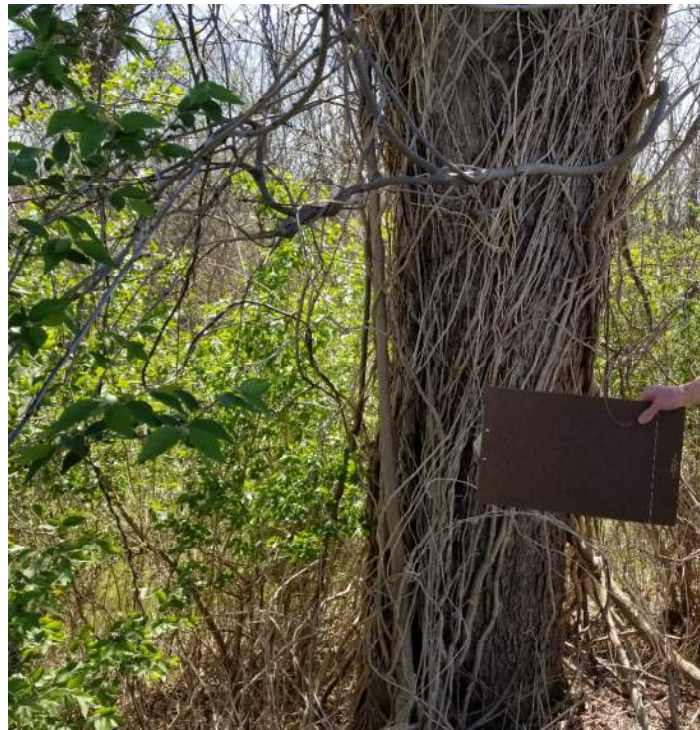
The center of the downstream face of the dam contains shallow rooted vegetation and two large mature trees on the crest of the dam (Figure 4). Smaller, less mature trees cover the remainder of the slope (Figure 5). The large trees appear to be around 24 inches in diameter and have canopies around 50 feet in diameter. The smaller trees are generally 6 inches in diameter or less. Additional vegetation, including shrubs and grasses, were observed in this area.

Figure 4: Photograph of Large Mature Tree on Crest of Dam

In our opinion, despite the seepage observed, the earthen dam is in relatively good condition. This is likely because the slopes of the dam are flatter than what new construction usually dictates. As such, remediation should begin with the construction of a pathway to the spillway. This will include removal of small vegetation 6 inches in diameter or less and any brush or weeds in the pathway. For trees greater than 6 inches in diameter, the path should be rerouted around the larger trees as the excavation to remove the entire root ball could be large and leaving the root ball in place could result in additional seepage paths developing in the dam.

Removal of the large trees should be delayed until final construction plans are developed and the lake can be drawn down to a level that does not destabilize the dam during excavations. Repair of the toe seepage can also be delayed until final construction.

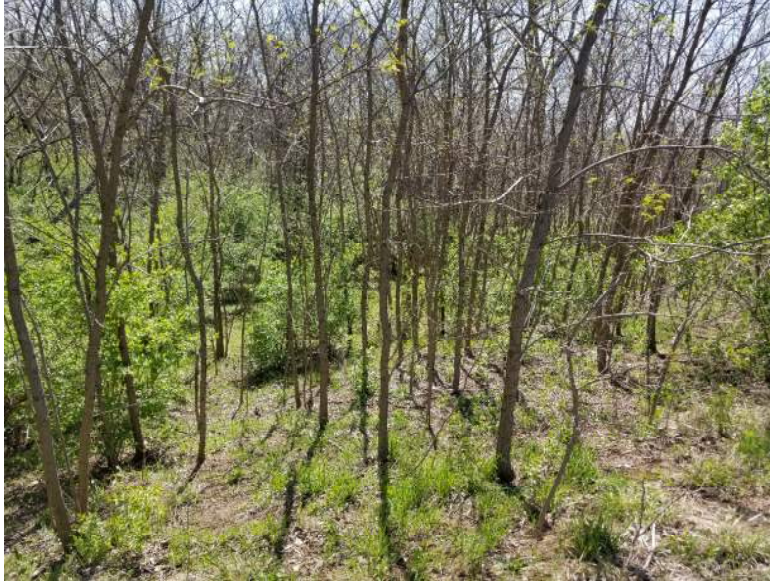
Figure 5: Smaller Trees on Slope of Downstream Side of Dam

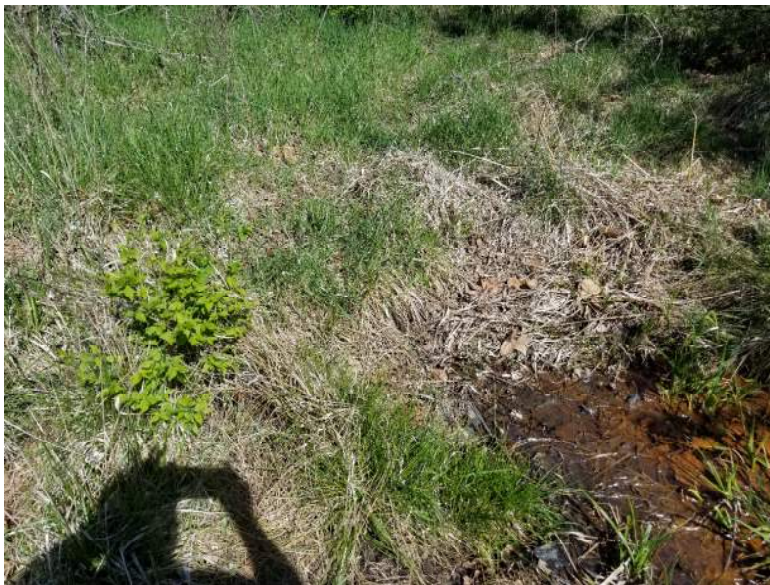
Seepage was observed at the toe of the slope in the central portion of the dam. In our opinion, the amount of seepage observed was relatively minor as erosion from the seepage or flowing water out of the toe was not observed. In addition, seepage was only encountered at the toe and not found along the slope. The pooling of seepage water at the toe of the slope is shown in Figure 6.

Figure 6: Photograph of Seepage at Toe of Dam

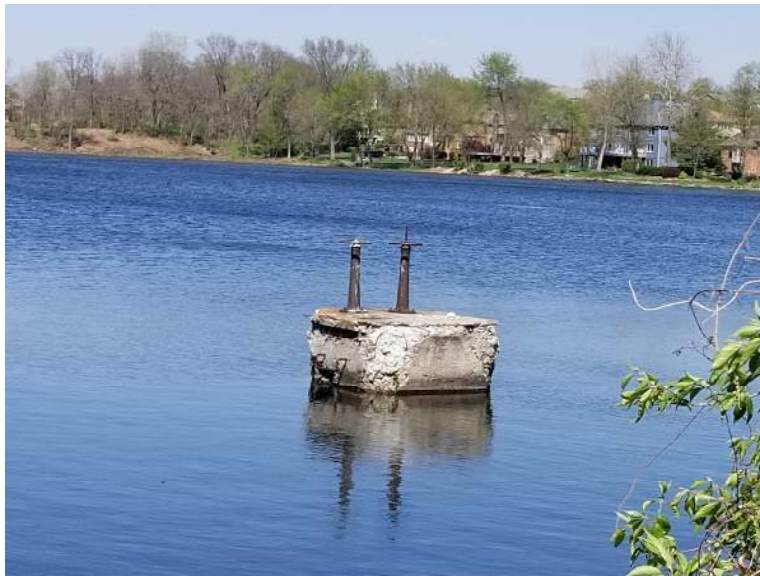
What appears to be a drawdown structure with a set of valves is located within the lake approximately 50 feet north of the dam. We did not investigate the structure as access to the structure is only available by boat. However, it appears that this structure is no longer serviceable as we could not locate an outlet pipe downstream and the valves did not appear operable from our vantage point. In addition, the concrete foundation for the valve structure is in very poor condition. The structure is shown in Figure 7. We do not anticipate this structure will be reused.

Figure 7: Drawdown Structure

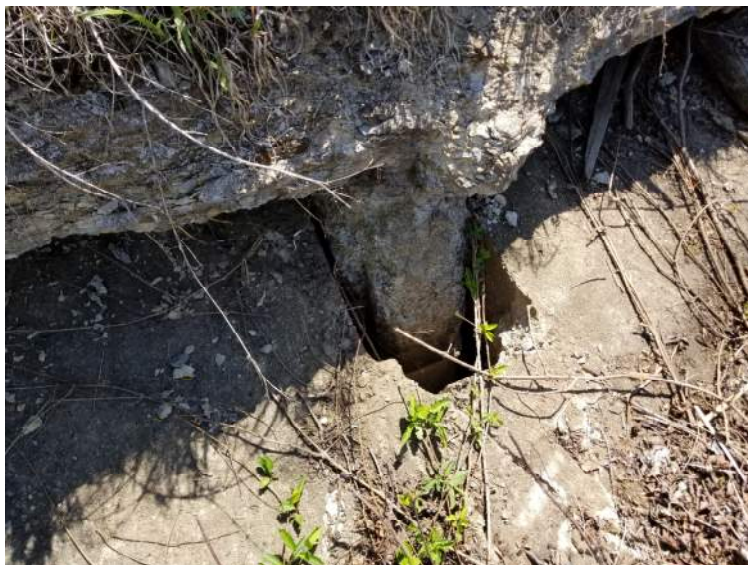
The primary spillway for the lake is located on the far east side of the dam. The spillway consists of a reinforced concrete double box with wingwalls downstream. The concrete is in very poor condition. Weathering has resulted in the exposure of the reinforcing elements. At the time of our site visit, the top portion of the box had punctured the concrete apron below (Figure 8).

Figure 8: Photograph of Spillway Puncture

The puncture appears to be due to loss of support from erosion below the bottom of the apron (Figure 9). In addition, the wingwalls appear to have been pushed into the channel from the growth of large vegetation (Figure 10).

We recommend the top portion of the double box spillway that has punctured the apron be removed to provide improved drainage along the spillway. From our observations, this portion of the spillway appears to only have been constructed to level the dam crest. Once the upper portion is removed, we recommend the holes in the concrete apron of the spillway be filled with non-shrink cement grout, flowable fill or Portland cement concrete. Any other noticeable seepage paths should also be grouted, including the erosion around the west side of the spillway. Once all the seepage paths are grouted, a minimum of 3 feet of rip-rap should be placed in front of the spillway extending 10 feet to either side of the spillway to help protect the spillway from additional erosion. The rip-rap should appropriately sized. Rip-rap should also be placed on the downstream side of the spillway to prevent any movement that could occur during high water events.

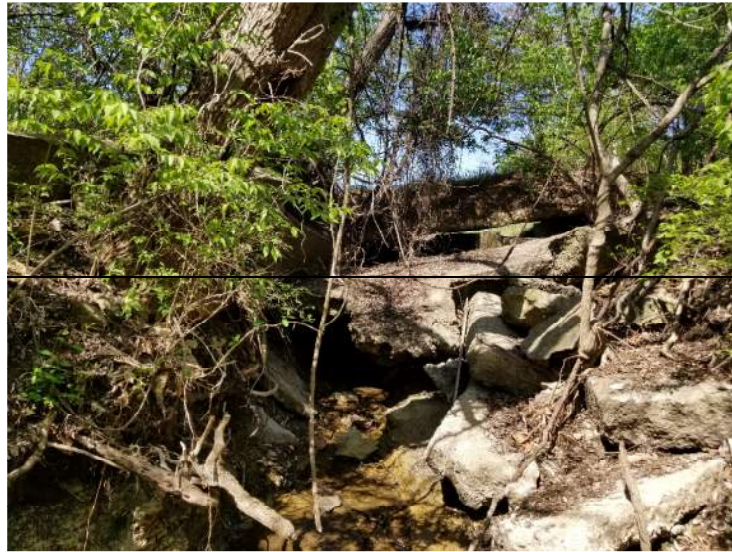
Figure 9: Photograph of Erosion Below Concrete Apron

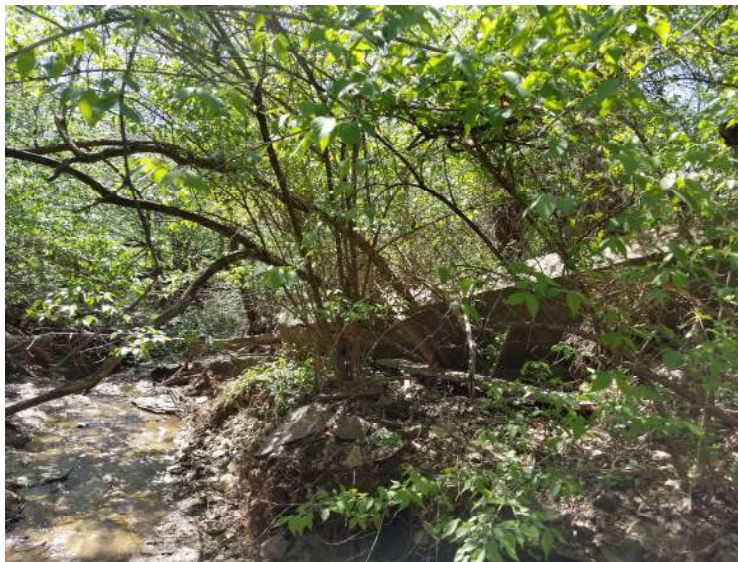
Figure 10: Photograph of Failed Concrete Wingwalls

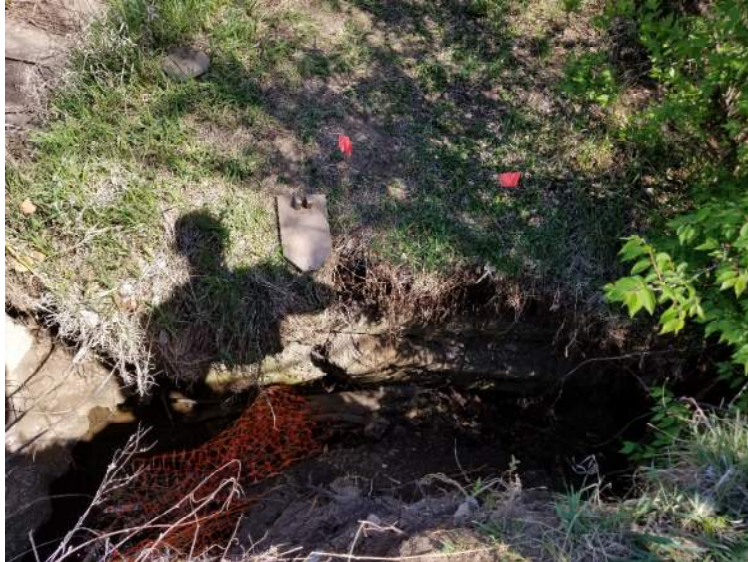
In addition to erosion below the spillway, we also observed erosion around the west side of the spillway (Figure 11). Erosion around the west side was around 3 to 4 feet deep and around 3 feet wide. At the time of our observations, the majority of water loss from the lake is directed through this area of erosion, however, the water level of the lake during our site visit did not reach the height of the spillway apron. It appears that during high water events, water would be directed over the spillway as normal. The areas downstream of the spillway appear consistent with most streams in the area. Some erosion is present, but erosion is limited by the thick vegetation and shallow rock elevation.

Figure 11: Photograph of Erosion Around West Side of Spillway
