Re: Site Visit – June 12th, 2017
Old Longview Lake Dam and Spillway
Lee's Summit, MO
Olsson Project No. 017-0305

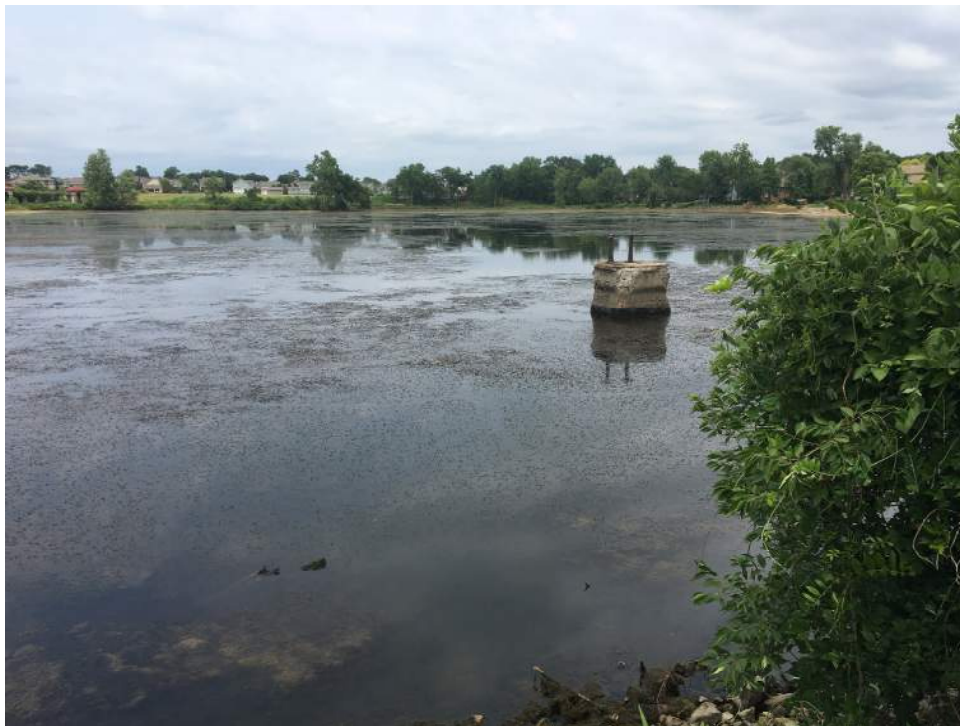
As requested, Olsson Associates (**Olsson**) visited the project site on June 12th, 2018 to observe the existing condition of the Old Longview Lake Dam and Spillway. Our previous observation noted a syphon pump drawing down the lake. At the time of our current observation, we observed the lake to be around 3 to 5 feet lower in elevation as indicated by the staining on the structure shown in the Figure below.

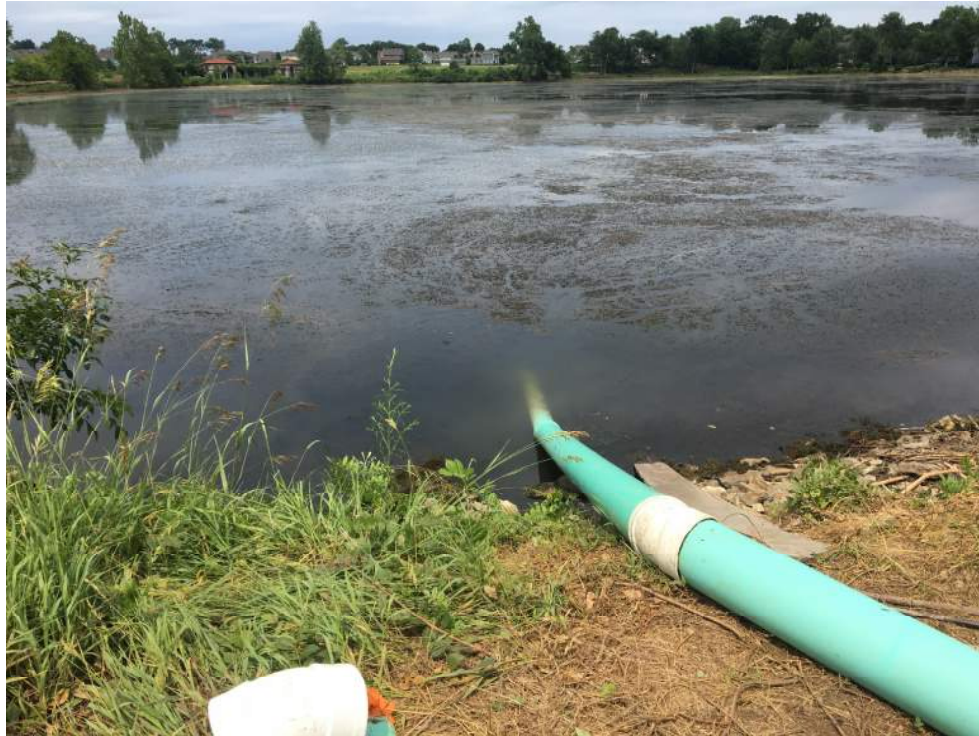
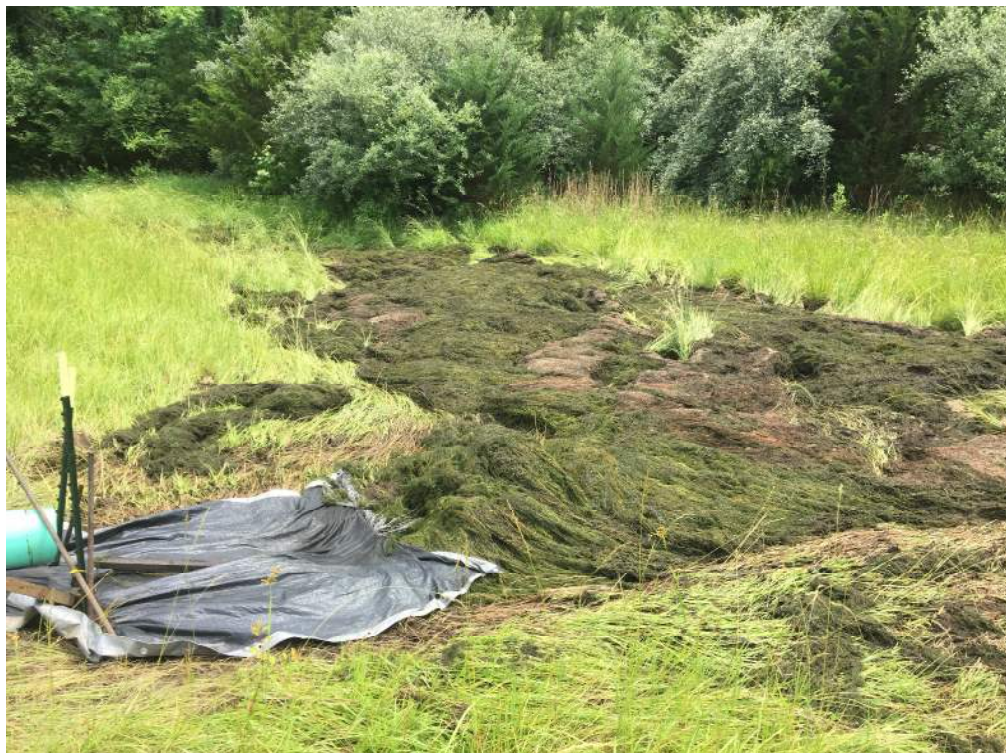
In addition, the pipe was no longer drawing water from the lake due to clogging from vegetation. Moss is shown at the base of the hill where the pipe outlets. This is shown in the Figure below. We understand the water collection area is to be deepened and cleaned in order to continue syphoning.

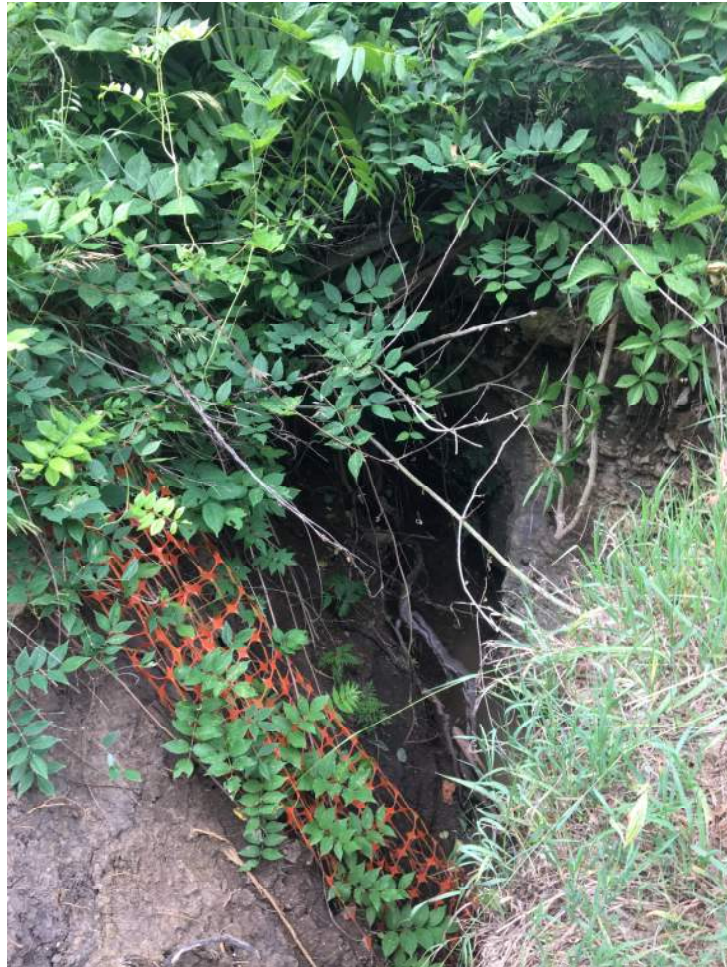
No water was observed flowing over the blanket of the spillway or through the eroded area on the west side of the spillway. Visually, the dam, spillway and erosion channel do not appear to have changed since our initial visit. We have included a current photograph of the area below.
